Temporary Construction Worker Dies After Falling from a Scaffold Plank in Washington State

FATALITY INVESTIGATION REPORT

Investigation: # 02WA01901
SHARP Report: # 52-16-2007

Release Date: June 25, 2007

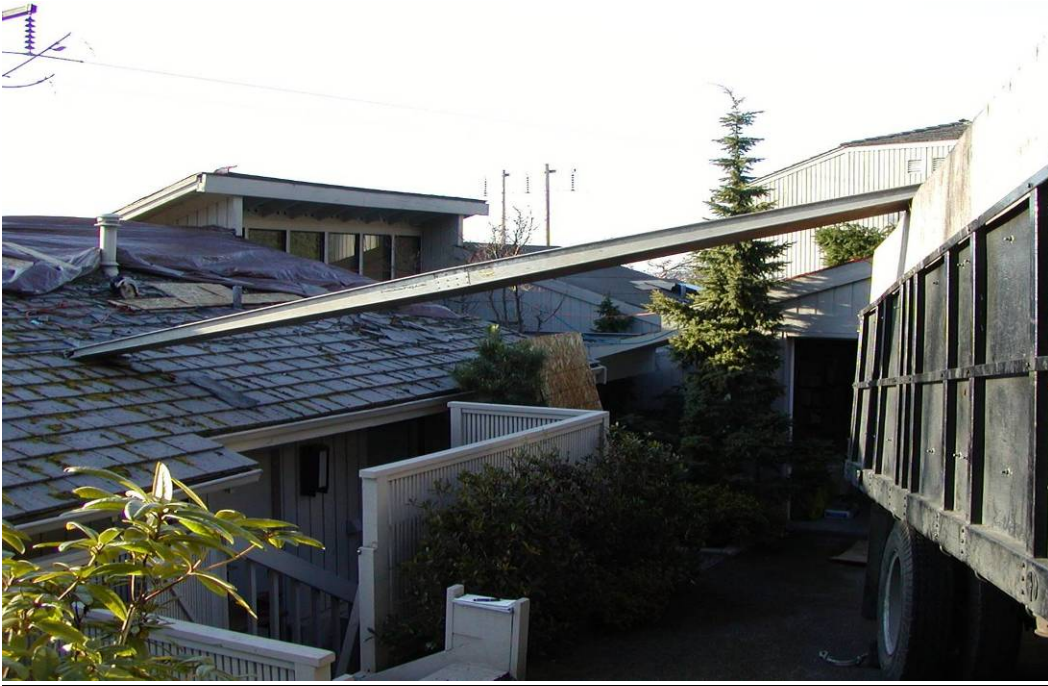
The upward angle was created partially due to the topography of the property and the relationship of the elevated driveway to the residence located on a hillside. The angle of the plank was also dictated by the length of the plank. Because of the length of the plank, it had to be positioned lower on the roof in order for it to reach the side of the dump truck. This forced the plank to be positioned in an upward angle from the roof to the truck. (see photo 1).

Photo 1: The job site after the incident, showing the plank from the roof to the edge of the truck bed.

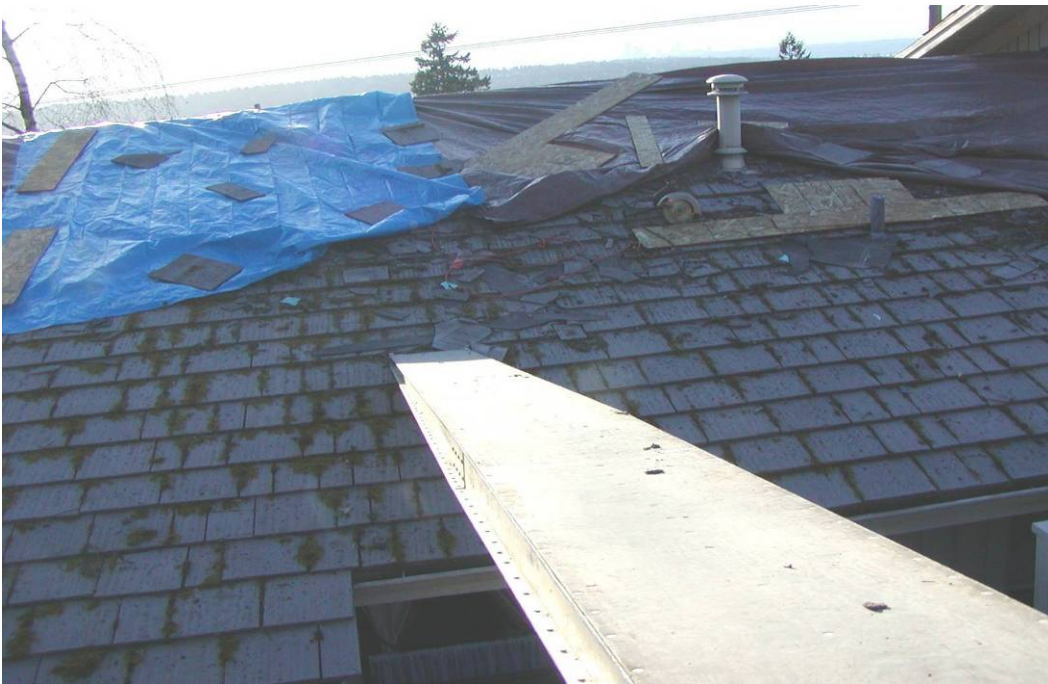
Photo 2: A view of the plank and roof at the incident site from the truck bed.

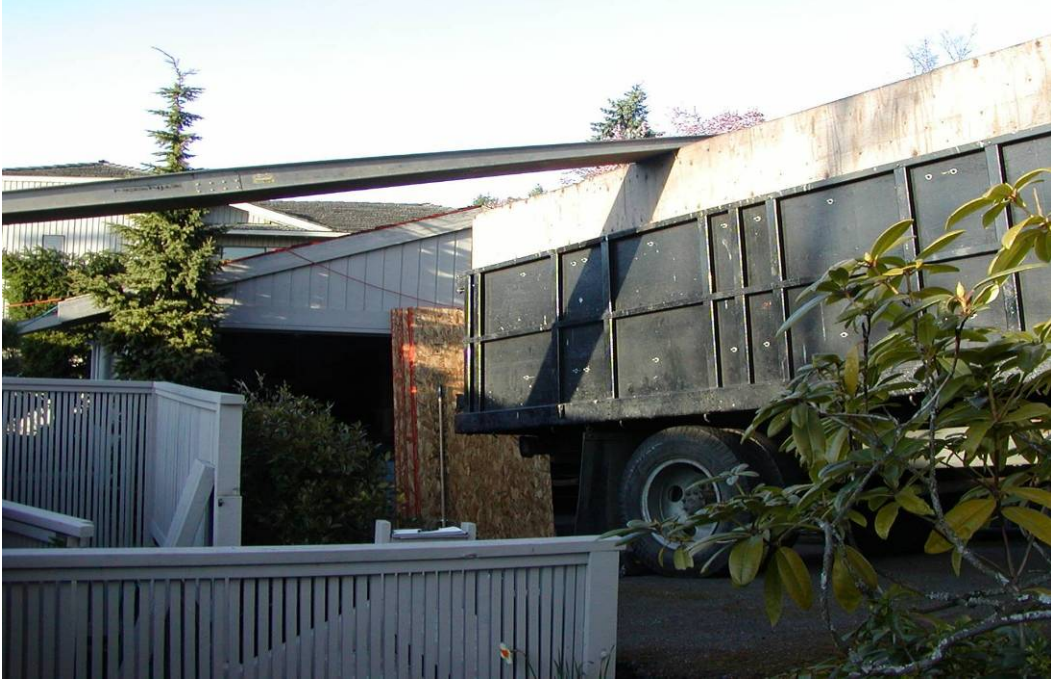
Photo 3: A view of the ramp and truck involved in the incident from the ground.

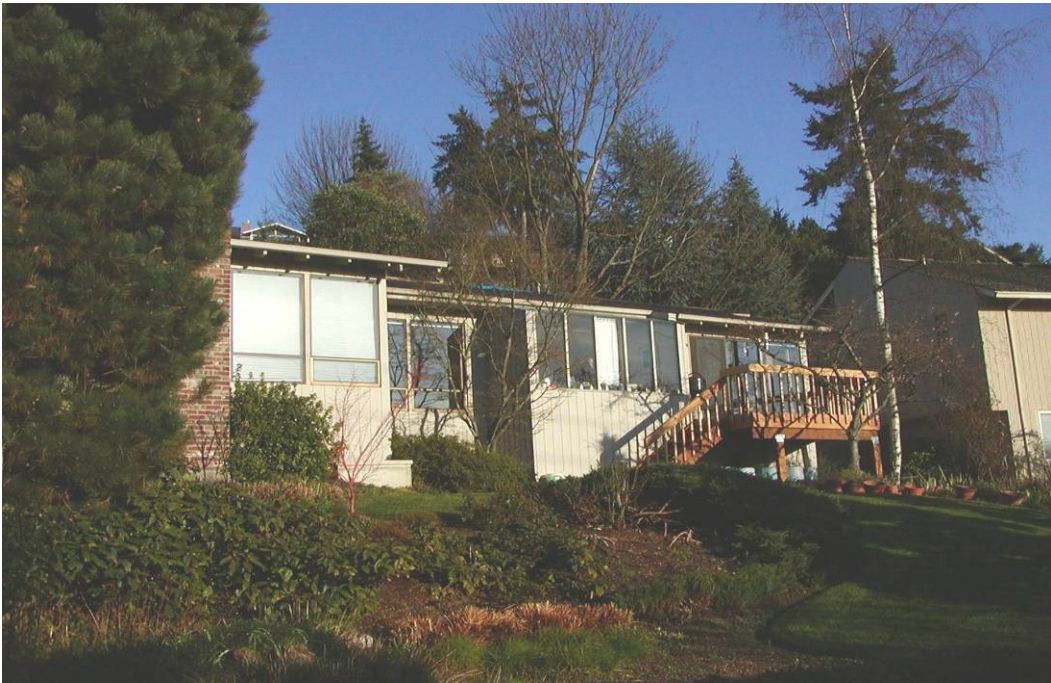
Photo 4: A view of the residence where the incident occurred from below, on the opposite side of the house from the truck and plank.
