Framer Falls 20 Feet Through Stairwell Opening

REPORT #: 71-198-2020s

REPORT DATE: August 10, 2020

SCENE: Multi-story residential/office building
under construction

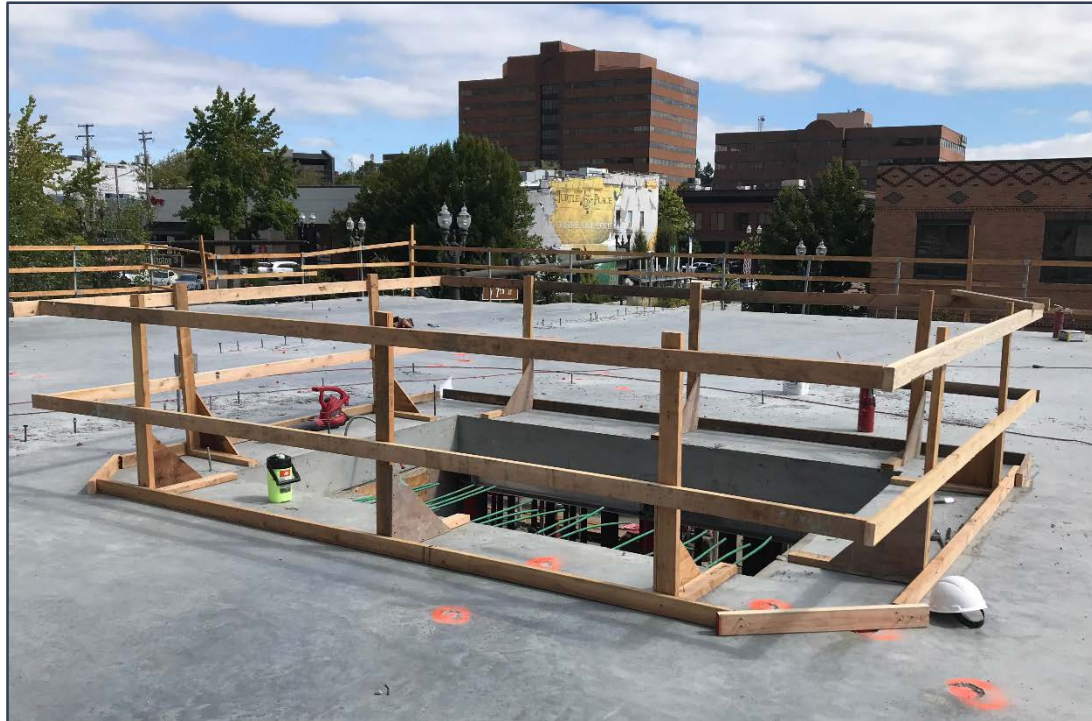
No one observed what happened next, but a time-lapse security camera captured the movements of the framer. He walked toward the stairwell, climbed through the guardrail, and stood on the opening's inner concrete ledge. He then fell into the stairwell opening, landing on concrete 20 feet below. First responders took him to a hospital where he later died.

Photo 1. Stairwell opening the framer fell through.

This tragic fatality could have been prevented if the worker had not gone on the other side of the safety guardrail system without the use of fall protection.

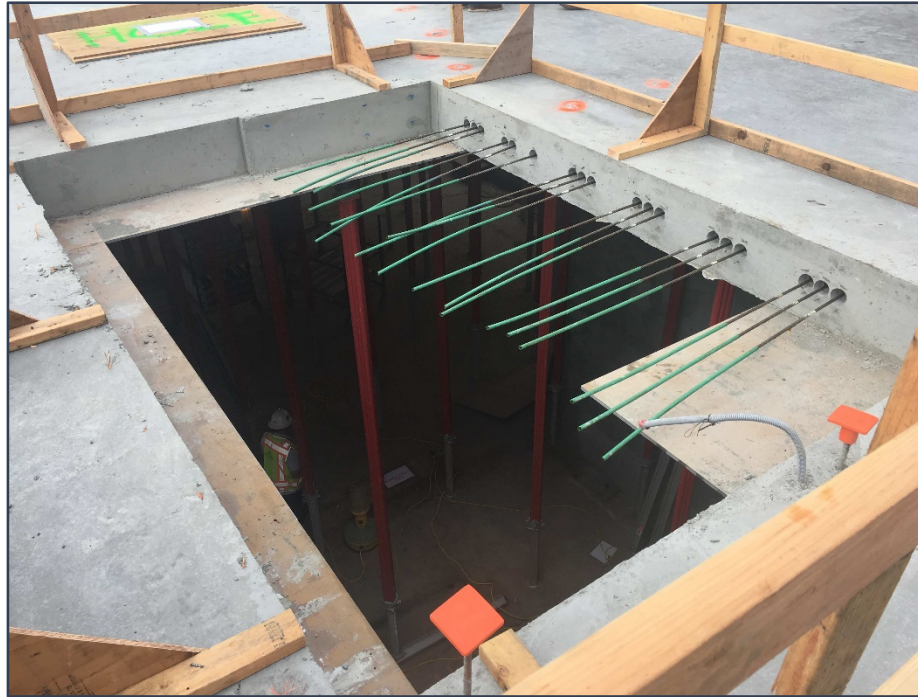
Investigators speculated that he went there to sit on the ledge and eat his lunch. It is possible that he had been in this area earlier in the day when it was safe to be there and he had not realized that workers had removed the decking cover.

Photo 2. Workers had recently removed a plywood cover from the opening. Investigators speculated that the framer might not have realized that the cover was not there when he climbed through the railings to eat lunch while sitting on the edge of the floor deck.

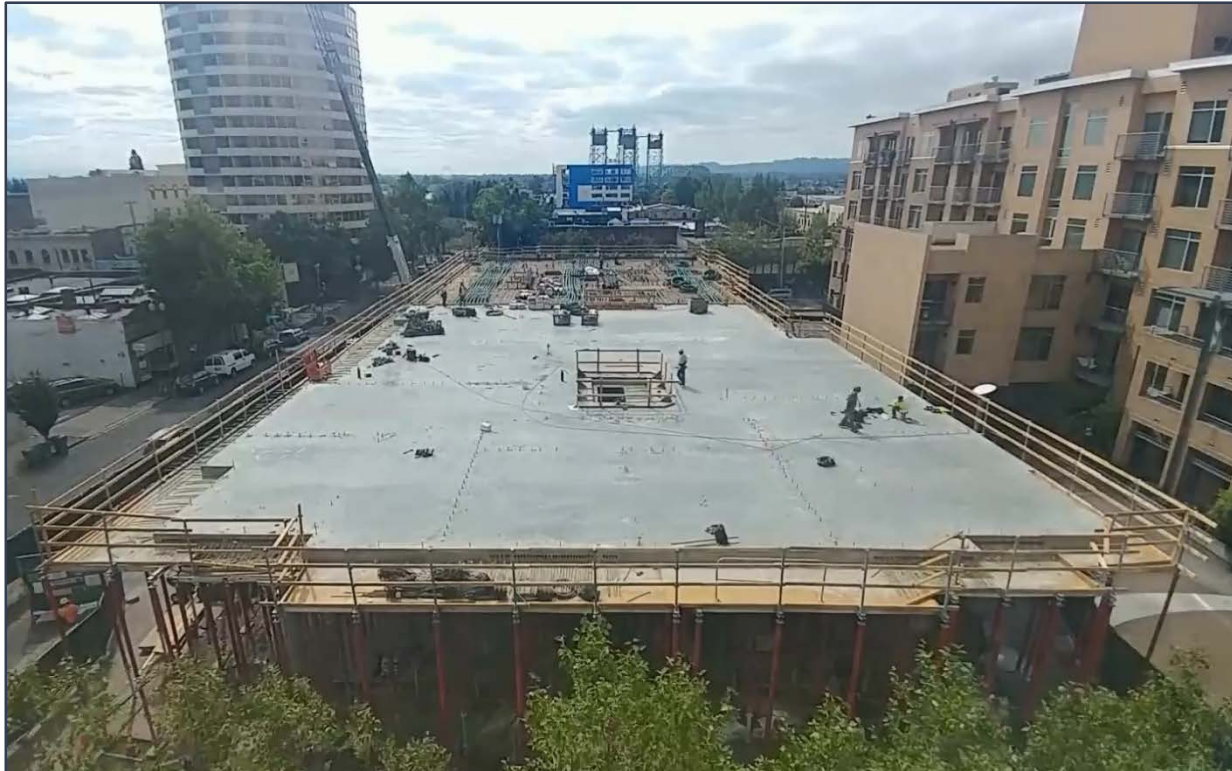
Photo 3. Security camera image of the building's second floor deck prior to the fatal incident. The stairwell opening with guardrails around it is in the center of the photo.
