REPORT #:
71-210-2021

REPORT DATE:
September 17, 2021

EVENT TYPE:
Electrocution

Father and Son Painters Electrocuted when Ladder Contacts Power Line

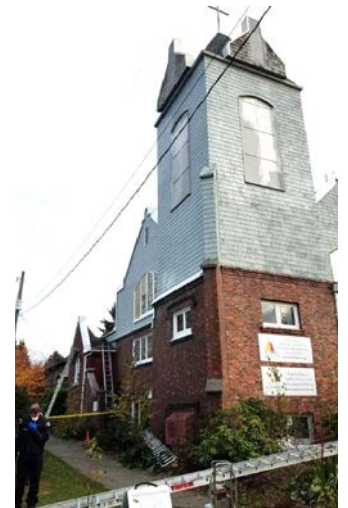
Investigators found: 1) Measures were not in place to protect against the ladder contacting the energized power line. 2) No account was taken of windy conditions when handling the ladder. 3) The distance from the power line to the face of the building was 10 feet 8 inches.

Church steeple, power line, and aluminum extension ladder.

- Identify the location of overhead power lines as part of all initial worksite surveys for jobs involving the use of ladders. Note power line heights and distances from work areas on site diagrams and provide information to site supervisors and workers.
- Perform a job hazard analysis of the worksite.
- Use non-conductive ladders around power lines.
- Lower the extension ladder and transport it horizontally.
- Be aware of windy conditions while moving a ladder near power lines.
