71-217-2022

New construction of cold storage facility

Apprentice Ironworker Struck by Dropped Steel Wedge

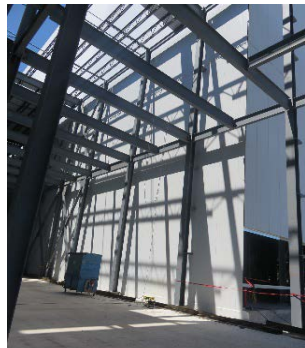
Incident scene where an apprentice ironworker was struck by a dropped steel wedge.

At this moment, the apprentice was in the area below getting a bottle of water that was being stored there for workers. As he was bending over to pick up the bottle, the wedge struck him in his upper back near his left shoulder. The apprentice suffered injuries to his shoulder, ribs, and lungs that kept him from working for several months.

Investigators found: The employer had not provided workers with a means of securing wedges from falling or being dropped. The employer had not used red caution tape to keep workers out of the area below where the ironworkers were working. There was not a designated water station. The ironworkers did not expect anyone to be working below them because there were no other workers in the area.

- Use red caution tape and/or have a spotter on the ground to keep workers from entering areas where objects may be dropped.
- Locate employee water stations away from active work areas.
- Provide safety training to new workers to ensure they understand the hazards associated with the work site.

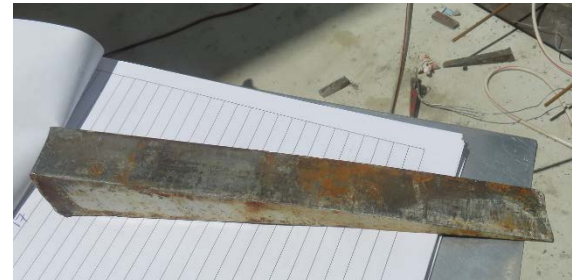
On the day of the incident, two ironworkers were working from the basket of a boom lift to install a beam on a column. This procedure generally took them 30 seconds to a minute before they quickly moved on to the next install. The ironworkers were using a steel wedge between the column and beam to help tighten the bolts securing them. One of the ironworkers was removing the wedge, which was under pressure, using a hammer to knock it loose. As he was doing this, the untethered wedge broke free, but he was unable to hold on to it, and it fell approximately 50 feet.

Steel wedge that was accidentally dropped 50 feet, striking an apprentice ironworker.

- Require that wedges and other tools used by workers at heights have lanyards, tethering devices, holsters, buckets and other devices to secure them.
- Add attachment points to wedges if they do not have them so they can be secured to a tether.
- Ensure that tethering systems are ANSI/ISEA 121-2018 Dropped Object Prevention Solutions compliant.
- Secure wedges and other tools, both when in use and not in use.
