71-226-2022

AUGUST 29, 2022

## Laborer Climbing Scaffold Cross Braces Falls 25 Feet

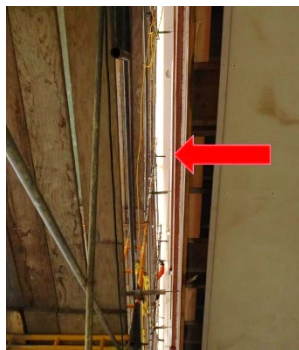
The 12 ½-inch gap between the building and the scaffold.

The laborer did not use the scaffold ladders. Instead, he climbed up the outside of the scaffold using its cross braces in the 12 ½-inch gap between the scaffold and the building exterior. He was not wearing personal fall protection. It was not required because the scaffold was within 14 inches of the work face. He then retrieved a saw from the second floor level and holding it in one hand began climbing the cross braces to the next level. As he reached up to hand the saw to a coworker on a balcony, he slipped and fell through the gap, landing 25 feet below on pavement.

- Train workers to never climb on or use scaffold cross braces as a means of access.
- Assess fall hazards and the need for personal fall protection, even when it is not required.
- Add scaffold side brackets and planks just below each level of decks to prevent workers from accessing or falling through the gap between building and scaffold.
- Provide one dedicated access point to each deck from the scaffold.

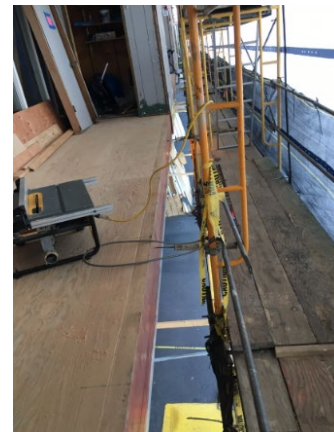
The 12 ½-inch gap between the building and the scaffold where the laborer was climbing the scaffold cross braces when he fell 25 feet.
