71-239-2023

May 22, 2023

Maintenance Coordinator Dies After Falling from Ladder

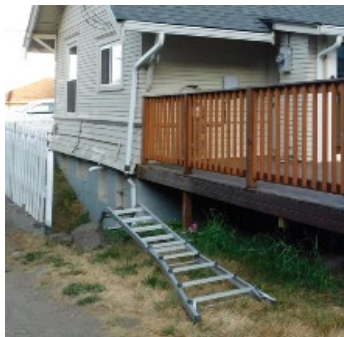
Unsecured top half of ladder resting on the grass surface.

The homeowner had arrived around 1 p.m., talked briefly with the worker, and went inside to sleep. No one else saw the worker until 7 p.m., when a home appraiser found him badly injured lying on his back. He fell onto rocks and concrete at the base of an 18-foot fully extended, portable, metal articulated or multi-positional ladder. The ladder's bottom half was leaning on a 6-foot below-grade rock retaining wall near the basement entrance. The top half was resting horizontally on the ground level grass surface.

- Place the ladder either: (a) With a secure footing on a firm, level support surface; or (b) Secure the ladder to prevent accidental displacement. [WAC 296-876-40015\(1\)](#)
- Train employees to recognize ladder hazards and the procedures to minimize these hazards. [WAC 26-876-15005\(1\)](#)
- Develop and implement a formal, written accident prevention program (APP) with a safety orientation that includes: (g) An on-the-job review of the practices necessary to perform the initial job assignments in a safe manner. [WAC 296-155-110\(3\)\(g\)](#)

- Ensure workers use ladders according to manufacturer's safety guidelines and warnings and maintain a 3-point contact, staying near the middle of the ladder, and facing it when climbing.
- Provide training to workers in each type of ladder they will use, including how to properly inspect, set up, secure, climb, relocate, transport, maintain, and store the ladder.
- Supervise a lone worker's safety by visiting work sites and requiring regular phone check-ins.

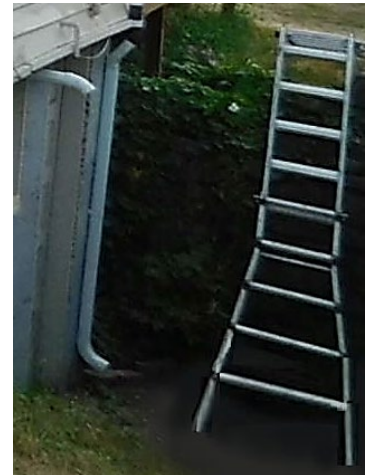
- The employer did not ensure the ladder was secured from accidental movement.
- The ladder was not in the self-supporting position with hinges locked, which created unstable work conditions that exposed the worker to a fall of around six feet.
- The employer did not provide documented ladder safety training and an on-site safety orientation as part of their accident prevention program (APP).
- The employer stated the ladder did not belong to them.

Bottom half of ladder against rock retaining wall.
