# FATALITY NARRATIVE

## Foreman and Laborer Fall when Aerial Lift Struck by Vehicle

**Task:** Installing retaining rods on bridge

**Type of Incident:** Fall

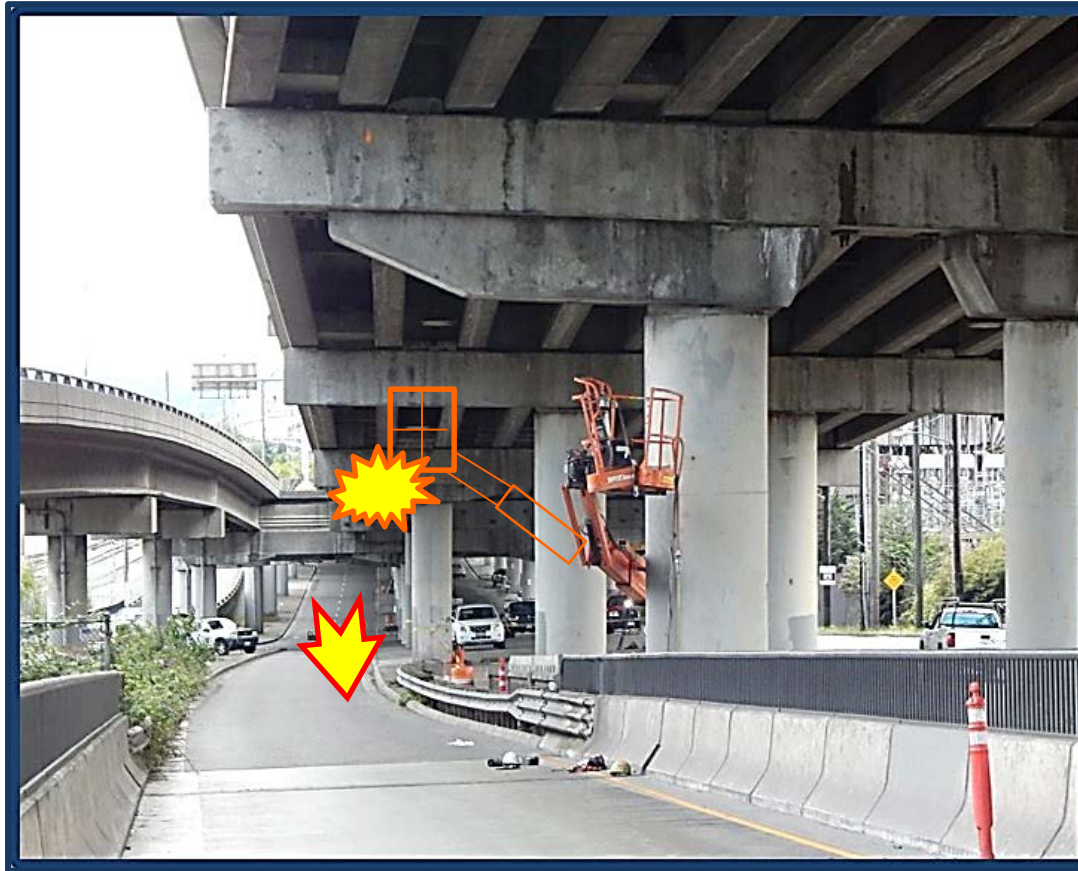
Incident scene showing the exit ramp under the bridge and the approximate height and position of the aerial lift when it was struck by a box truck and how it came to rest afterwards. The arrow indicates the direction in which the truck was traveling.

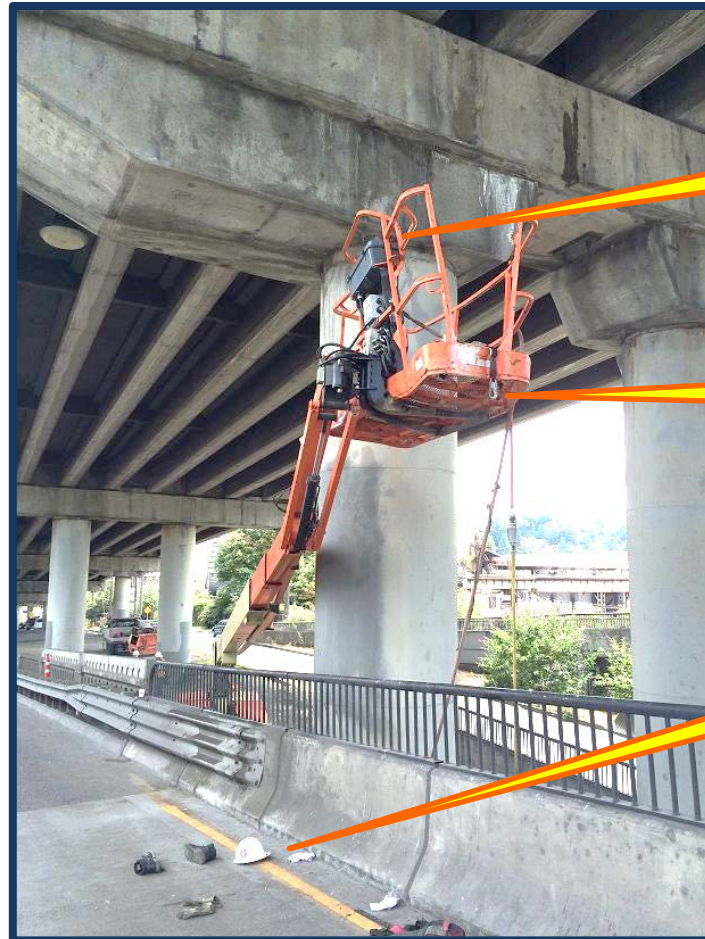
Anchor lanyard connection point

Harness anchor lanyard

Hard hat, boots, gloves, and fall protection harness

Incident scene showing the aerial lift and the injured laborer's PPE.

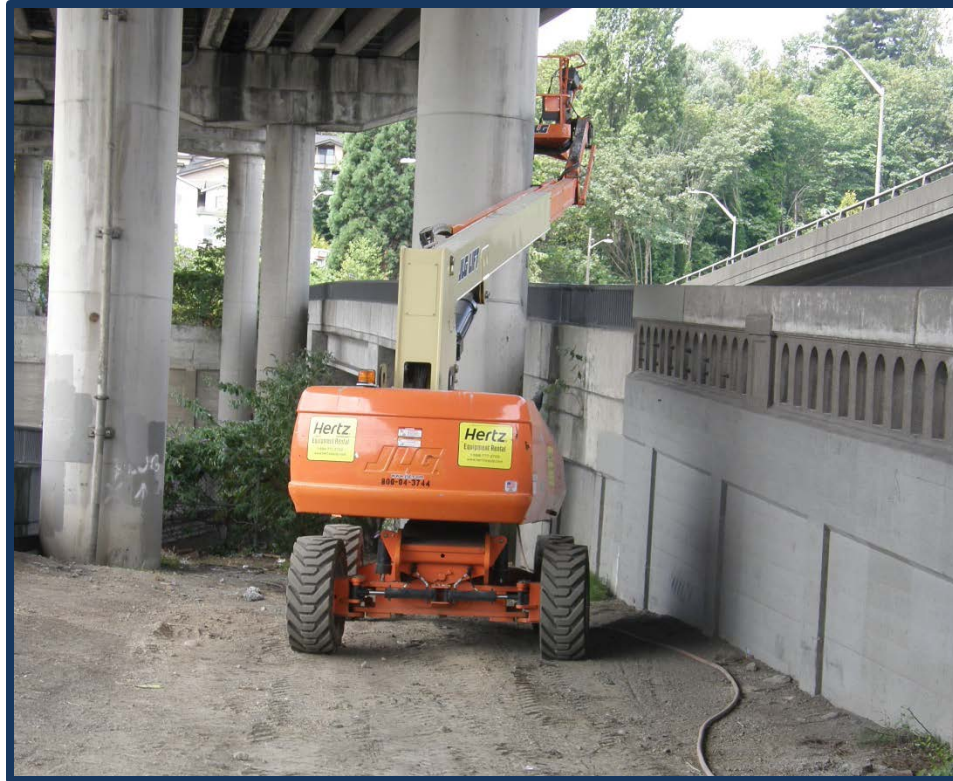
Incident scene showing the aerial lift positioned in a median under the bridge.

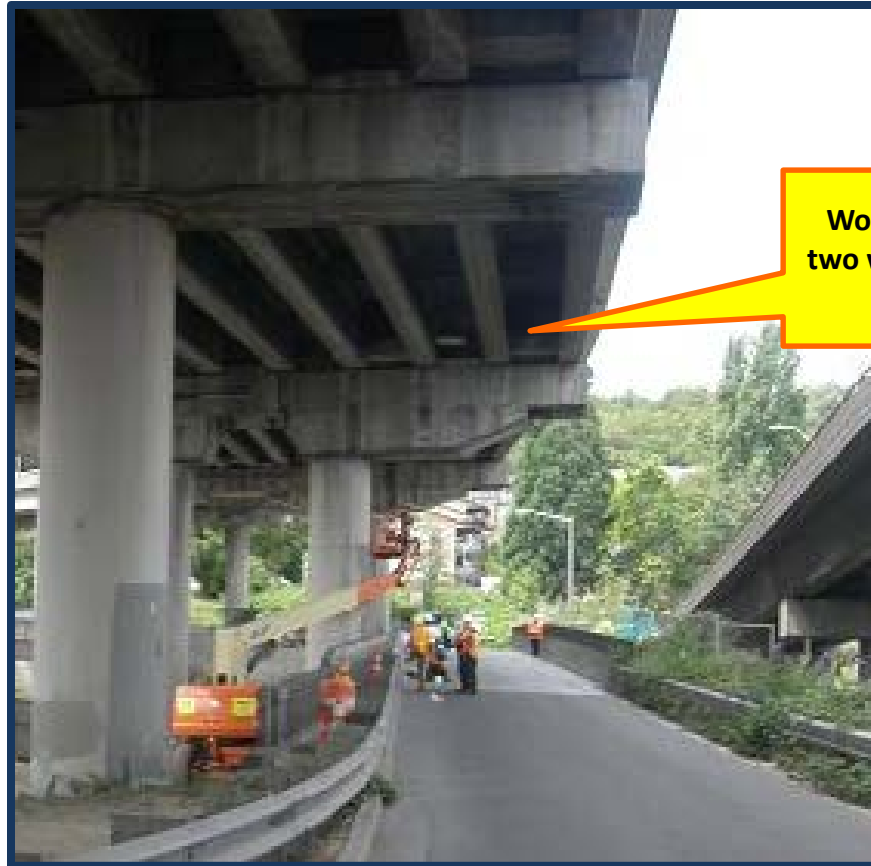
Incident scene showing the location under the bridge where the workers were using the lift to access the work area. No traffic controls were used.

Apply the requirements of WAC chapter 296-155 Part E, Signaling and Flaggers. Then use temporary traffic controls according to the guidelines and recommendations in Part 6 of the [Manual on Uniform Traffic Control Devices](#) when operating an elevated work platform over a roadway.

Take special precautions to meet the requirements of local ordinances or workplace safety standards, and use warnings such as flags, roped-off areas, flashing lights and barricades when setting up an elevated work platform when other moving equipment or vehicles are present.

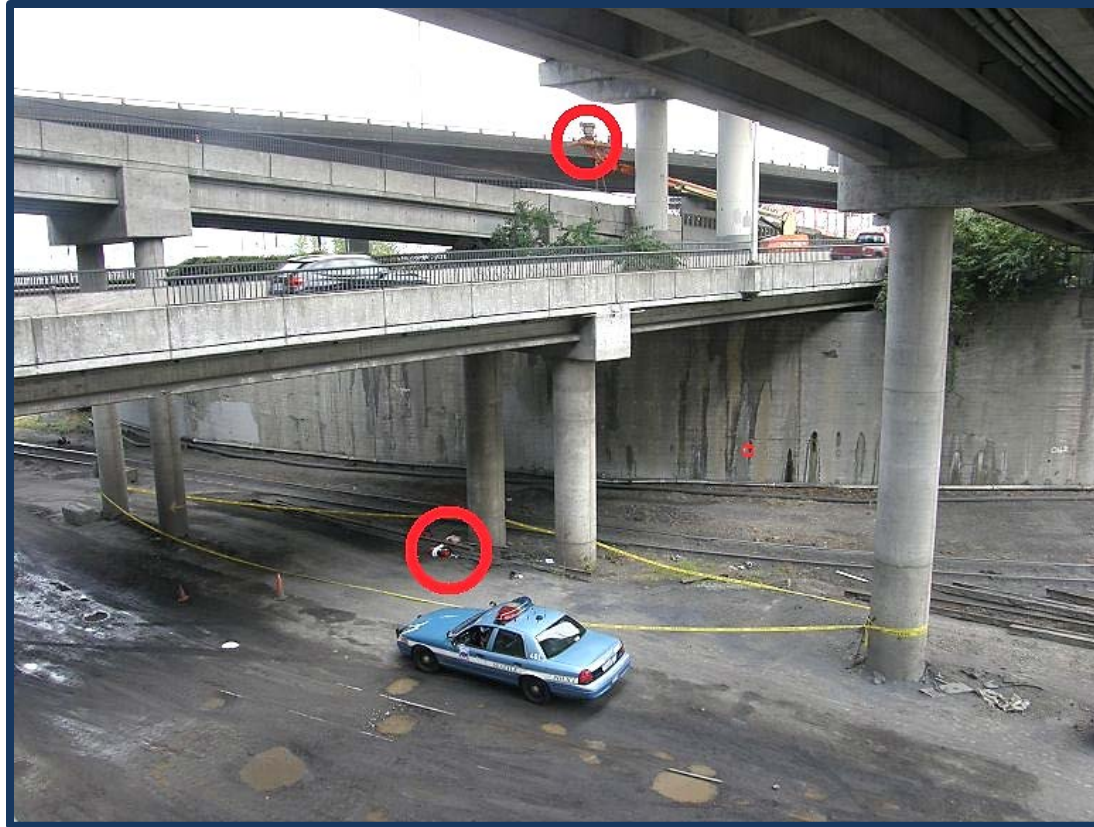
When a truck struck the aerial lift, the foreman was ejected from the lift's platform. Though he was wearing a full body harnesses with a lanyard, the lanyard was not attached to anything. He was thrown 50 feet horizontally, landing 48 feet below on railroad tracks.

Ensure all persons on the platform of boom-supported elevating work platforms wear a full body harness and lanyard fixed to manufacturer provided and approved attachment points.

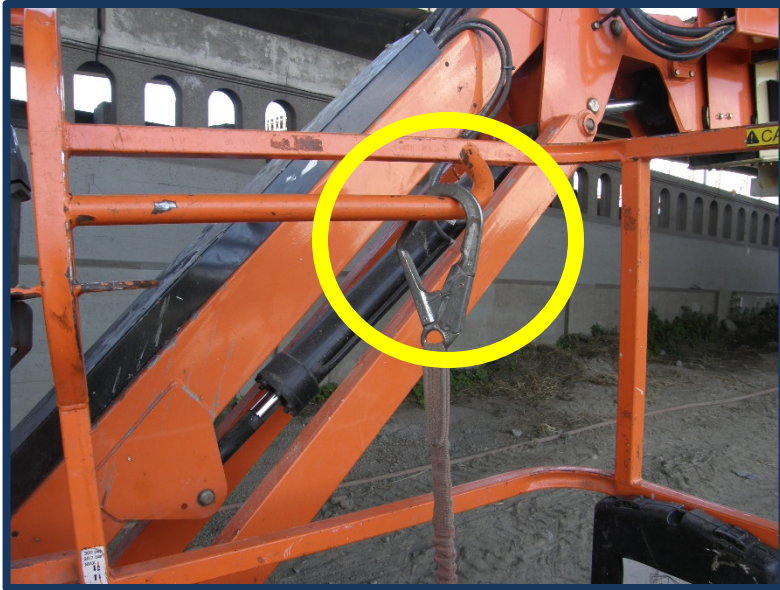
Photo 1

**Photo 1** shows the laborer's lanyard attached to the handrail of the aerial lift.

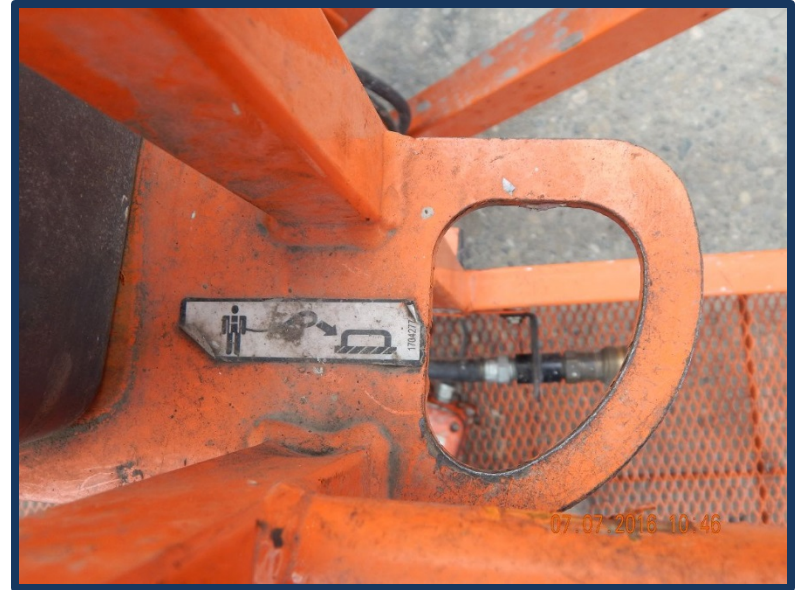
Photo 2

**Photo 2** shows the manufacturer's provided and approved lanyard attachment point.
