# FATALITY NARRATIVE

## Carpenter Falls 60 Feet from Bridge Concrete Form

**SHARP Report No.:** 71-158-2017

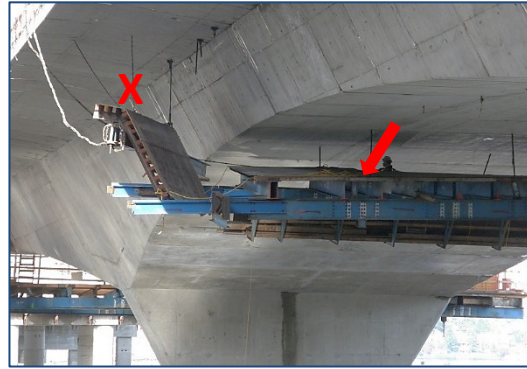
Incident scene showing the concrete form suspended below the bridge. The X indicates where the victim was working when he fell. The arrow indicates the anchor point of his retractable lifeline.

off the rod. When this did not relieve the pressure, they decided to cut the rod with a torch. Keeping the chain hoist in place, the victim wearing a full body harness with a retractable steel cable lanyard went to the top of the wing wall and cut the rod. Cutting the rod caused the wing wall to shift. The victim lost his balance and slid down the wing wall and fell into an opening between the wing wall and the main concrete form. His lanyard cable severed when it went over the steel edge of the main form and he fell 60 feet to a concrete pier below. The investigation identified that the victim's fatal fall was due to improper use of the retractable lanyard. The victim was working more than 6 feet above his anchor point and during the fall the cable went over a steel edge of the form, both of which the lanyard manufacturer warns against. Also, there were retractable lanyards located above the victim that could have been used as an anchor point.

- Forms intended for use where there is a free fall of over 10 feet must be equipped with adequate scaffolding and guardrails or employees working on forms must be protected from falls in accordance with chapter 296-155 WAC, Part C-1 during forming and stripping operations.  
See [WAC 296-155-689\(4\)](#)

- When an unplanned situation arises that exposes workers to fall hazards, stop, regroup and discuss what should be done to address the issues. If changes to the fall protection work plan are needed, make those changes and retrain all those involved.
