INCIDENT FACTS

71-175-2018

Laborer Severely Injured in 60-Foot Fall from Scissor Lift

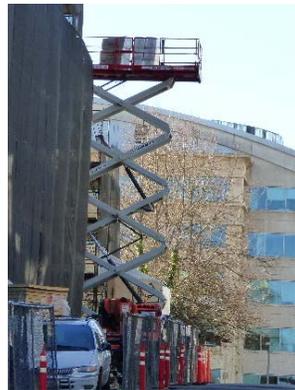
Incident scene showing the scissor lift from which the laborer fell 60 feet.

A 39-year-old construction laborer was severely injured when he fell 60 feet to the ground below. He fell through a gap between the scissor lift he was working from and the building when the deck extension platform of the scissor lift moved.

The day before the incident, an employee reported to a foreman that the rental scissor lift had a broken deck extension locking pin. This spring-loaded pin was used to lock the lift's deck extension in place to keep it from moving while in use. The foreman instructed the lift operator to contact the rental company for a replacement pin and continue to use the lift until a new pin arrived.

On the day of the incident, the replacement pin had not arrived. The victim and another laborer removed a portion of the lift's platform railing so that they could unload insulation bundles from the lift onto the building's sixth floor. They extended the platform to allow access to the floor. The other laborer positioned himself toward the rear of the platform. As he was using his foot to brace the extension to keep it from moving, he passed a bundle toward the victim who was standing on the extension. The victim received the bundle from the laborer and began rolling it along the platform. As he was doing this, the extension rolled back into the retracted position, causing him to lose his balance and fall through the gap between the building and the lift. He landed 60 feet below. He suffered numerous severe injuries.

- Do not enter or exit a Mobile Elevating Work Platform (MEWP) when elevated to another level, unless the manufacturer allows for this. If the manufacturer allows for this use, then follow their recommended guidelines and procedures.
- Consider other means of delivering materials to elevation, such as a material hoist or reach forklift.
- Do not use damaged or malfunctioning equipment or machinery. Tag and remove from service until it has been repaired by a qualified technician.

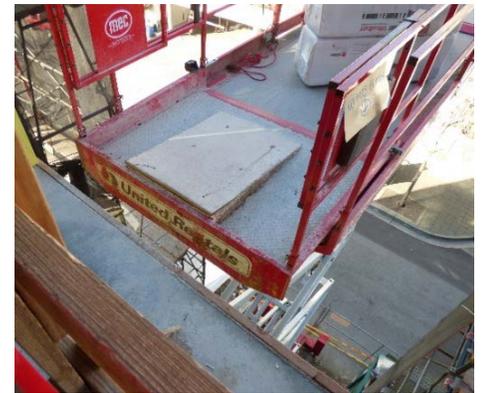
Incident scissor lift showing the gap between the lift platform and the building through which the laborer fell 60 feet.
