Fatality Investigation Report: Struck by lumber at a sawmill

Report #52-1-98

Sawmill Unscrambler Operator Killed when Struck by a Board Ejected by Trim Saw in Washington State.

Investigation: #98WA06001

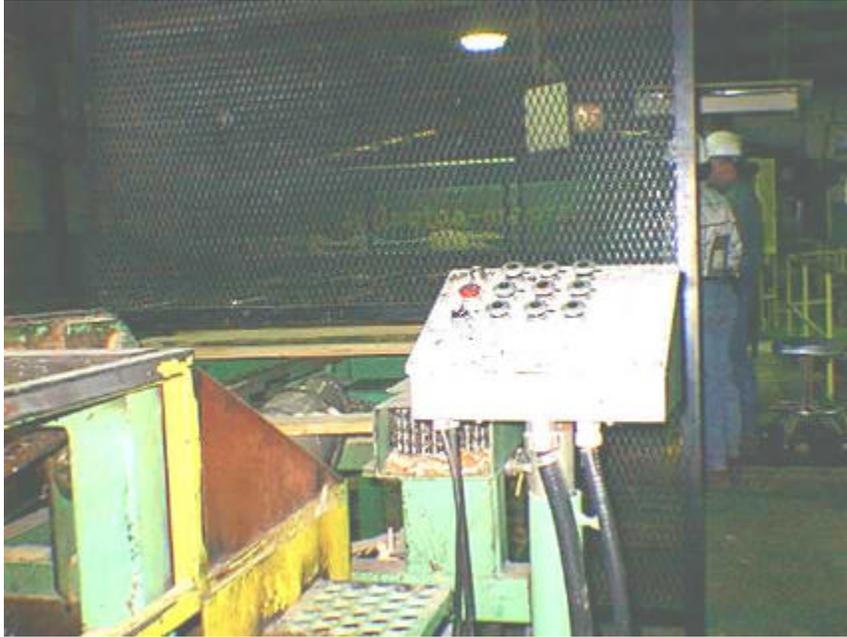
Photo #1. "Unscrambler" operator's workstation - facing "trimsaw" operators work station and trimsaw system. New guarding in place.

- The employer fabricated expanded metal guards situated at both sides of the trim system extending the length of the saws. There is still space below the trim system guards to allow for production flow.
- The employer also set up expanded metal guards at the trim saw and unscrambler operator's stations. These guards act as a second layer of defense in the event a board gets by the trim system guards. WISHA had made the operator station guarding recommendation. (see photos #1 and #2)

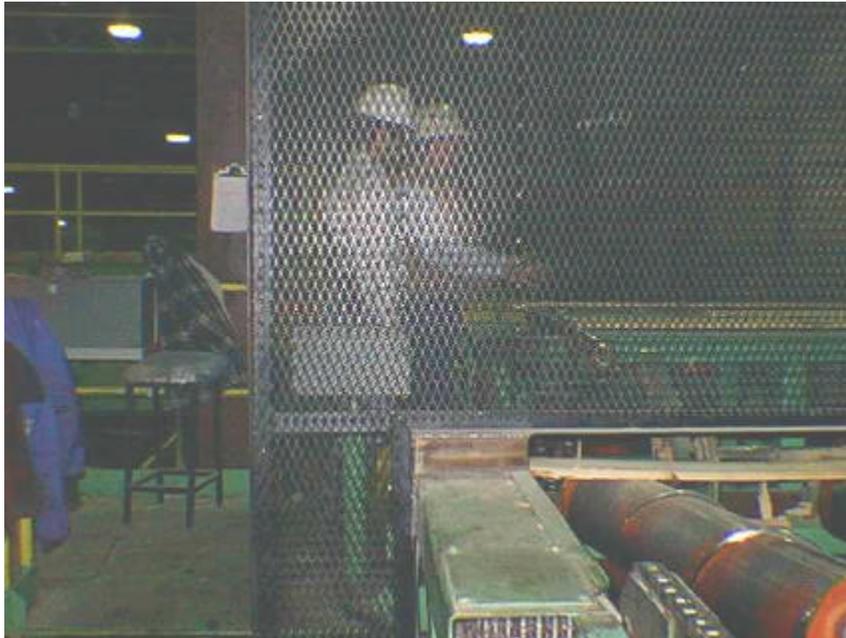
Photo #2. "Unscrambler" operator's station viewed from "trimsaw" operators work station. New Guarding in place.

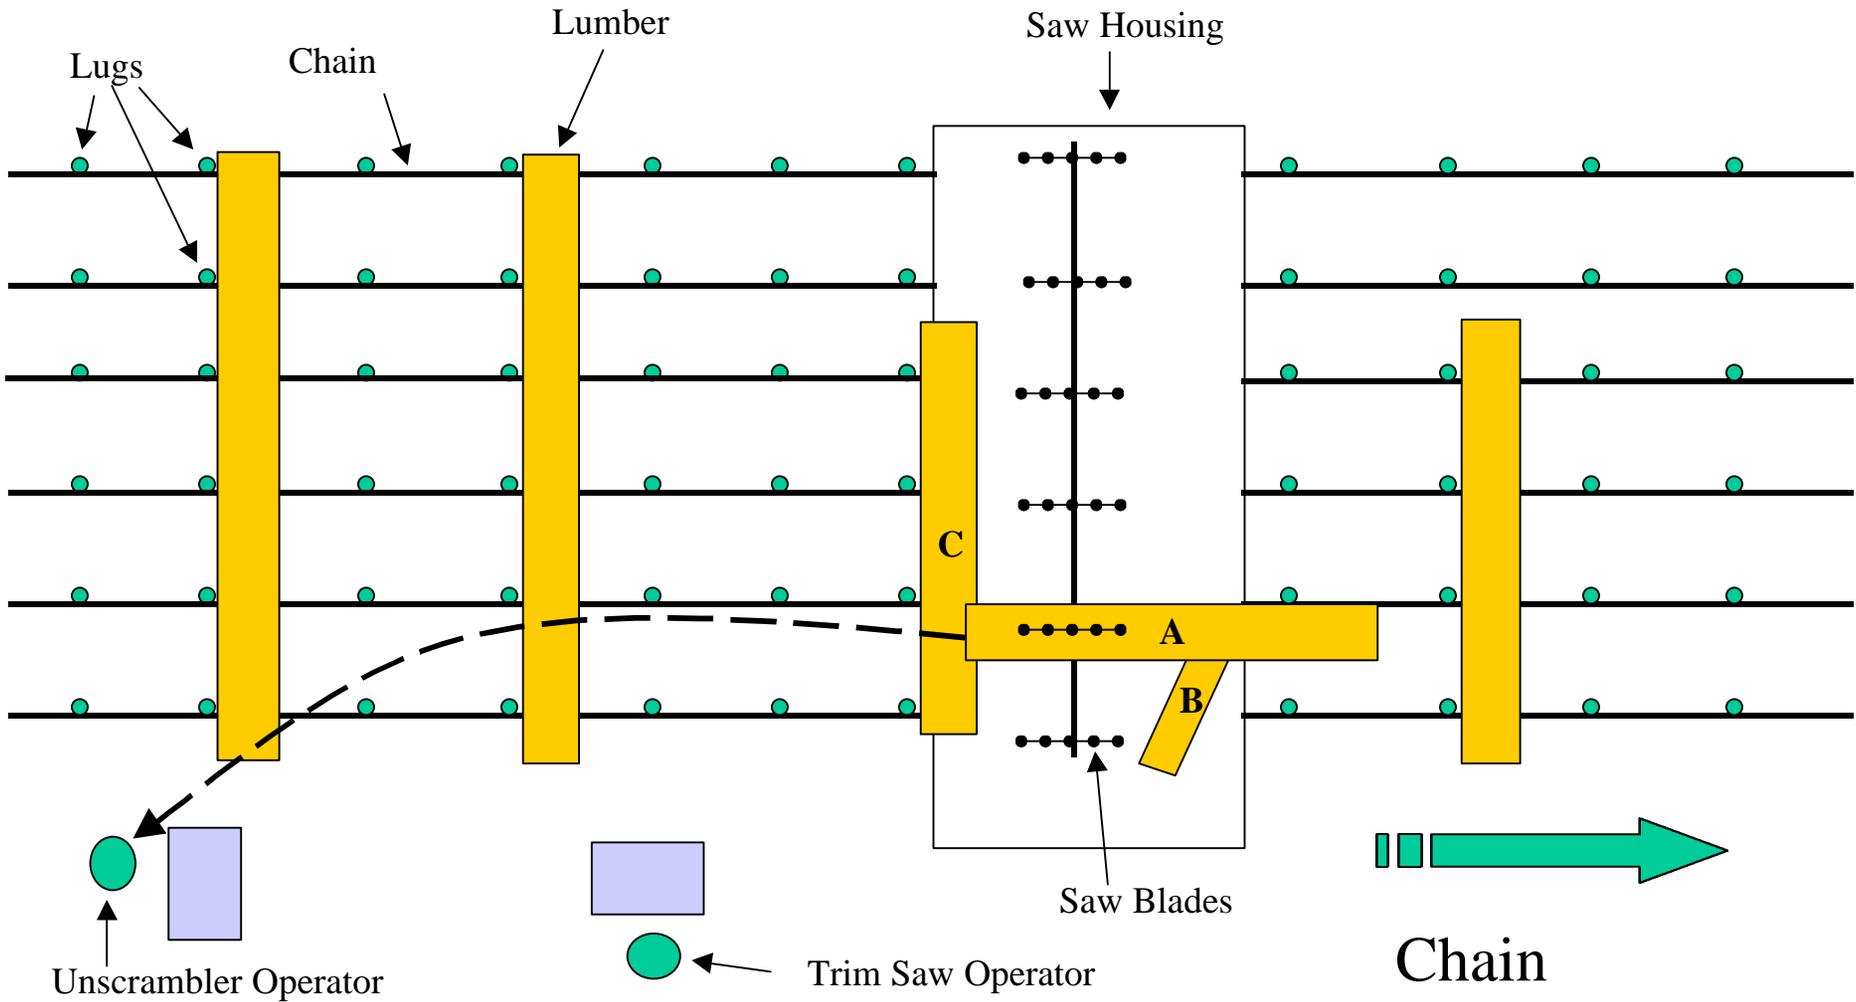
Diagram 1

The unscrambler operator worked with a trimsaw operator on the rough lumber line. The unscrambler operator's workstation was approximately 45' on the "upstream" side of the trimsaw system. The trimsaw operator's workstation was centered between the trimsaw and the unscramblers workstation (see diagram 1).

The hypothesis of how this occurred, was that a piece, or pieces of material and/or other debris (depicted as [B] in diagram 1) might have caused the board (A) to "hang up" after exiting the trim saw system, rotate 90 degrees, get caught by one of the saw blades and then be ejected from the system, while riding on top of board (C) (see diagrams 1 and 2).

A - board that hit worker
 B - debris caught in the saw housing
 C - normal board going down the chain

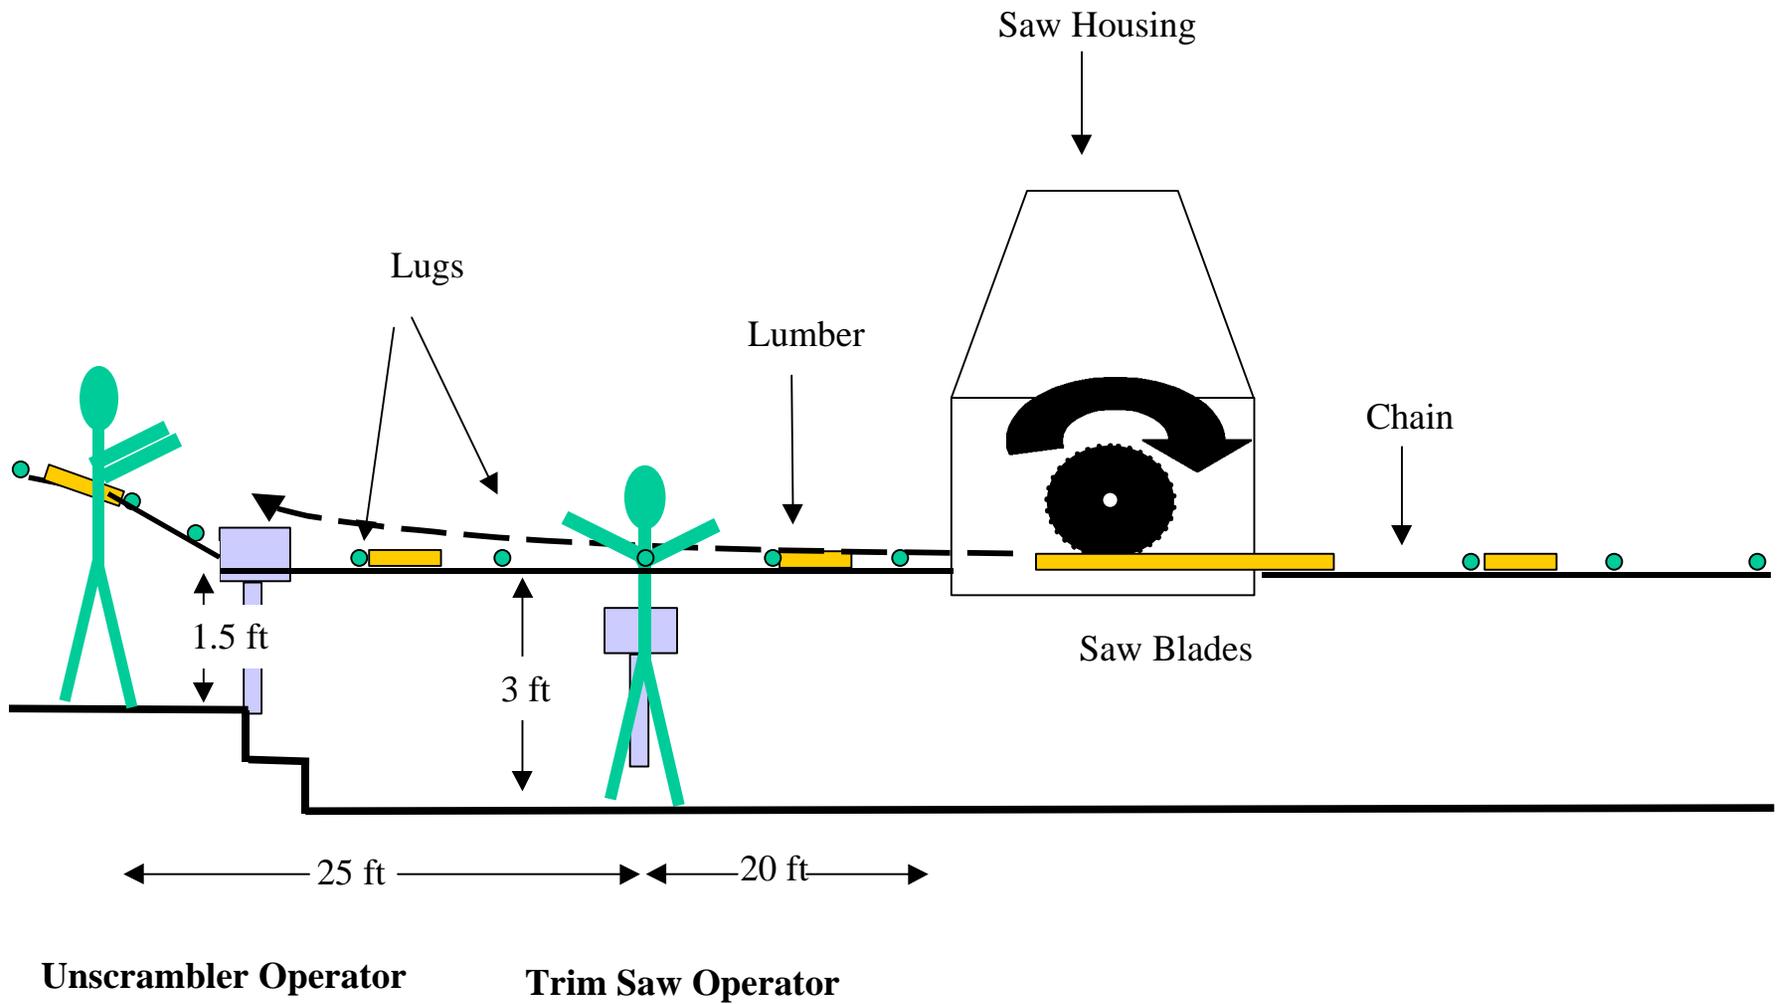
Diagram 2

In the investigation of the incident, it was noted that the board appeared to have been trimmed on both ends, which suggests that it had traveled through the trim saw. The board had a saw cut that extended 69" down and through the middle of the board. This would suggest that the board had rotated 90 degrees after having been trimmed and gotten caught by one of the saw blades. The saw blade proceeded to cut into the board starting at a point 21" in from the end that struck the victim (the cut was with the grain). Then after about 69", it appears that the blade began to lift from the board, grabbing rather than cutting the board, which provided the energy to propel the board toward the victim at a high rate of speed.
