Maintenance Worker Killed When Struck by a Vehicle Along a Highway in Washington State

Fatality Investigation Report

Investigation: # 02WA04801
SHARP Report: # 52-15-2006

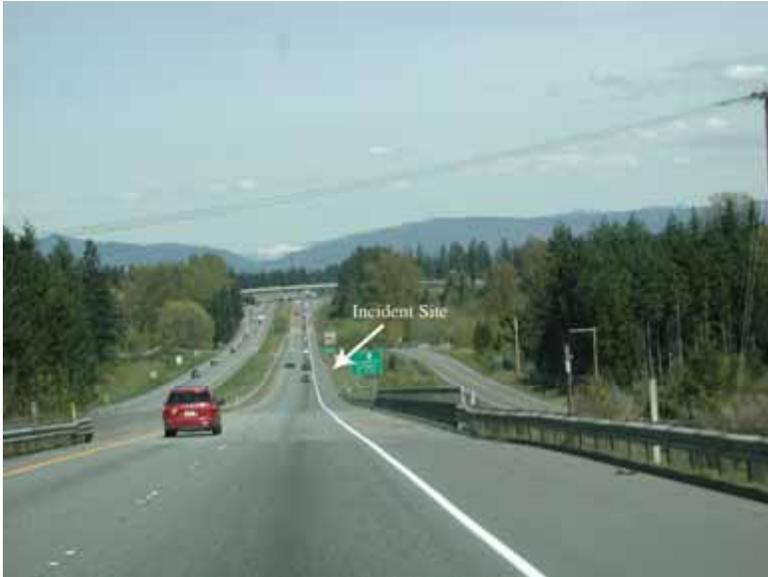
Photo 1: The view traveling down the highway east toward the incident site. The incident occurred at the bottom of the hill on the right shoulder.

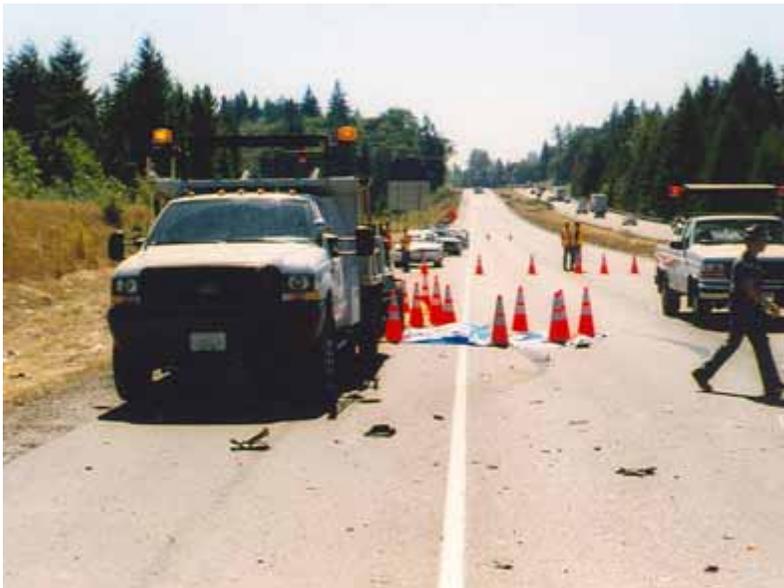
Photo 2: The incident scene after emergency response, facing west, looking up the hill toward on-coming traffic.

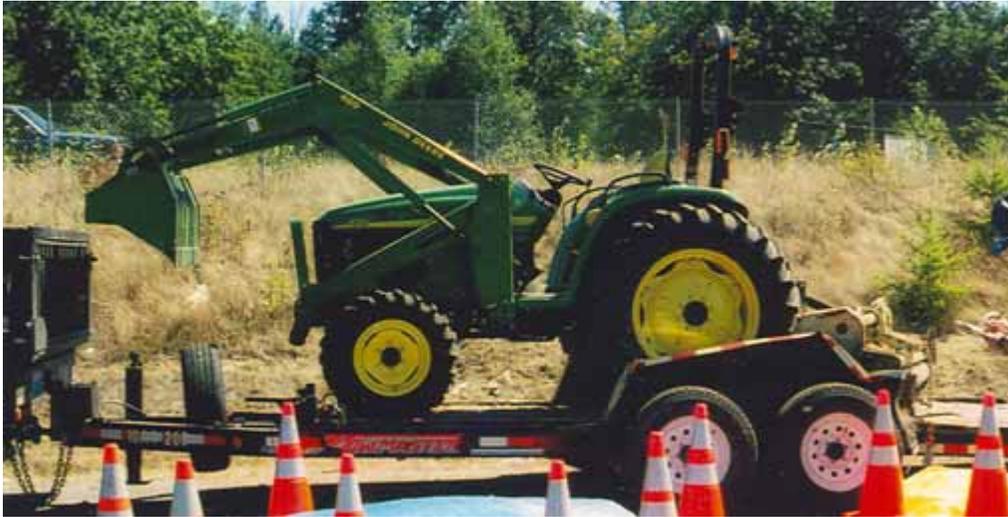
The victim was working on engaging the left side of the tractor/trailer binders while standing near the highway traffic side of the road. The co-worker was on the opposite side of the trailer working the right tractor/trailer binders. The driver of the co-workers' vehicle honked his horn to get the attention of the two men who were working along the shoulder of the road, and to alert them of the errant vehicle heading their way.

The victim in this incident was fatally injured when a vehicle struck the victim while he was securing a tractor onto a utility trailer. The victim was standing on north side (the driver's side) of the utility trailer which was situated along the shoulder of the highway but was exposed to the fast moving (60 mph +) traffic traveling past the work-site. Both the victim and the co-worker were focused on securing the tractor/mower to the trailer using the trailer's load binder/safety chain system. They had just finished securing the front of the tractor and were working on the back section when the impaired driver traveled off the road and struck the victim.

Photo 3: This photograph shows the tractor and mower attachment that were in the process of being tied-down to the trailer when the incident occurred.

- **Recommendation #1: Re-engineer the equipment load-binder/safety chain system on the trailer so that workers are able to secure equipment without having to stand near the traffic-side of the trailer.**

It is recommended that the load-binder/safety chain system be reviewed in order to look at the possibility of the system being re-designed or installation of a new system to help minimize worker exposure to traffic while loading equipment along roadways. The employer should check with the utility trailer manufacturer or distributor to see what equipment securing devices are available for upgrade or changes that can be made to upgrade the system.

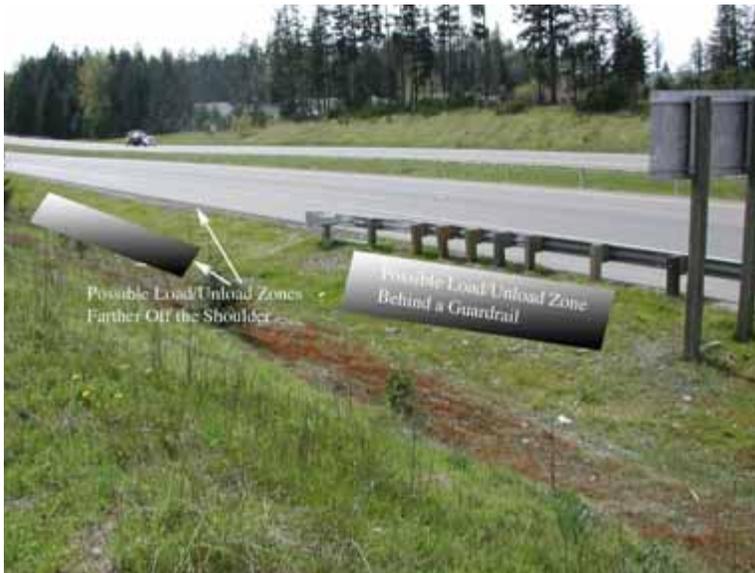
Their truck and trailer were parked primarily off on the asphalt shoulder of the highway. Part of the passenger-side trailer wheels, were on the grassy edge of the shoulder. The grassy area was level, and firm, with light vegetation which transitioned into the asphalt shoulder with no significant drop off. The area was easily able to support the weight of the truck and trailer plus that of the tractor/mower without any issues. (See photo 4)

Photo 4: This figure shows several additional options, just beyond the site of the incident, for parking a trailer to load/unload that might provide better protection than the shoulder.

- **Recommendation #2: Strategically load and unload equipment onto trailers in areas with no traffic exposure. Use distance or existing protection such as highway guardrails for added protection.**

If there are existing guard rails and/or crash cushions and there is adequate and reasonably level terrain to safely park vehicles, take a look at the ability to be able to park and locate the vehicle/trailer behind these existing devices to provide protection for loading and unloading equipment. If there are no guardrails, or crash cushions available in the area, then take a look at some of the natural topography of the work area that can provide a degree of protection for the workers on foot. Though perhaps not as effective as engineered guardrails, sometimes the natural topography can provide adequate protection when other protection modes are not available.

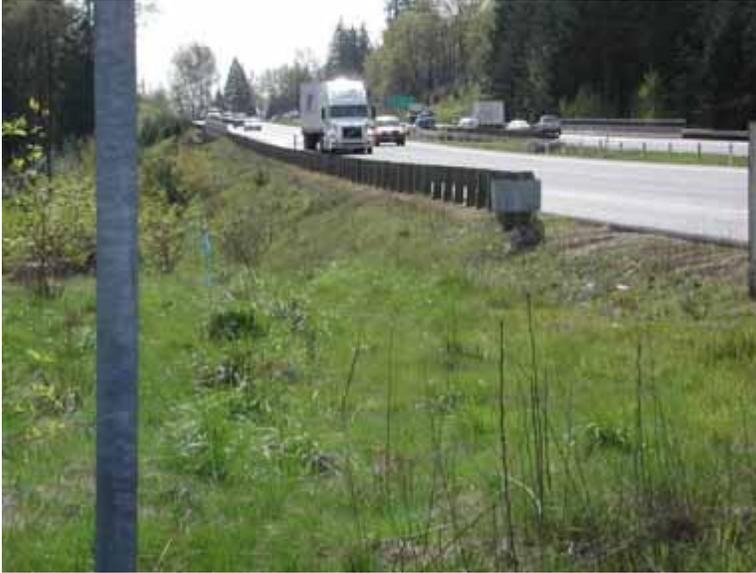
Photo 5: This photograph shows another possible site at the bottom of the hill, just before the incident site, where a trailer might be able to load/unload if feasible. This site would give good protection, behind a guardrail.
