Deck Engineer on Barge Dies When Struck by Crane Counterweight in Washington State

Investigation: # 10WA040
Release Date: June 8, 2012
SHARP Report: # 52-24-2012_summary

Washington State Department of
Labor & Industries

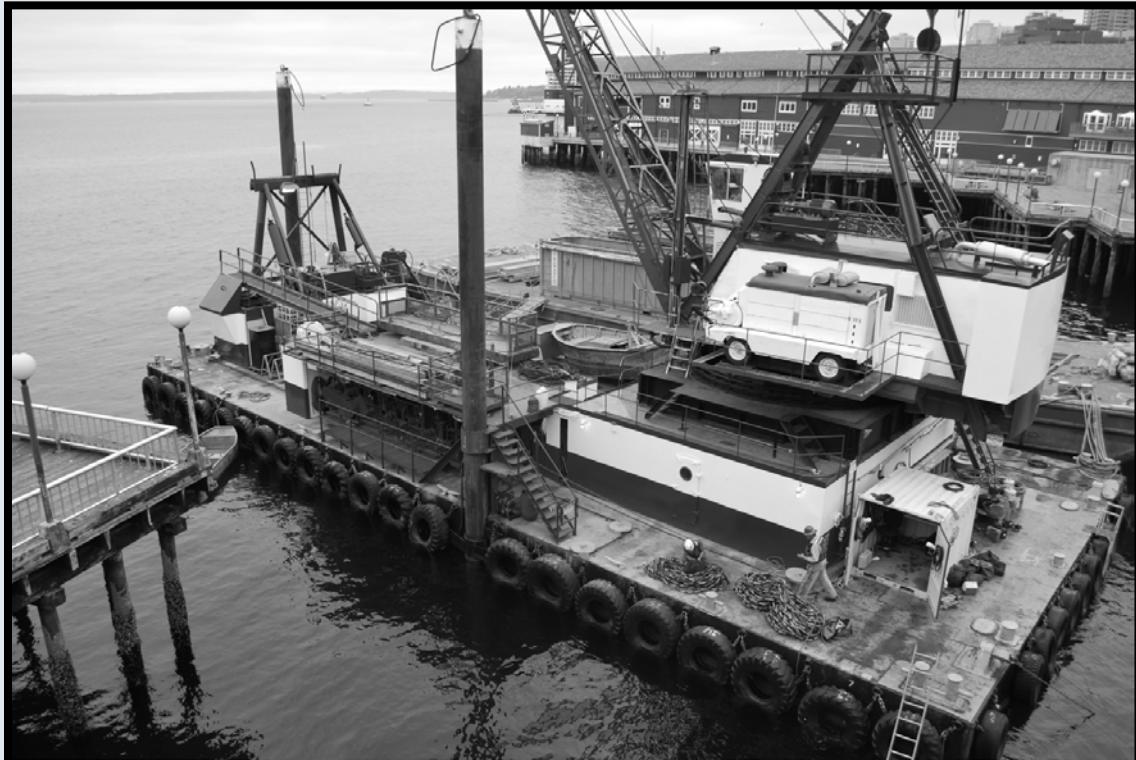
In June of 2010, a 26-year-old female deck engineer died when she was struck by the counterweight of a barge mounted crane/derrick. The deck engineer (victim) and a crane operator, both employees of a marine construction company, were working from a crane/derrick barge in support of a crew working at a job site on a project to replace pilings underneath a pier. The project involved having divers in the water and workers in small boats taking out the old pilings and replacing them with new ones. The crane operator on the crane/derrick barge would operate the crane to lift waste pilings from the water and place them on an adjacent barge and lift new pilings and other supplies to workers in the water.

The victim was an apprentice heavy duty repair mechanic and an inexperienced deck engineer who had worked in the company shop for the past 10 months; this was her third day on the job as a deck engineer. She was welding repairs to a guard railing on the barge's upper deck when the crane operator rotated the crane to make a pick of pilings from the water. The crane's counterweight struck her in the head and neck, pinning her against the railing.

- **Ensure that the area within the swing radius of the rotating superstructure of a crane is barricaded so as to prevent workers from entering and being struck.**

- **Ensure that a method of communication is established and that communication is maintained between the crane operator and other workers and that the crane and its superstructure do not move until the “all clear” signal is given.**

- **Lock out/tag out the crane when workers need to perform work that will expose them to the hazard of being struck by the crane or its load.**
- **Train employees performing work in a crane’s vicinity or in support of the crane operator to recognize and avoid the hazard of being struck by the rotating crane superstructure and its counterweight.**
