Orchard Laborer Dies when Crushed Between a Motor Grader and Semi-Truck in Washington State

Investigation: # 09WA04701
Release Date: February 11, 2013
SHARP Report #: 52-27-2013

Washington State Department of
Labor & Industries

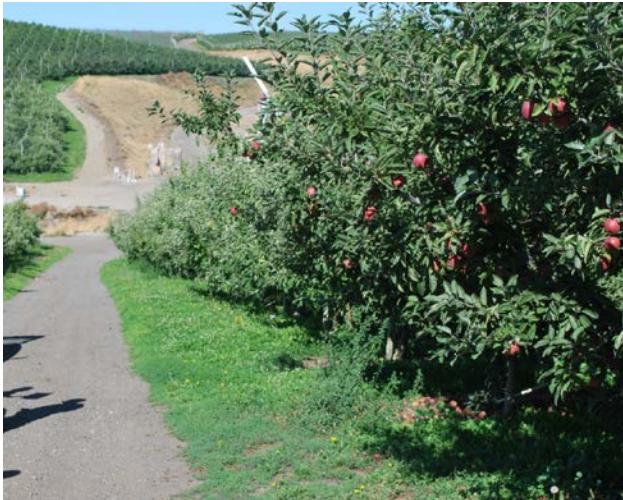
Orchard Road with 6-7% grade.

The semi-truck and flatbed trailer was at the orchard to pick up full apple bins. The semi-truck was traveling to a designated level area used for loading apple bins when it lost traction due to the 6-7% grade road and got stuck.

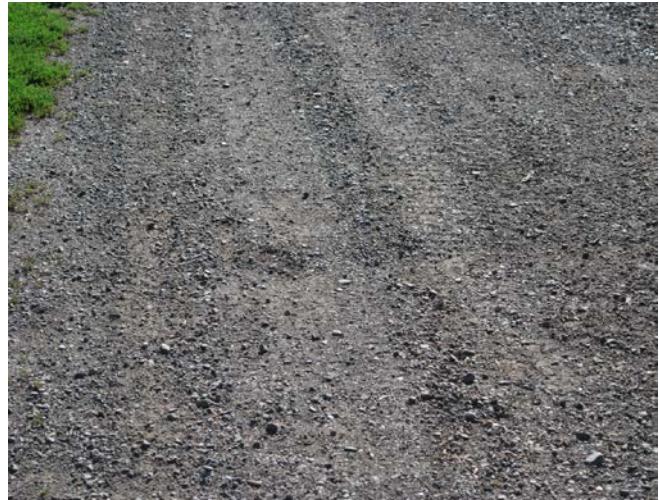
Close-up of gravel covering the orchard road.

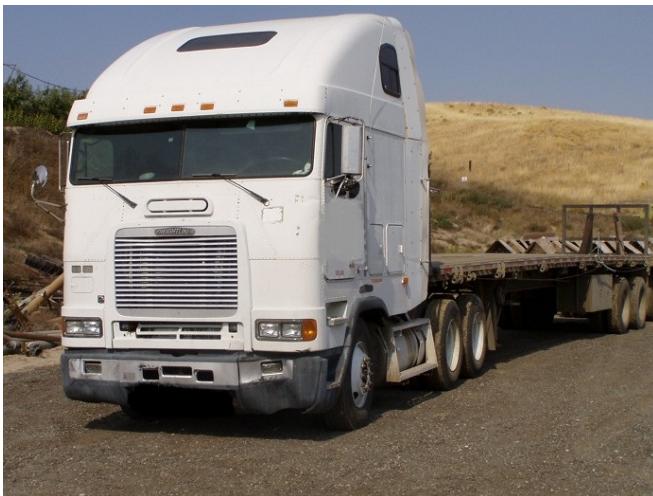
Semi-truck with flatbed trailer involved in incident.

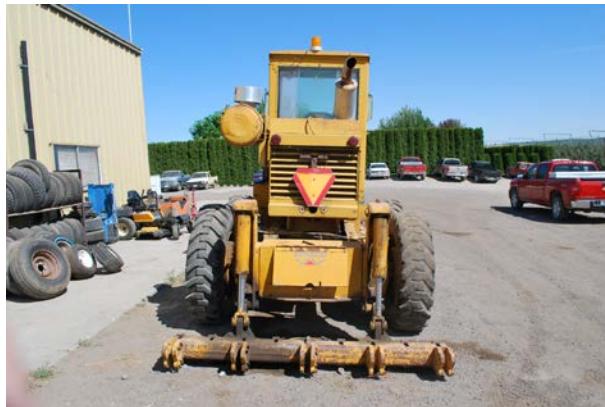
View of motor grader from rear.

According the National Safety Council all motor graders, bulldozers, and scrapers should be equipped with an audible reverse alarm that operates automatically when the machinery is in reverse motion.³ The incident motor grader was not equipped with a reverse alarm. If it had a reverse alarm, the worker and semi-truck driver might have been less likely to remain in the crush hazard area. If heavy mobile machinery was manufactured without a reverse alarm it is recommended that employers either remove that piece of machinery from service, or have it retrofitted with a reverse alarm.

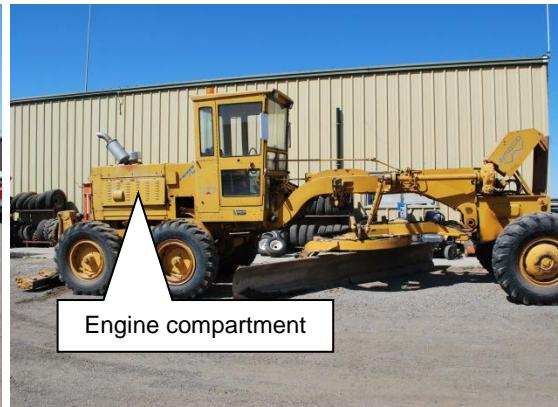
Side view of motor grader.

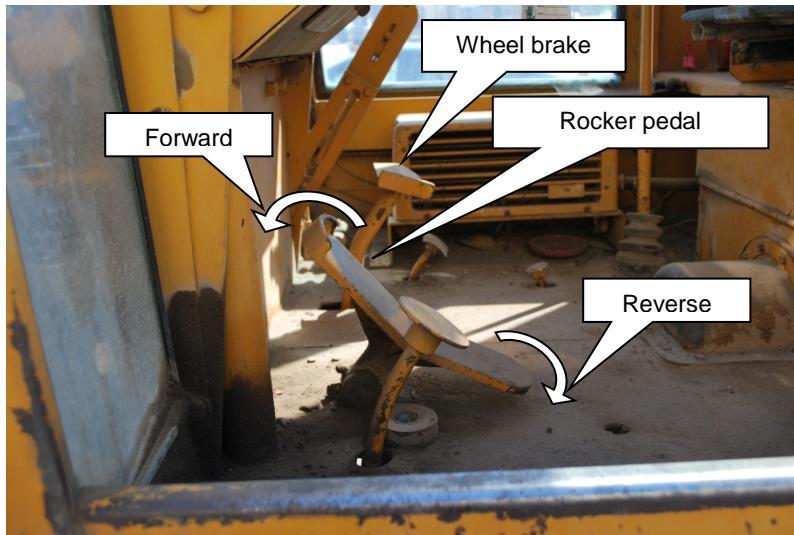
Rocker pedal and wheel brake.

According to manufacturer's manual, each of the four tandem wheels on the motor grader is equipped with a hydraulic actuated, shoe-type brake. The brakes activate when the operator pushes down on the wheel brake located to the right of the rocker pedal. The operator of the grader at the time of the incident said that the brakes failed and he was unable to stop it as it was backing up. The operator said that the brakes often needed to be pumped before they would work completely after the grader had not been used for at least a week.

After the incident the DOSH inspector tested the traveling and emergency brakes of the motor grader on the orchard road where the incident occurred. The inspector did not find any brake fluid leaks, and both the traveling brakes and the emergency brakes prevented movement of the grader on the sloped road.

Prior to reversing downhill, the operator did not conduct any functional testing of the motor grader brakes or other systems. He said he pushed down on the brake pedal as he reversed downhill (approximately 40 feet from the semi-truck) and noticed that the

brakes were not working. He tried pumping the brakes but the motor grader only slowed and did not stop. He also tried yelling at the worker and truck driver to move out of the way but was unable to be heard over the noise from the motor grader.

Two eye witness reports claimed that the motor grader came to a complete brief stop about 7 feet away from the semi-truck before suddenly reversing into the semi-truck. This indicates that the brakes may have been functioning properly at the time of the incident.

Recommendation 4: All operators of heavy machinery should perform a safety inspection before operating machinery. Inspections should include functional testing of safety devices.

The operator reported that the motor grader had not been used in a couple months. Before using the motor grader, he did a quick walk around inspection but it did not include any functional testing of the hydraulic brakes and other safety systems. The operator also reported it was common for the motor grader to need the brake pedal pumped to work when it had not been used recently. If the brakes had been functionally tested, the operator could have identified and addressed any problems with the brakes before reversing the motor grader down a sloped road.

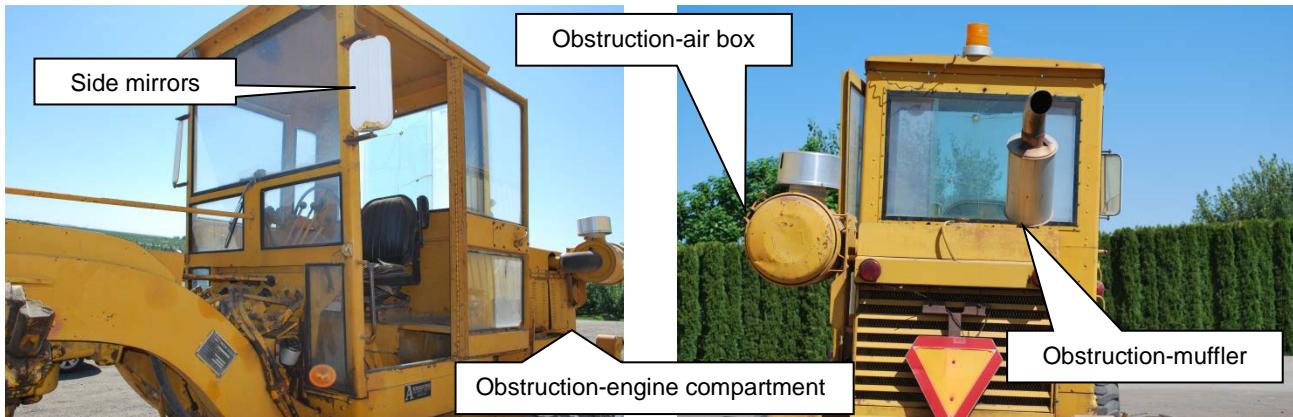
Side mirrors and back window (along with view obstructions) the motor grader operator would have used while reversing downhill.

Based on the inspection of the motor grader cab done by the WA FACE program and the managing partner, it is likely that the operator of the motor grader would have to stand in the cab and look over his shoulder out the back window beyond the rear of the engine compartment in order to see the worker and semi-truck driver while reversing the motor grader down the sloped road.

This motor grader was equipped with side mirrors. However, it still had blind spots for the operator. The height and length of the engine compartment created blind spots behind the machine that obscured the operator's view of the area where the worker and the driver were attempting to connect the chain. Diagrams 2 and 3, in appendix A, show examples of a motor grader operator's blind spots from the ground level and five feet above the ground (These blind spots were determined using a 27 ton CAT16G motor grader).⁴ For more diagrams characterizing machinery visibility for motor graders and other commonly used heavy machinery see NIOSH's Construction Machinery Visibility webpage at: www.cdc.gov/niosh/topics/highwayworkzones/BAD/imagelookup.html

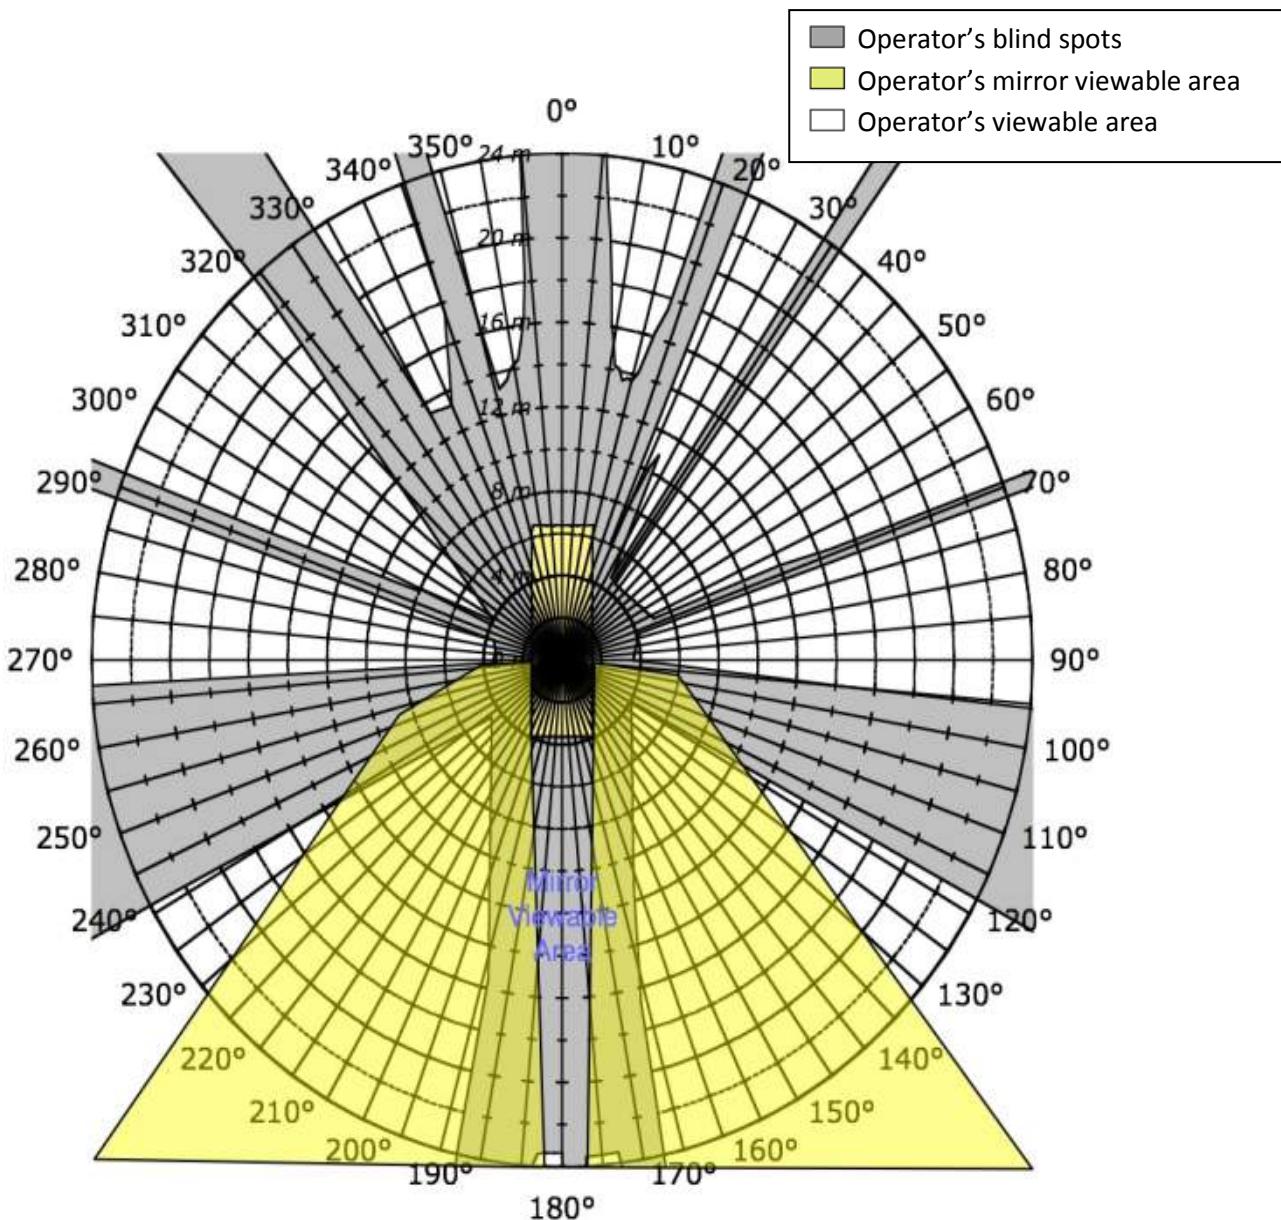
Diagram 2: Blind spots at ground level for a 27 ton CAT16G Motor Grader

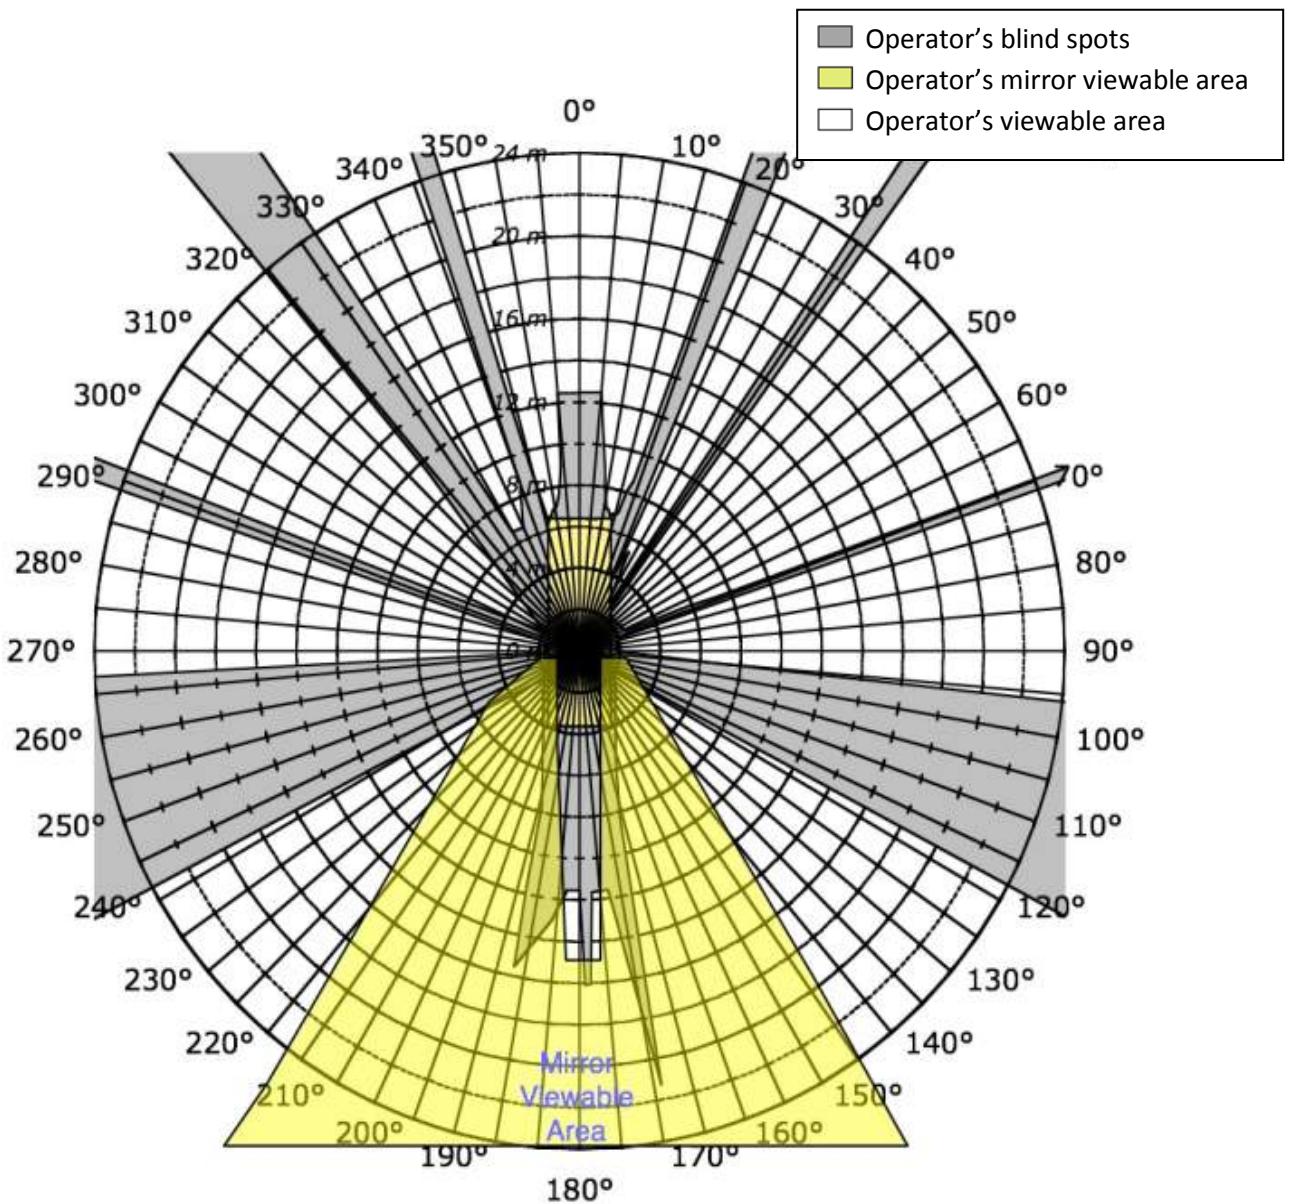
Diagram 3: Blind Spots at five feet above ground level for a 27 ton CAT16G Motor Grader
