Timber Harvester Operator Killed Following a Chain Shot Incident

Investigation: # 10WA04801
Release Date: 02-24-2014
SHARP Report: # 52-30-2014

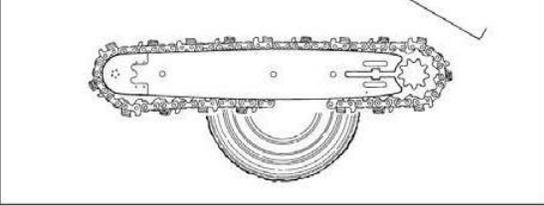
The free end of the chain begins to whip away from the break.

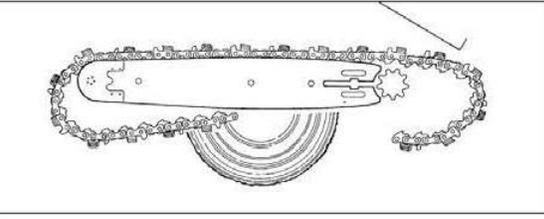
If the chain is not contained by the saw box or an energy-absorbing guard, the broken chain’s free end can speed up rapidly and carry immense dynamic energy.

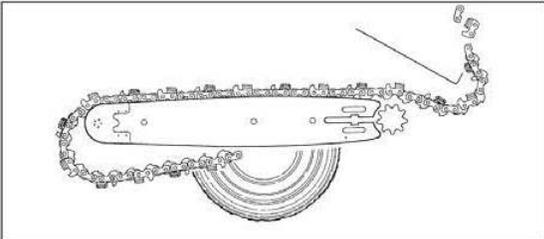
At the peak of the whip, chain parts may break loose and be ejected at high speed, especially if the free end of the chain strikes the saw box. Chain shot can cause chain parts to be thrown in many directions, especially along the plane of the saw bar.	Fragments have been measured at between 180 and 310 m/s under laboratory simulated conditions.

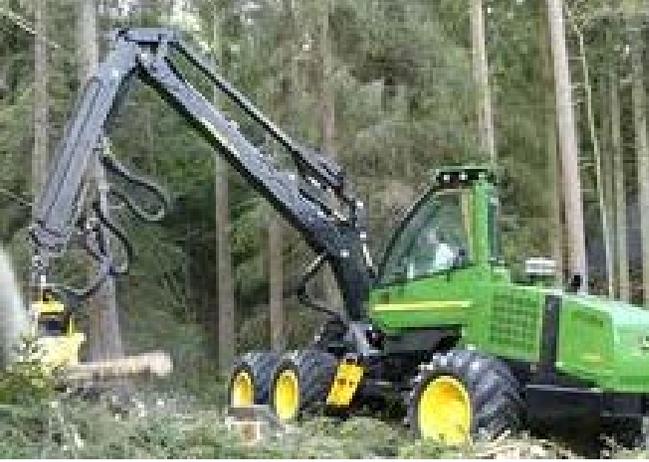
Photo 5: Photo of a harvester in the action of processing a tree with a cutting head. This particular harvester is designed so that the cab and boom with attached cutting head articulate independently. This allows the operator to position the cab so that it is not in line with the cutting bar while processing. (Not the harvester involved in the incident.)

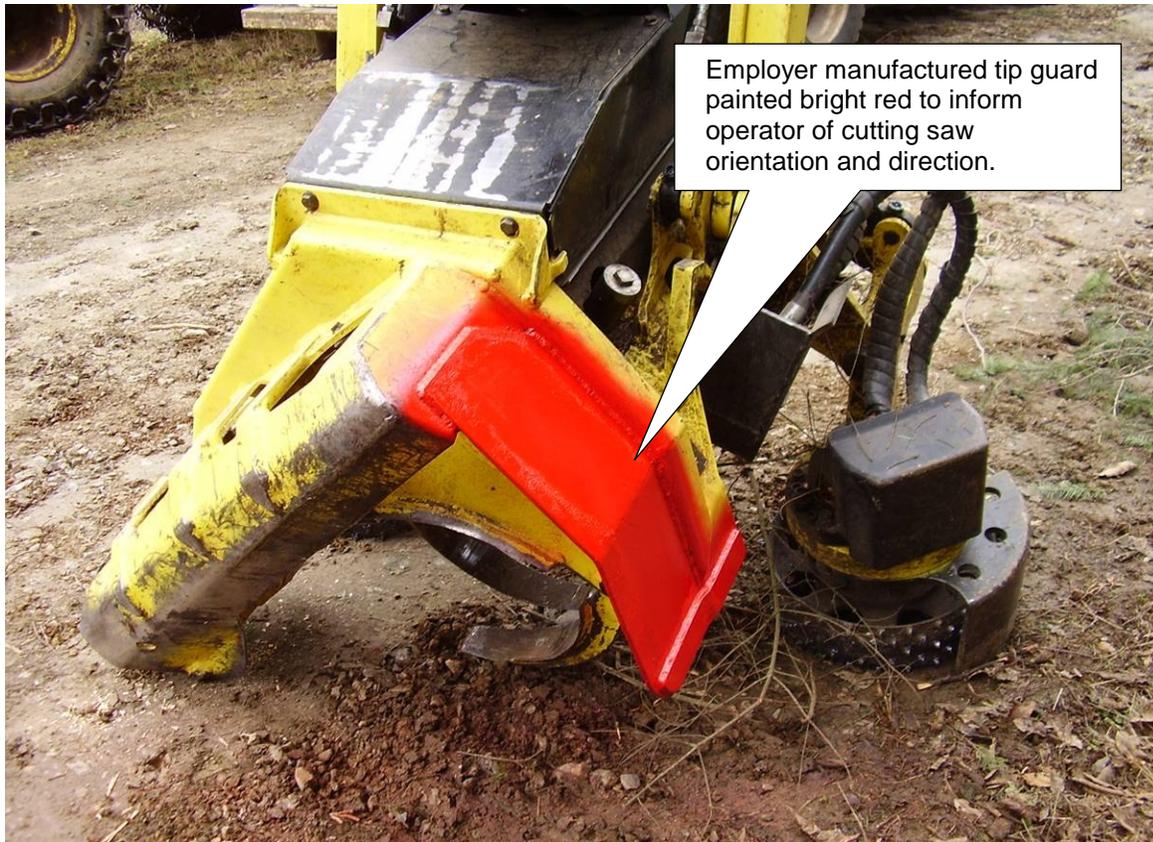
Photo 9: Tip guard manufactured by the employer after the incident. The design of the guard is intended to force any occurrence of chain shot down towards the ground.

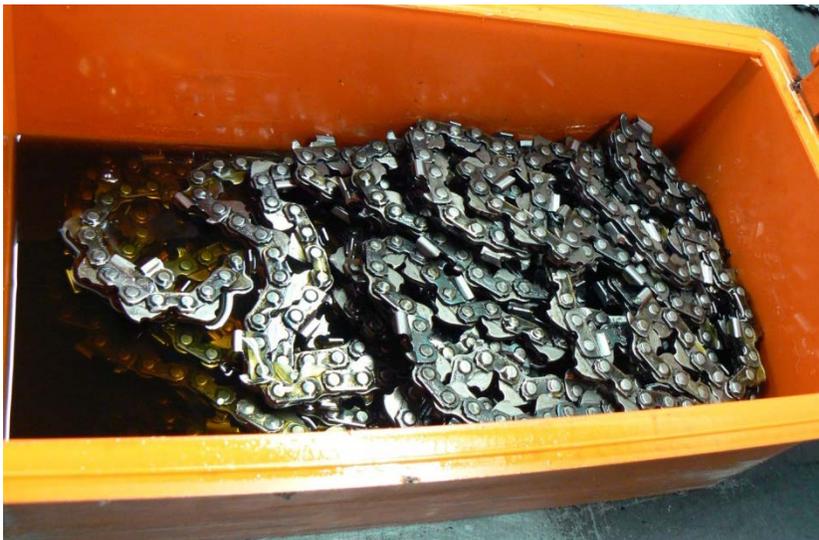
Photo10: Photo showing the inside of the orange bins with motor oil used to pre-lube chains.

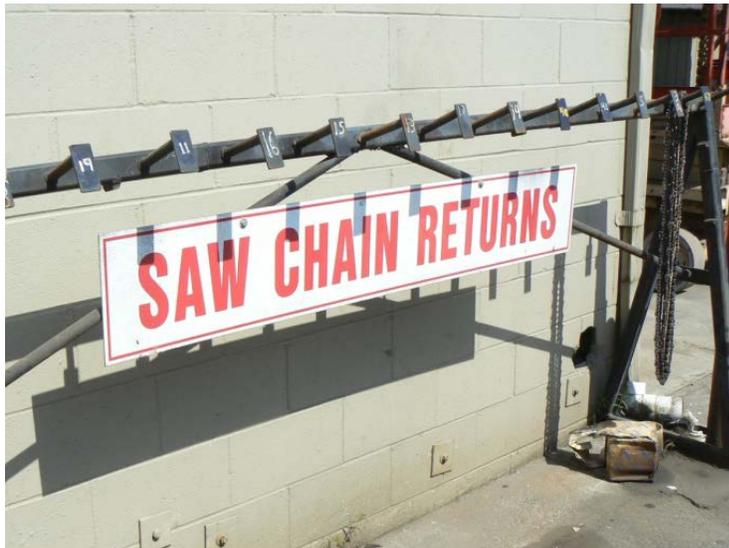
Photo 11: The numbered chains return rack used by equipment operators.

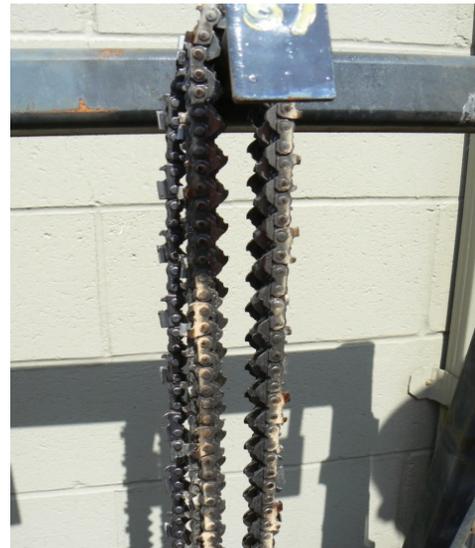
Photo 12: Close-up of chains returned to numbered rack.

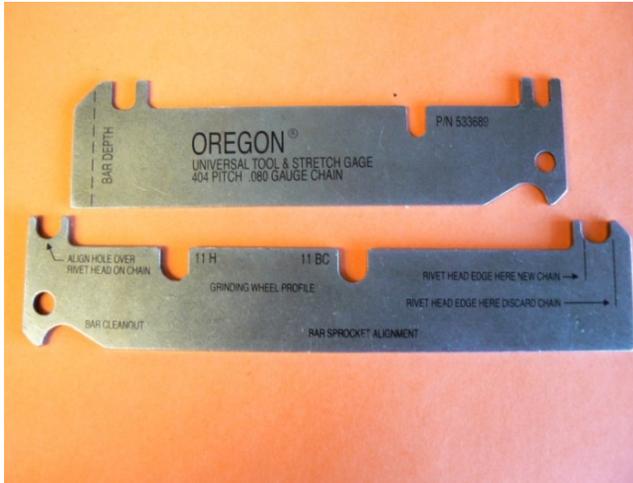
Photo 13: Tools used for inspecting chain stretch and bar depth.

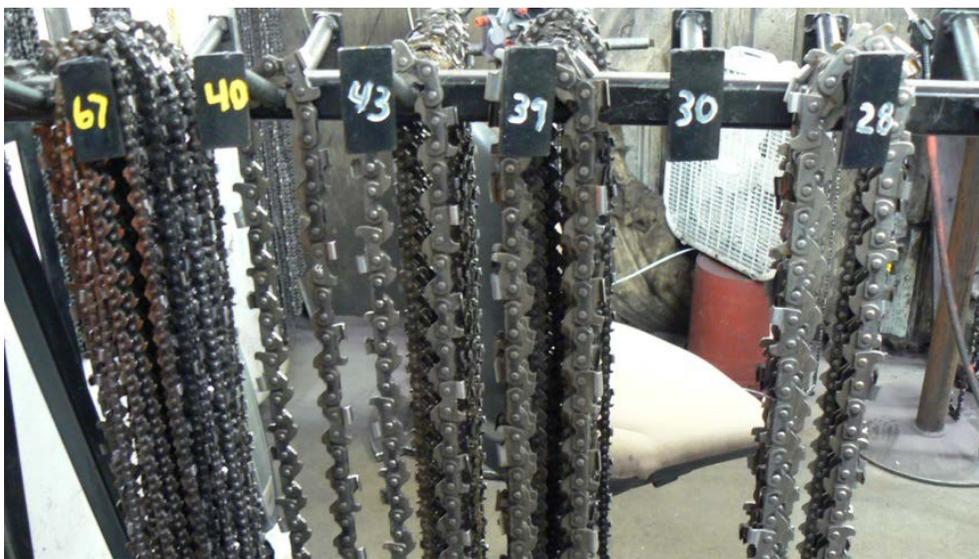
Photo 15: Numbered rack in maintenance shop. Chains on rack have been inspected and are waiting to be put into orange bins with motor oil. Rack is locked to ensure that equipment operators cannot take chains from rack.

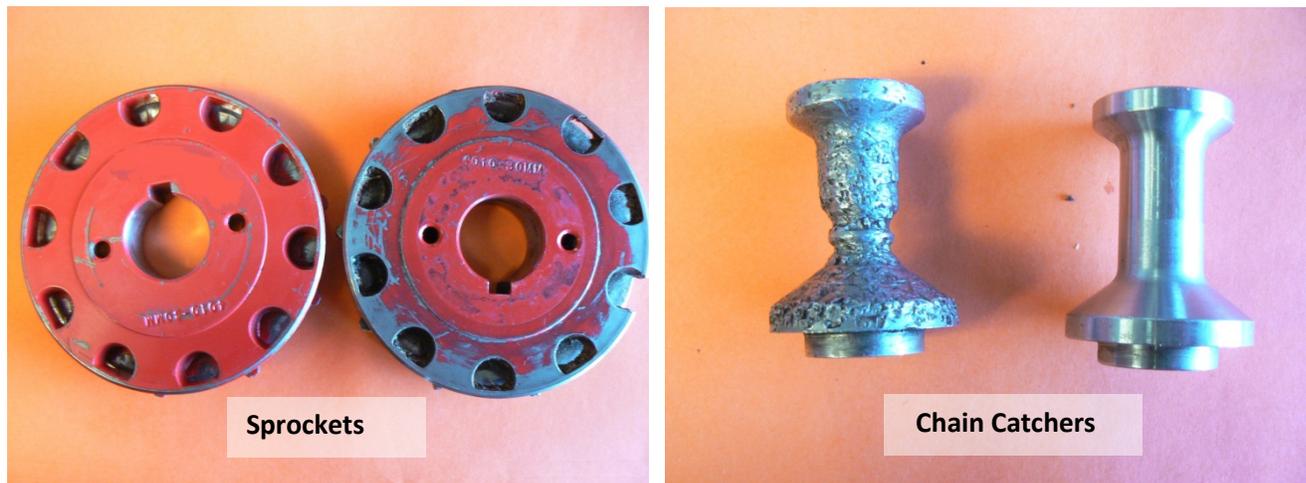
Photo 16 and 17: Used sprockets and chain catcher. The sprocket on the left is worn and was changed at the appropriate time. The sprocket on the right is worn and was run too long. The chain catcher on the left is an example of one that needs to be replaced, while the chain catcher on the right is new.
