REPORT #:
71-192-2020

REPORT DATE:
March 2, 2020

Service Technicians Receive Electrical Burns When Electricity Arcs from Power Line to Boom Lift

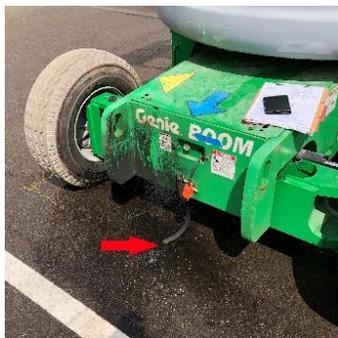
Exit location of electrical current through the boom lift. One technician was standing in this area; the other was standing to the side of the lift.

After they repaired the hydraulic line, they decided to test that the repair had been successful. The technicians were focused on their task and did not notice the high voltage 69 kV power transmission line 36 feet above the ground overhead. The day was overcast with intermittent showers, which may have affected their ability to see the power line. From the ground, one technician operated the lift's controls to elevate the boom. The other stood behind the lift to check for a hydraulic fluid leak. As the technician raised the boom, it came near to the power line, but did not touch it. Electrical current arced from the line to the lift basket's wet metal railing and traveled through the lift's frame into the parking lot asphalt where the technicians were standing.

- Employers must have the operator survey the area for hazards before using an aerial lift. See [WAC 296-869-20035](#)
- Employers must ensure that operators maintain the minimum safe approach distance to energized power lines. See [WAC 296-869-60035\(1\)\(f\)](#)

- To recognize electrical hazards from overhead power lines.
- That electricity can arc, or jump, from a power line to an aerial lift without contact with the line. If any part of the lift gets too close to a power line, an arc can cause electrical current to energize the lift and run through it to the ground. This is especially true when a conductive object, such as a lift's boom or basket, is wet.
- To be aware that power lines can be difficult to see, and that judging their height from the ground can be difficult, especially on cloudy, showery days when there is low contrast.

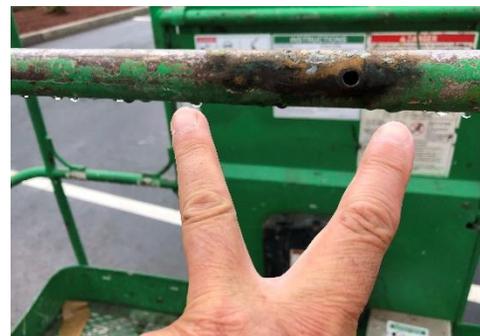
Location where electric current made contact on railing of boom lift basket after arcing from a power line.
