INCIDENT FACTS

71-195-2020

New Single-Family Housing
Construction

Framer Struck by Falling Wall Section

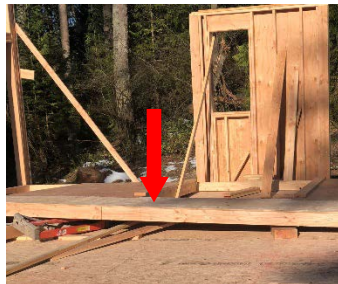
Section of the fallen wall where the crew leader was working.

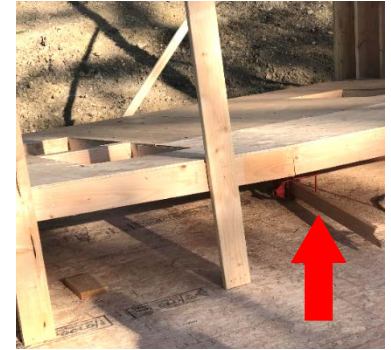
As they were raising the wall, the framer was working on one end of the wall, the crew leader on the other end, and the carpenter was in the middle. When they had raised it about eight feet, they stopped to place brace poles. Their plan was to secure the wall with braces and then when other workers arrived on site they would push up the wall the rest of the way by hand. As the framer was securing a brace pole under the wall, the pole broke. The wall then fell in sections, with one section striking and crushing him underneath. He suffered multiple fractures and internal injuries. The other workers were not injured. When work started again several days later, seven workers lifted the wall.

Section of the fallen wall that crushed the framer. The arrow indicates the broken 2x4 brace pole with wall jack.

- Follow manufacturer’s instructions and guidance on the use and maintenance of wall jacks.
- Inspect all wall jack equipment, including the wall jack pole, before and after each use to be sure there is no damage or deformation to any of the equipment.

- If it is safe to lift the wall manually and that is the method chosen, ensure that a sufficient number of workers are continually assisting while the wall is being raised to prevent the wall from falling back onto them.
