INCIDENT FACTS

71-198-2020

Framer Falls 20 Feet through Stairwell Opening

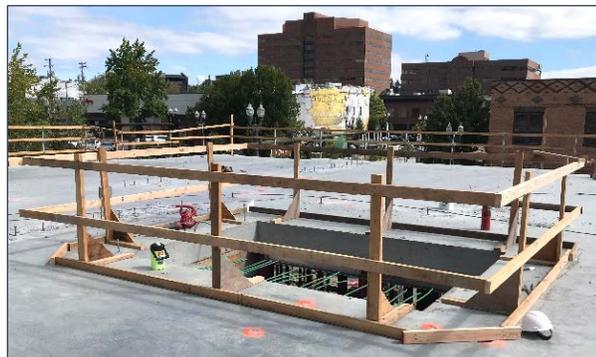
A 39-year-old framer died when he fell 20 feet through a stairwell opening in the second floor deck of a building under construction.

No one observed what happened next, but a time-lapse security camera captured the movements of the framer. He walked toward the stairwell, climbed through the guardrail, and stood on the opening's inner concrete ledge. He then fell into the stairwell opening, landing on concrete 20 feet below. First responders took him to a hospital where he later died.

Stairwell opening the framer fell through.

- This tragic fatality could have been prevented if the worker had not gone on the other side of the safety guardrail system without the use of fall protection.
