## INCIDENT FACTS

71-200-2020

Elevated light rail section under construction

## Laborer Struck by Temporary Steel Shoring Tower Parts

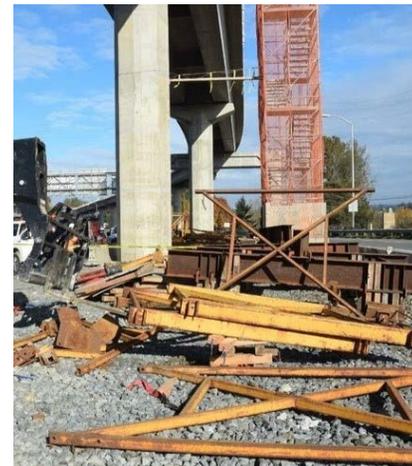
As the crew was working, they experienced a problem that prevented easy disassembly of two coupled steel frames. The two frames could not be separated due to the binding of steel pins used to connect the shore tower sections.

A member of the crew had been using a forklift to hold the frames upright. The laborer instructed him to move the forklift away from the frames. The laborer then attempted to free the pins by using a sledgehammer to knock the pins out. After he hammered out the last pin, the two coupled 690-pound frame sections fell on him as he stepped into their path. He was hospitalized with head injuries. He died four months later.

Incident scene beneath an elevated section of a light rail line under construction.

Safe methods of disassembling the shore tower parts would include the use of a forklift or crane to stabilize the shore tower parts while a worker removes the pins connecting the frames.

- Workers must follow manufacturer's instructions for disassembly of shoring systems, and any supplemental instructions provided by the employer; such as a hazard assessment or on-the-job instructions, when specially prepared by the employer's mechanical and safety engineers.
