71-201-2020

Roof deck of three-story  
college building under  
construction

**Ironworker Falls 42 Feet through Hole when Cover Fails**

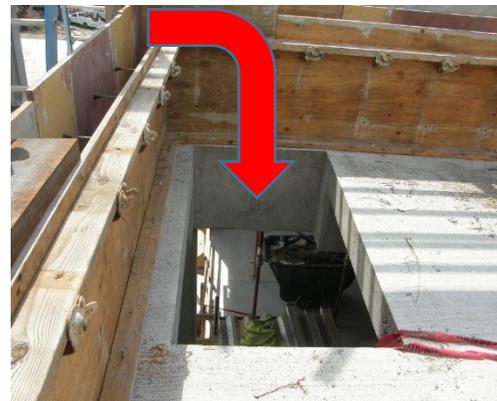
Investigators determined that the general contractor had installed the cover. The 32-inch by 62-inch hole was covered by a 5/8-inch thick piece of 10-year-old worn plywood. The plywood was 48 inches by 60 inches and was secured on one side with two nails to the stem wall sill. This placement left a gap of one inch on each end and only two sides of the plywood supported. When the ironworker landed on the plywood, it buckled in the center.

Incident scene on building roof deck showing the hole that the ironworker fell through when a plywood cover failed.

- Subcontractors should check hole covers to verify that the covers are adequate in strength and placement and report potential problems to the general contractor.
- Employers on multi-employer sites should use contract language that clearly defines the safety responsibilities of each contractor prior to initiation of work.
