INCIDENT FACTS

71-215-2022

Communication Tower Worker Falls 260 Feet

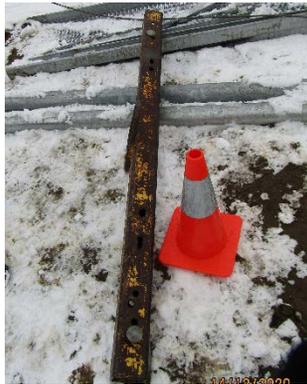
Gin pole jump plate used in the operation.

The crew was in the process of adding the final 20-foot section to the self-supporting tower. They were using a triangular lattice gin pole to “stack” the tower sections. They had just jumped, or raised, the gin pole into position in order to lift the final section. They used a jump plate to help lift and position the gin pole. The plate was a 6-foot long square steel tube with a steel loop welded in the center.

The climber was in the process of unbolting the plate so they could lower it to the ground. He removed the last bolt that secured the plate to the tower and then leaned back. When he did, he fell 260 feet to the ground. The climber did not connect either pelican hook of his fall arrest Y-lanyard to an anchor point on the tower. The plate was still attached to the winch line when it swung down and struck his coworker in the chest.

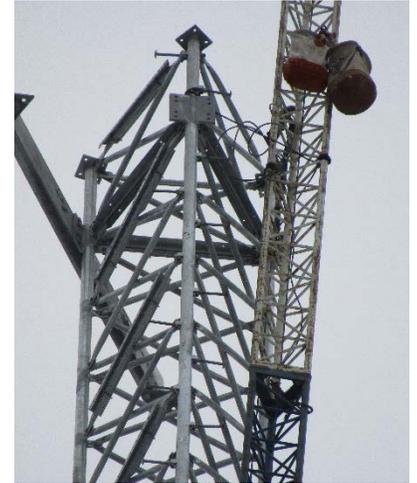
A 24-year-old tower climber fell 260 feet from a communication tower under construction.

Tower from which the climber fell with the smaller triangular gin pole suspended in the front.

- Establish and maintain a communication system among all workers on site and ensure workers on the tower communicate and confirm step-by-step procedures anytime they change positions or perform tasks that require them to detach and reattach their fall arrest systems.
- Frequently reinforce training on proper use of fall protection equipment with emphasis on always maintaining one point of attachment and reattaching before detaching so that workers maintain 100% tie-off while on the tower.
