71-230-2022

November 21, 2022

## Carpenter Falls through Floor of Two-Story Garage

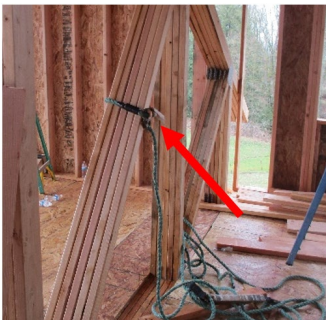
Example of how crew tied-off lifeline ropes to roof trusses.

After the incident, the brothers demonstrated to investigators how they tied-off their fall protection lifeline ropes by wrapping them around roof trusses. They did not have fixed or temporary anchors installed. Investigators determined their method of tying off was inadequate since diagonal truss braces are not rated for that. Investigators also found that the employer did not have an Accident Prevention Program (APP) and did not develop a fall protection work plan for the project.

- Frequently remind workers of the need to use fall protection 100% of the time they are at risk of falls.
- Develop policies and train workers to:
  - Tie-off to approved fixed or temporary anchors only. Wood beams of roof trusses are not designed to support fall protection systems.
  - Not store raw materials like OSB over floor joists or other areas where fall hazards exist.

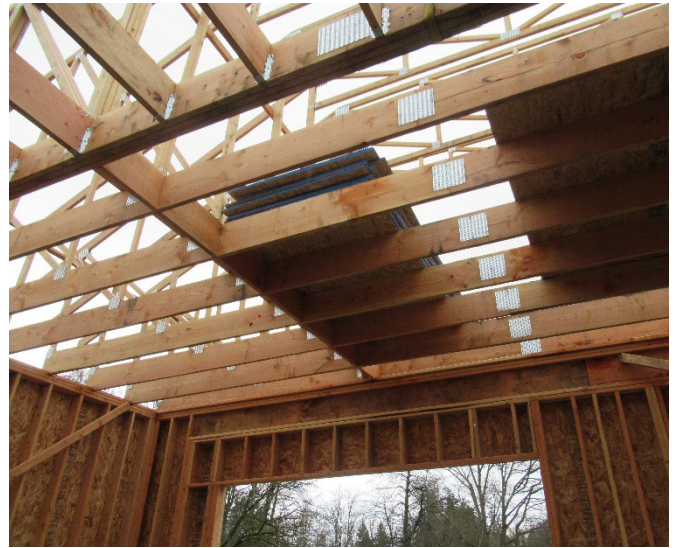
View through the unfinished floor of the room above the garage. The leading edge of the floor is on the right and the OSB sheathing is stacked on floor joists.
