Family Dairy Farm Worker Dies When Tractor Rolls Down Embankment

SUMMARY

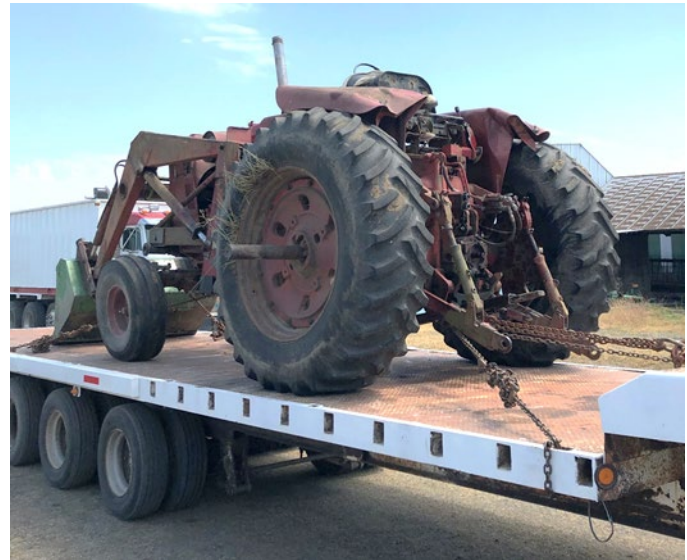
The pond area was dark, as it was two hours before sunrise. The only light came from the tractor and nearby farm buildings. The lone worker was driving the tractor on the embankment road to his final pumping location. The tractor was traveling close to the unmarked edge of the road.

As the tractor turned sharply near its final destination, its front left wheel got caught in a rut that caused the tractor to roll over the edge down the 25-degree outer slope of the embankment. The worker fell to the ground, and the tractor's 3-point hitch fatally pinned him against his back. His wife and son were first to find his crushed body around four hours later. The employer, who was the worker's father, called 911 and used another tractor to lift the rolled tractor off the worker's body so the coroner could take custody of it.

- Install manufacturer-approved, certified ROPS and seat belts on tractors.
- Develop a formal, written APP with job hazard analysis (JHA) and ROPS and seat belt safety training requirements.
- Improve tractor safety on embankments by assessing road and slope hazards, installing lights, and marking edges of roads with visual cues, such as reflective driveway stakes.
