INCIDENT FACTS

71-251-2024

March 18, 2024

Heavy Equipment Mechanic Dies Repairing Excavator

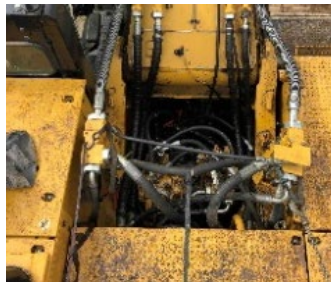
Swing drive compartment
where mechanic was trapped.

The mechanic was installing a swing drive into the de-energized excavator. A supervisor showed up at 9 am to check the work and arranged to have new hydraulic hoses delivered to the mechanic. He then left the jobsite. After the hoses were dropped off, an assistant came to help the mechanic. They completed installing the swing drive just before noon. The assistant then left the site as the mechanic planned to install the hoses by himself. Another supervisor who was getting ready to leave asked the mechanic if he needed anything. The mechanic said no, so the supervisor left him alone at the site.

At 1:45 pm, the assistant texted and called the mechanic but got no response. The first supervisor texted the mechanic almost an hour later but also got no response and thought he went home. At about 5:30 pm, the mechanic's wife left a voice message on the employer's call service asking about her husband. A worker heard the message and texted the supervisor, but the text failed to reach him. The mechanic's wife also called a family friend. The friend did not know where the mechanic was but was able to get directions to the site from a worker. The worker also contacted the supervisor, whose GPS showed the mechanic's service truck was still at the site. Now around 40 miles away, he began driving back to the site. The friend arrived there first, found the mechanic unresponsive and upside down in the swing drive compartment, and called 911. First responders pronounced the mechanic dead at the scene. The medical examiner reported the mechanic died from suffocation caused by being trapped in a head-down position.

- The mechanic had prior experience installing excavator swing drives.
- Ratchet straps, a come-along, and tools for the job posed trip hazards near the swing drive compartment.
- The boom side operator's cab window was shattered presumably when the incident happened.
- The employer had no written safety policy for lone workers.

- Develop and enforce policies and standard operating procedures (SOP) in their written accident prevention program (APP) that:
 - Prohibit lone work and instead require using a buddy system where workers team up so they can observe each other and assist quickly when someone becomes endangered.
 - Require a formal job hazard analysis (JHA) be conducted jointly by supervisors and workers to identify hazards for lone work. Prevent hazards by implementing less hazardous work practices.
 - If lone work is unavoidable, provide and require use of lone worker monitoring technology or communication procedures, such as two-way radios, in-person check-ins, wearable panic buttons or worker down apps for cell phones.
 - Require supervisors to routinely observe workers to ensure they are following policies and procedures.

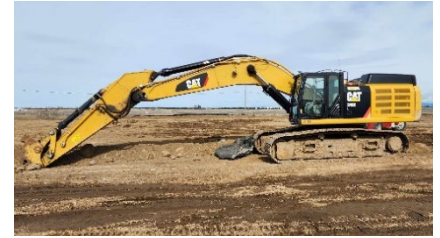
Excavator that was being repaired.
