71-259-2024

October 14, 2024

Truck Mechanic Struck by Trailer Air Suspension Spring

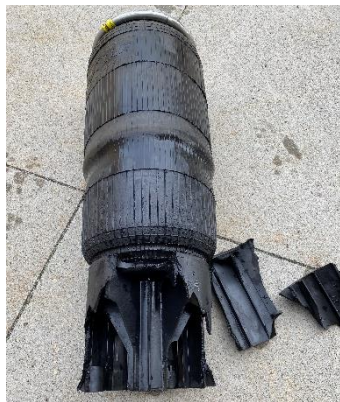
Air spring that struck mechanic.

The mechanic stayed under the trailer and gave the driver instructions while the spring was inflating. It was inflating for about three minutes when the driver heard a loud boom. The spring had ejected from its wedged position and struck the mechanic in the head. The driver yelled to the mechanic but got no reply. He ran to the trailer and found the mechanic unresponsive with severe head injuries. He then ran to the hospital's emergency room for help. Medical staff rushed to the scene, where other first responders were arriving. They pulled the mechanic out from under the trailer but could not save his life.

- The mechanic did not follow the air spring manufacturer's instructions to:
 - Fully secure the spring before inflating it. With only one bolt installed, the spring was not properly secured before being inflated.
 - Use new bolts for the spring installation. The bolts found at the scene were worn out and one was sheared in half.
- The employer did not have a hazardous energy control plan or lockout/tagout (LOTO) program.

- Develop a hazardous energy control program for commercial vehicle maintenance operations, including LOTO requirements, as part of their written accident prevention program (APP). Policies should clearly identify hazards and provide precautions, controls, and how to verify zero-energy for all energized vehicle systems, including pneumatic potential energy stored within pressurized air in air suspension systems.

- Provide recurring hands-on training that gives mechanics the knowledge and skills to implement hazardous energy controls and LOTO requirements. Training should include showing mechanics how to properly follow the manufacturer's installation, maintenance, and safety instructions for different system components. Have mechanics demonstrate their knowledge and skills before allowing them to work on or near vehicle systems where hazardous energy is present. Conduct periodic refresher training and support it with toolbox talks and safety meetings.

- If lone remote work is unavoidable, require field service mechanics to call their supervisor to verify they have applied hazardous energy controls or LOTO before repairing an energized vehicle system.
