INCIDENT FACTS

REPORT #:

71-264-2025

Framer Falls 8 Feet from Rim Joist

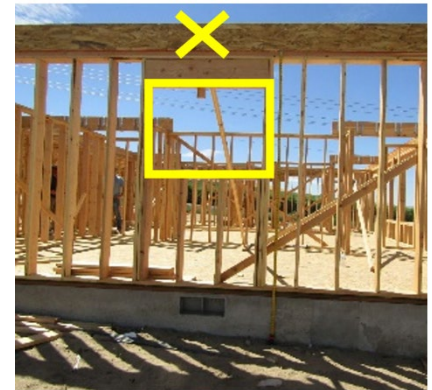
Circle shows area where framer fell.

The framer was with a co-worker removing previously installed second-level floor joists to relocate an inside kitchen wall that was framed in the wrong place. After finishing his task, he went to an outside wall where his co-worker was working. He sat down on a rim joist to wait. The joist was eight feet above the floor decking and had a window opening just below it. He was straddling the joist to support himself above the opening. He then leaned to the inside of the wall and lost balance. Unable to regain balance due to the opening, he fell headfirst to the floor decking below.

- The framer fell from an inside wall height of eight feet, three-quarters inches. The fall hazard to the outside of the wall was nine feet, nine and three-quarters inches. Fall protection was not used because workers were under the 10-foot trigger height for fall protection requirements while installing structural members.
- The framer attended weekly safety meetings where fall protection was a recurring main topic.
- The employer had a written accident prevention program (APP) with a fall protection plan.
- The project manager for the general contractor was on the jobsite when the incident occurred.

Framer fell from rim joist (x) above window opening to floor deck.

- When workers must walk on top plates, joists, rafters, trusses, beams or other similar structural members, provide fall protection by using scaffolding, aerial lifts, edge protection platforms, guardrails, safety nets, or personal fall protection systems. Train workers to use these methods and equipment properly and periodically evaluate their fall protection knowledge and skills.
- Arrive on-site before work begins or appoint a supervisor to jointly conduct a site hazard assessment with workers to identify fall hazards and develop fall protection solutions.
- During the pre-job safety meeting, review the site hazard assessment and discuss workers' responsibilities to use fall protection and follow fall prevention safe work practices.
