INCIDENT FACTS

71-268-2025

Maintenance Worker Crushed by Plywood in Service Truck

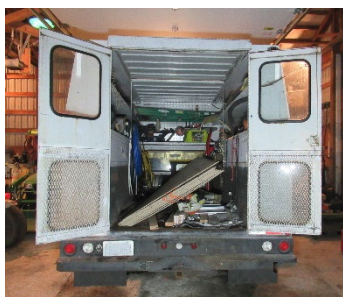
Rear view of truck cargo area.

He had loaded 11 four-foot by eight-foot plywood panels in the back of an enclosed body service truck a week before. The panels were stacked upright against the left side of the truck body with the long edge down.

- Each plywood panel weighed between 35-40 lbs., for a total weight around 450 lbs.
- Based on the worker's body position and the direction of his head, he had likely been standing and facing the plywood when something made it shift and fall toward him.
- It is unknown if the plywood had been secured or not.
- Lumber and ladders laying on the truck floor may have presented a tripping hazard.

- Ensure workers load plywood flat and evenly on the truck floor and secure it with ratchet straps at multiple points. Use a panel rack or trailer if truck floor space is limited or if hauling plywood frequently. Require workers to use a buddy system when loading and unloading heavy cargo.

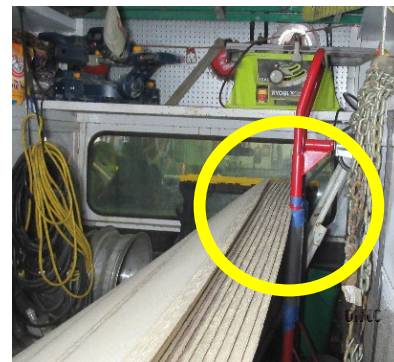
On the day of the incident, the worker arrived at the company shop a few minutes before his employer. When the employer arrived, he saw the truck's rear cargo doors opened, walked toward them, and looked inside. He found the worker sitting unresponsive with his back against a dolly that was strapped to the right side of the truck body. The stack of plywood had shifted to the right and pinned the worker by the neck against a metal cross brace between the dolly's rails. The employer then went in the truck and used his back to push the plywood up enough to pull the worker out. He called 911 and started CPR. When first responders came, they pronounced the worker dead at the scene.

Crush point between plywood and dolly.
