Farm Worker Crushed in Riding Lawn Mower Rollover

REPORT #: 71-270-2025s

REPORT DATE: September 8, 2025

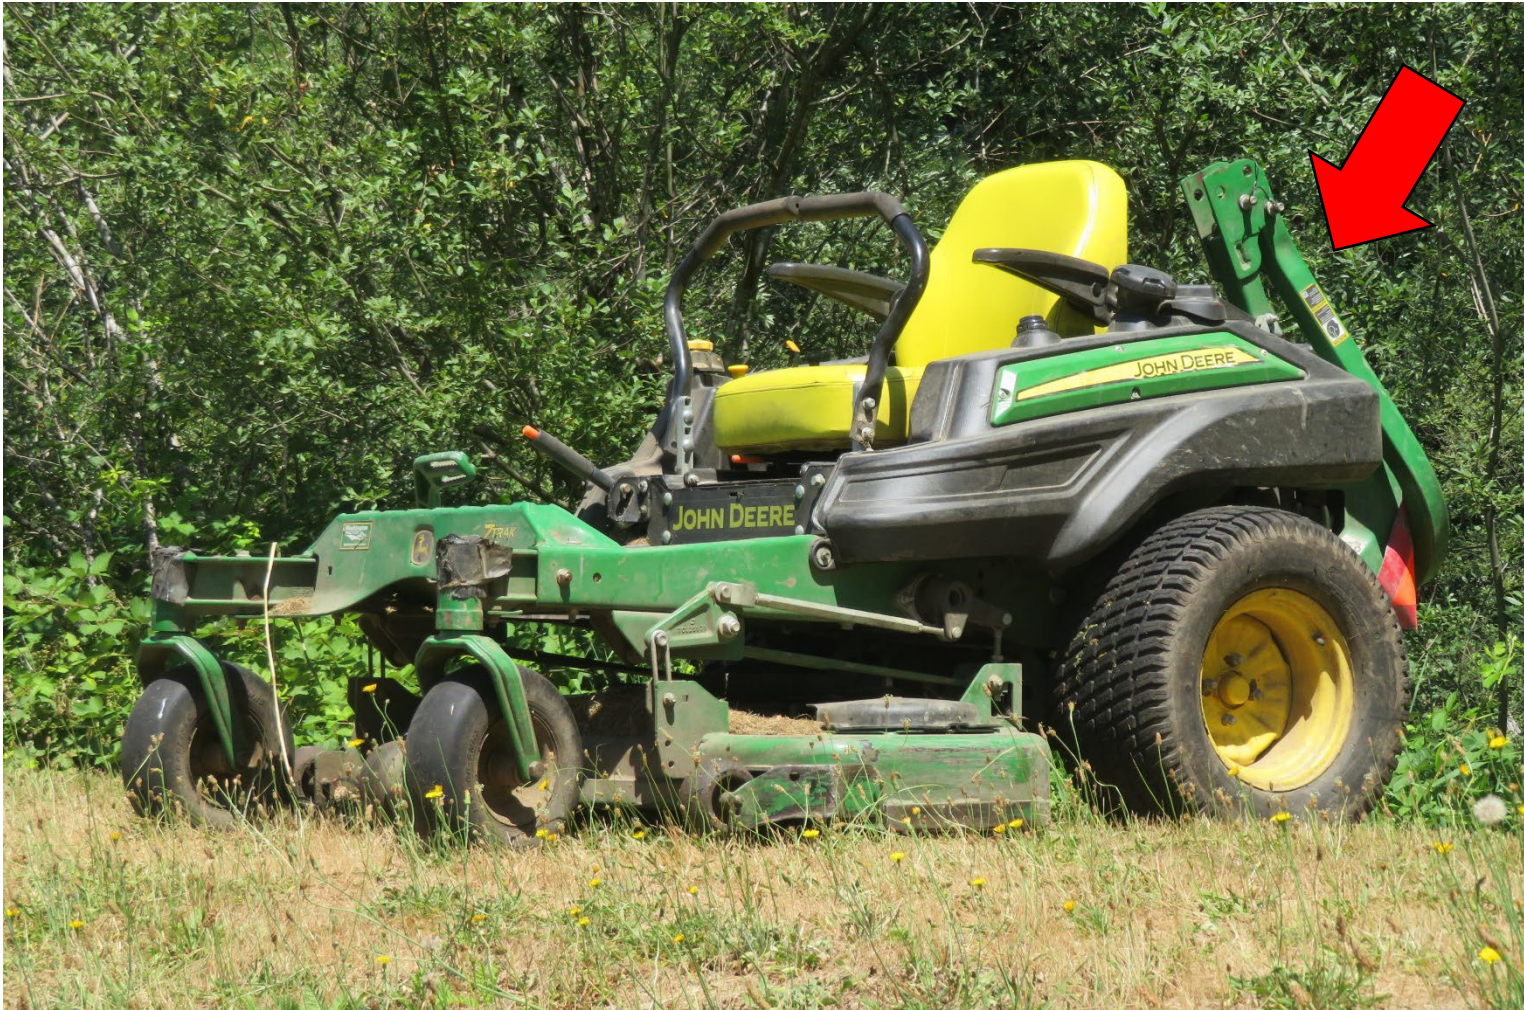
- The worker was not operating the mower according to the manufacturer's instructions in the following instances: 1) the rollover protective structure (ROPS) was not in the upright position, 2) no seat belt was used, and 3) mowing was taking place where the risk of a rollover was high.
- The riding surface on top of the embankment was 12 feet wide but uneven with steep slopes on both sides, including a three foot drop off on the inner slope, that exposed the worker to rollover hazards.
- There were no overhead obstructions that interfered with using ROPS in the upright position.

Photo 1. Mower with ROPS down.

- Require the use of a walk-behind mower or string trimmer instead of a riding mower in hazardous areas such as embankments, steep slopes, soft ground, bodies of water, edges along bodies of water, and terrain with holes, ruts, bumps or other hidden objects.
- Develop and enforce policy requirements for ROPS and seat belt use and mower operator safety training in their written [accident prevention program](#) (APP). At a minimum, the policy should conform to the manufacturer's safety requirements. Review requirements with supervisors and operators at safety meetings and training.

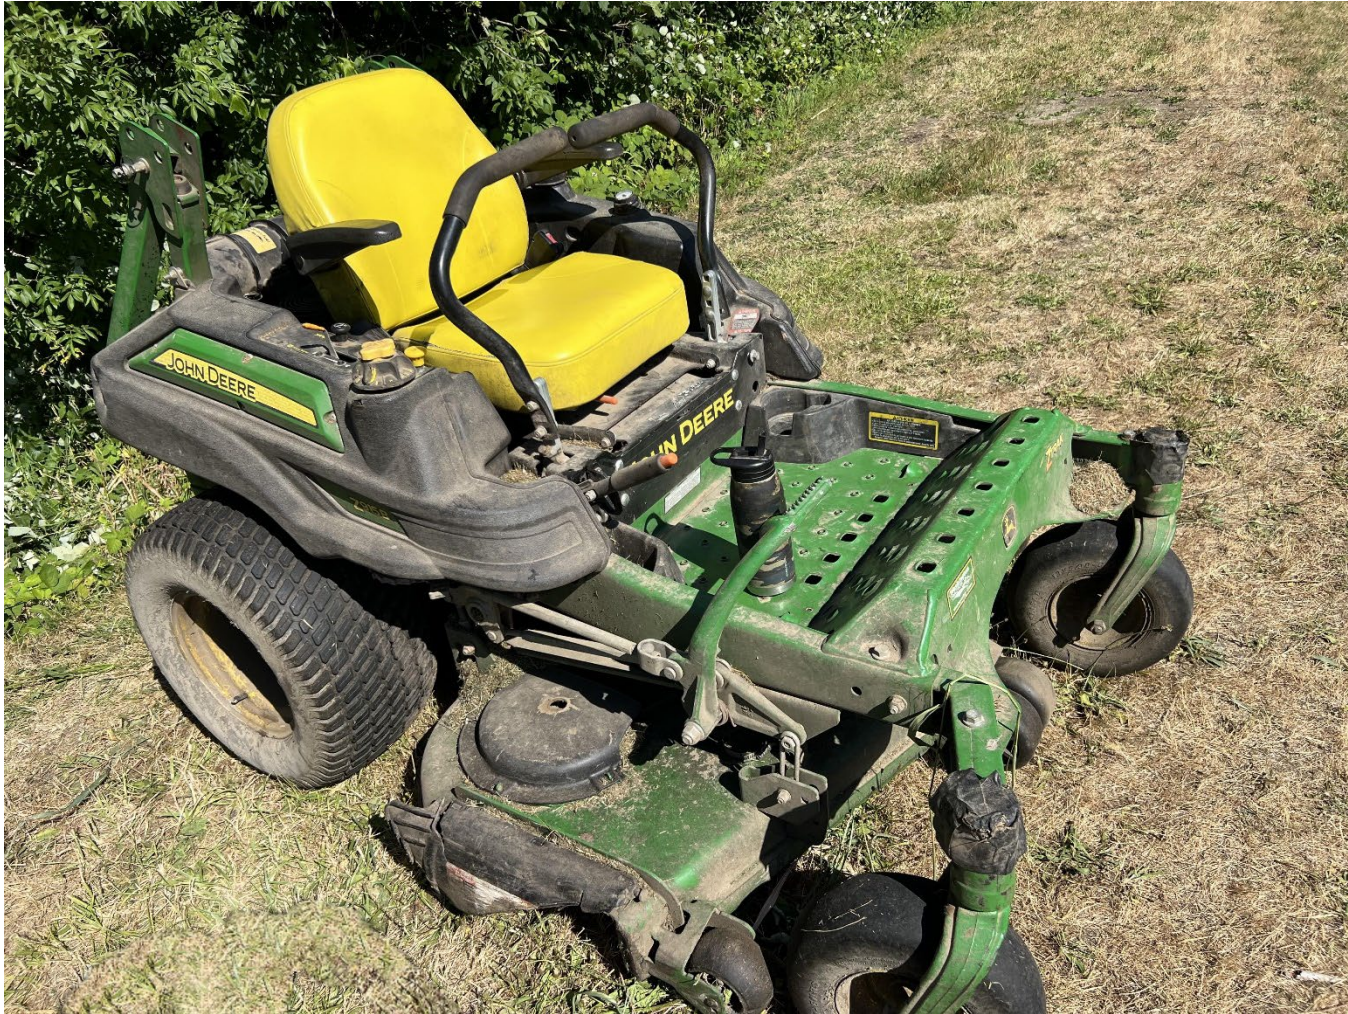
Photo 2. Close-up view of mower.

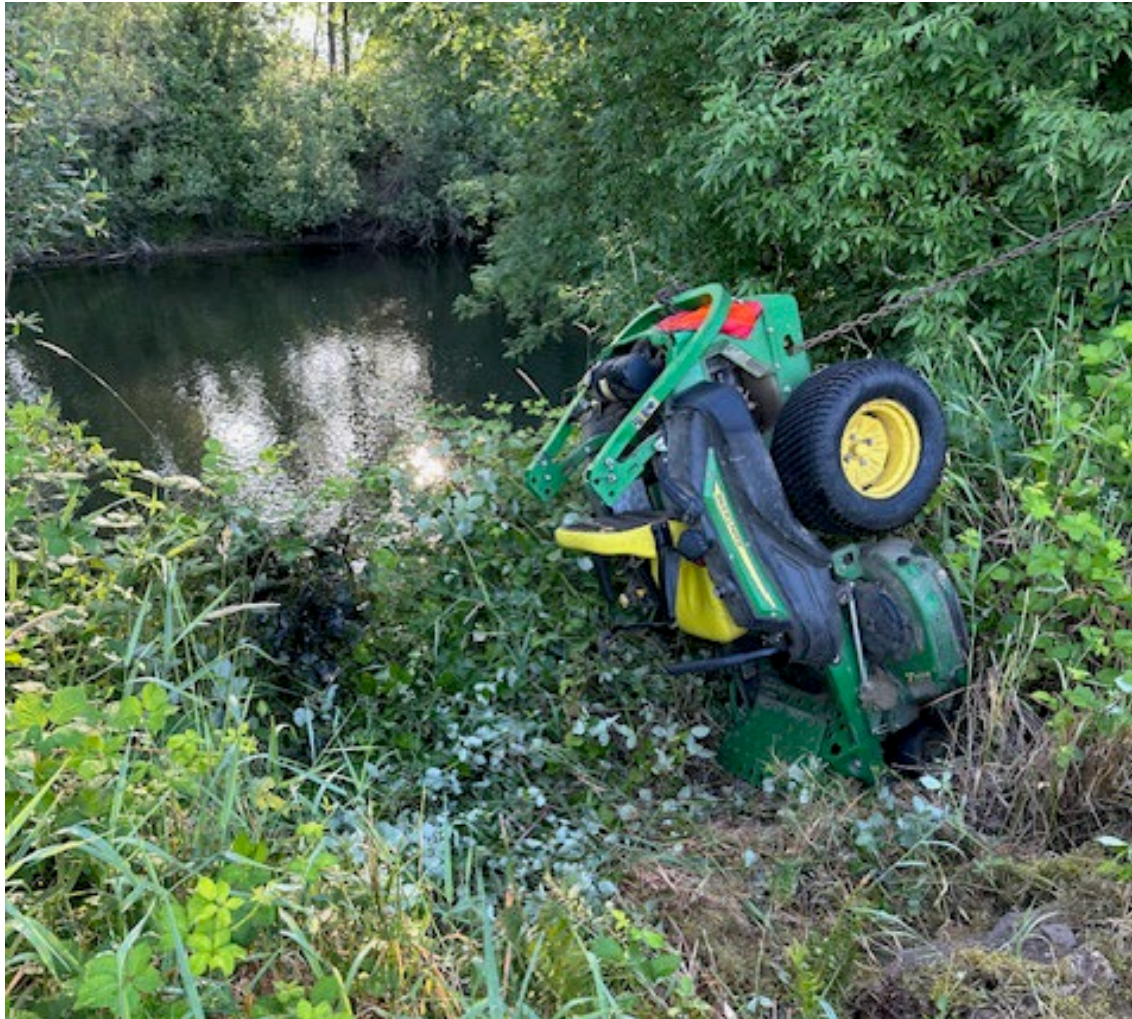
Photo 3. Mower being recovered.

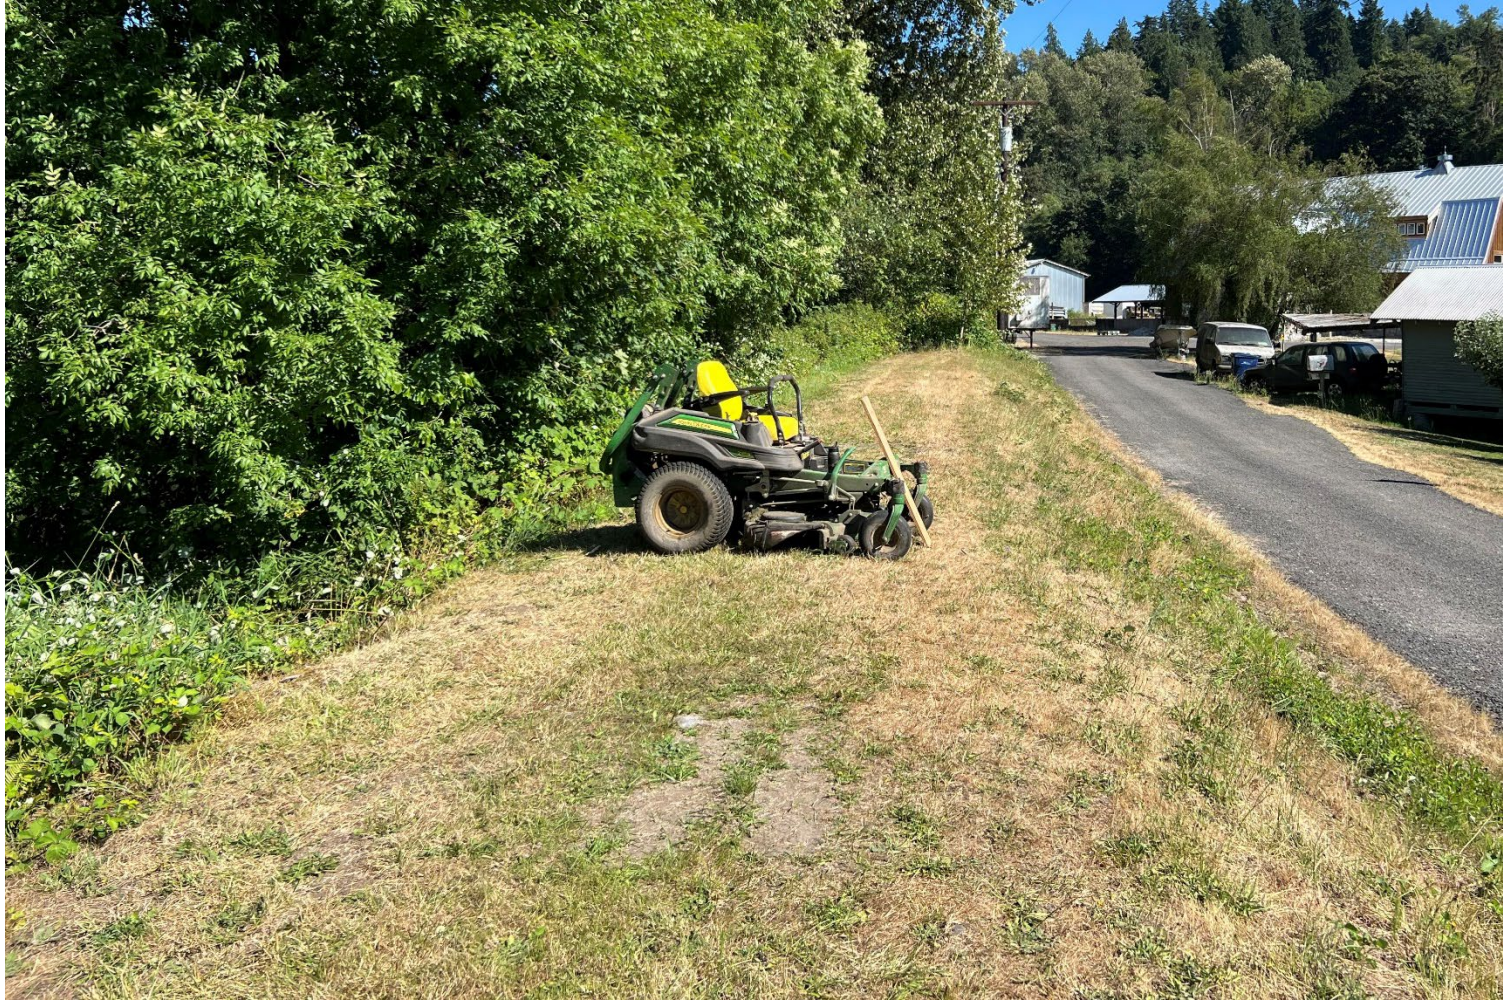
Photo 4. Mower on top of embankment.

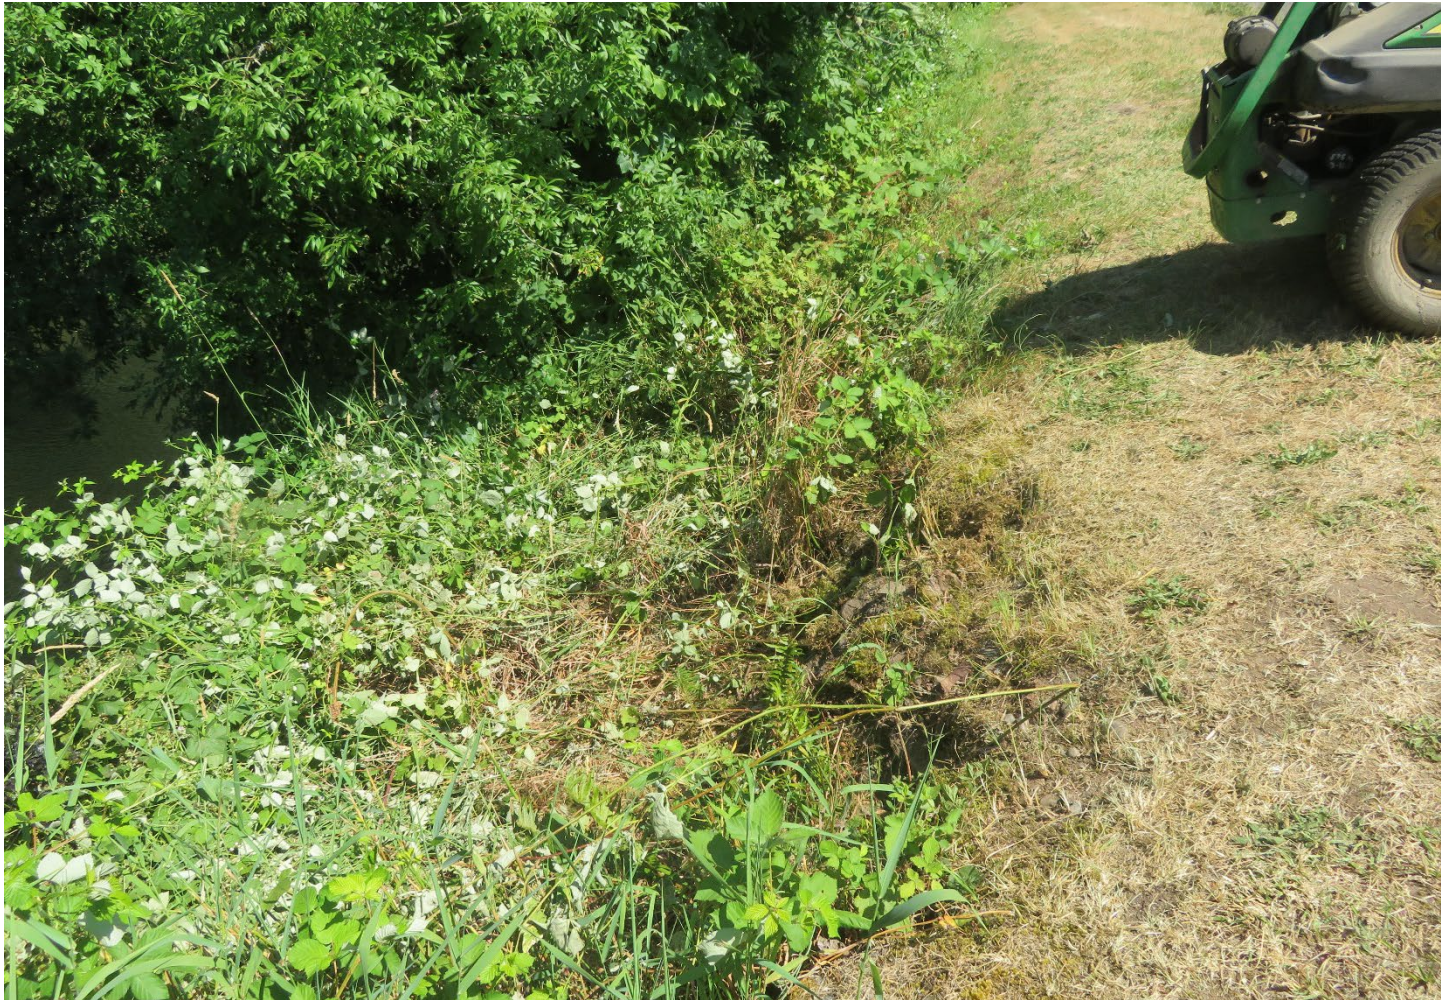
Photo 5. Eroded drop off on side of inner slope where mower rolled over.

- Perform and document a [Job Hazard Analysis](#) (JHA) for riding mowers that identifies and assesses all associated operating hazards. Use the JHA to develop injury prevention controls or hazard solutions.
- Make sure that riding mower operators follow the machine manufacturer's instructions to always use ROPS in the upright position and to wear the provided seat belt.
- Maintain a buffer area at least as wide as the mower between hazards and the mowing area. Do not mow or operate the mower in the hazard area or buffer area.

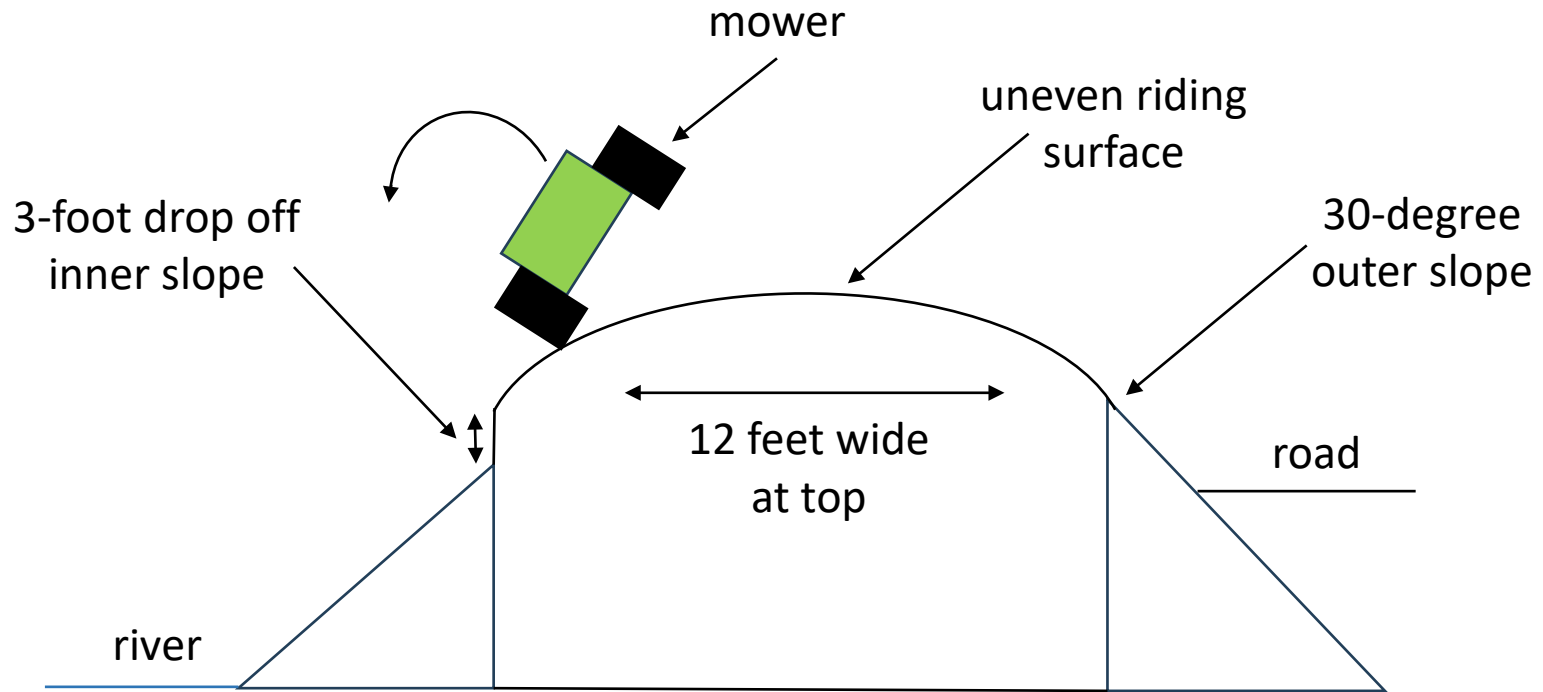
Diagram 1. Cross section diagram of embankment (not to scale).
