Bark Company Owner Dies After Being Crushed By Ecology Block Wall

Investigation: # 15WA02901

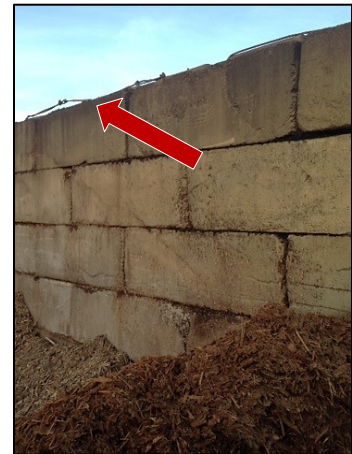
Photo 3. Steel cable threaded through ecology block picking eyes at top of wall

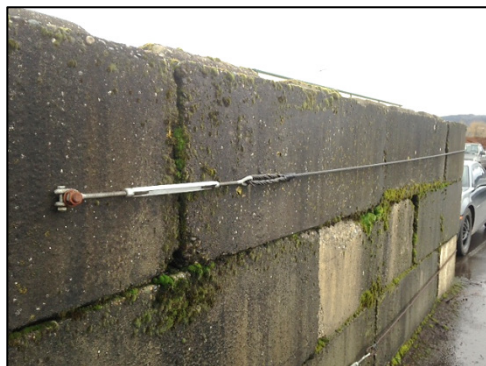
Photo 5. Steel cable bolted into side of ecology block wall
