## FATALITY INVESTIGATION REPORT

### INCIDENT FACTS

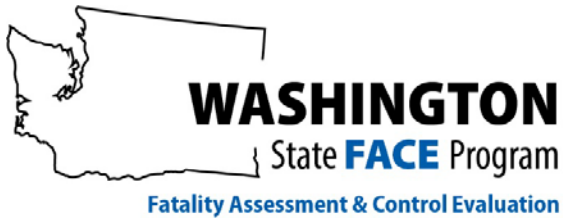
- Provide a way for workers to safely inspect and maintain conveyors.
- Apply principles of Prevention through Design (PtD) to existing and new facilities, structures, equipment, and procedures to identify and eliminate safety hazards to workers.
- Provide fall protection and ensure that workers use it when necessary.
- Perform a job hazard analysis (JHA) of conveyor and similar maintenance tasks.
- Evaluate the safety management and safety culture within their organization and make a commitment to injury prevention.

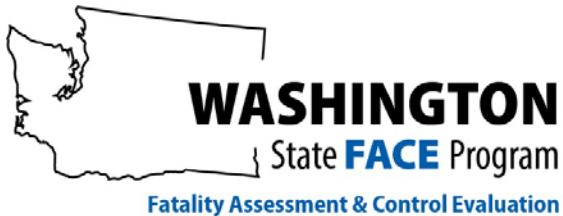
This was to ensure that no one could start the conveyor while the workers were doing maintenance. A subsequent investigation by the OSHA approved State Plan Division of Occupational Safety and Health (DOSH) determined that when pressure was applied to the slats they moved slightly.

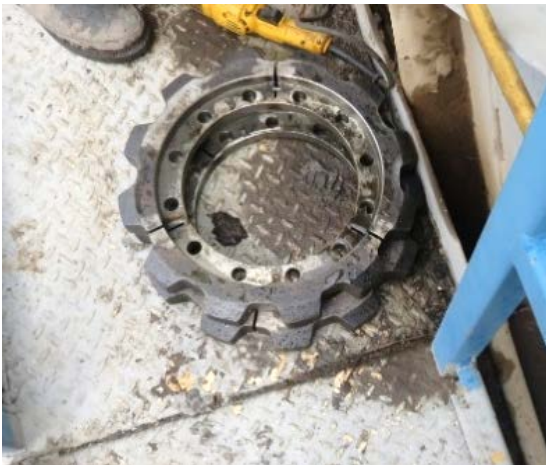
**Photo 5: Head sprocket that workers were intending to install.**

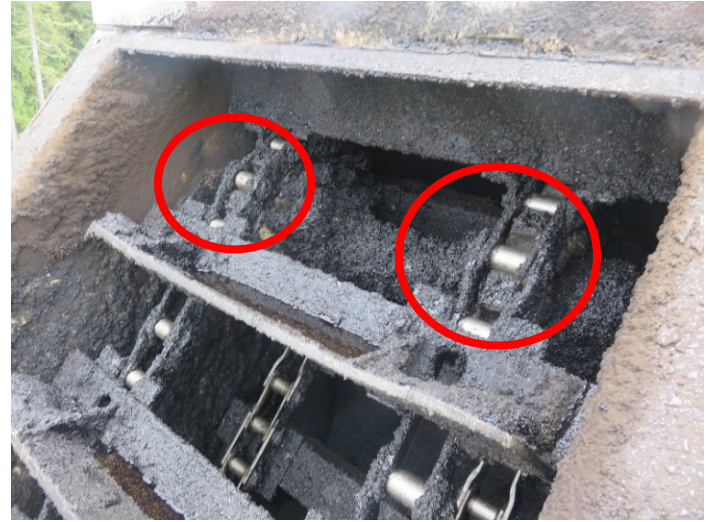
**Photo 7:** Conveyor gearbox with asphalt buildup on slats, drag chain, and head sprockets (circled) located under the drag chain. Workers use a pneumatic chisel to remove the asphalt from the sprockets so that they could remove and replace them.

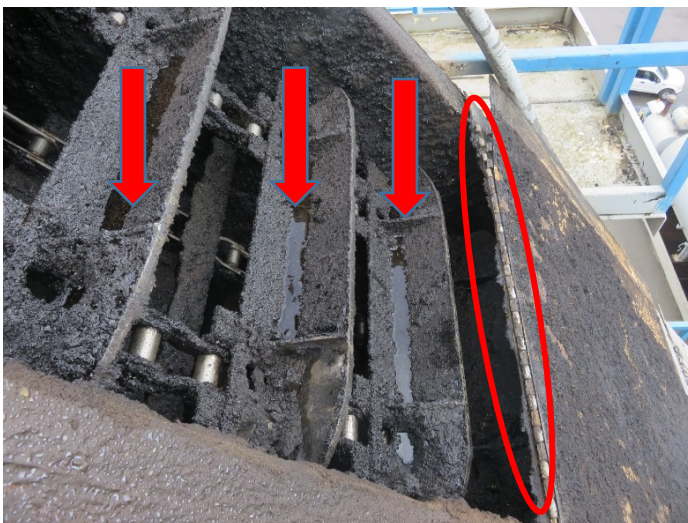
**Photo 8:** Conveyor slats (indicated by arrows) and the hinge of the open lid of the gearbox cover (circled) on which the supervisor may have been standing prior to falling.

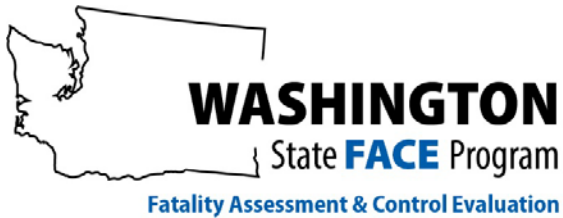
**Photos 11 and 12: Views of the conveyor and silo access stairs. After sliding down the conveyor cover, the supervisor struck the blue smoke fan housing and fell down the silo stairs, landing on the concrete slab.**

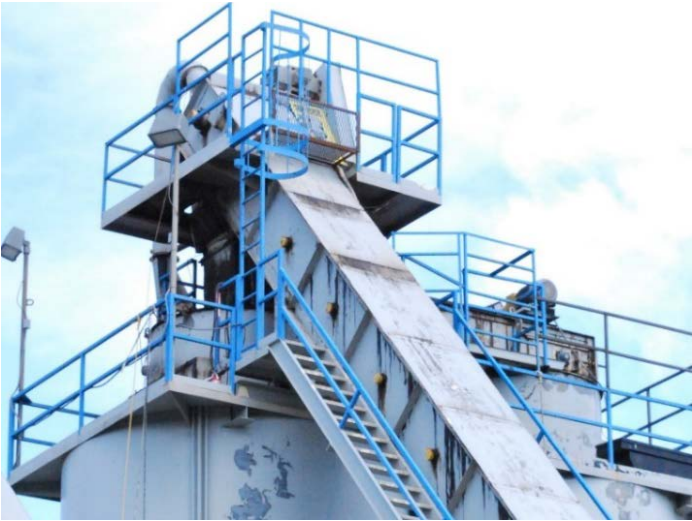
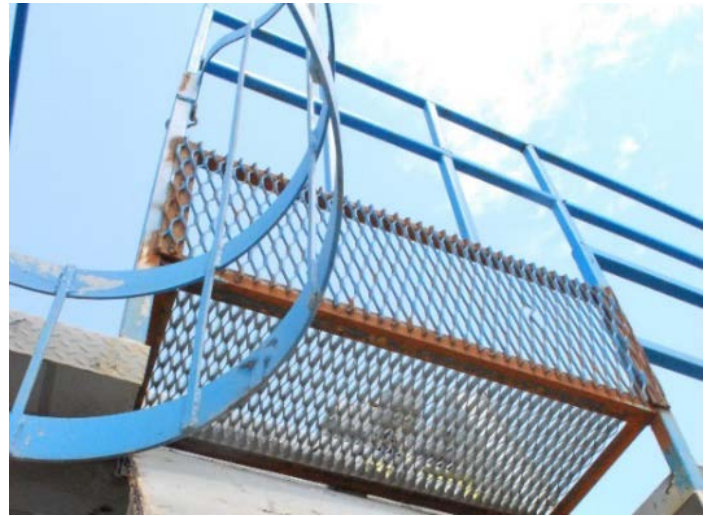
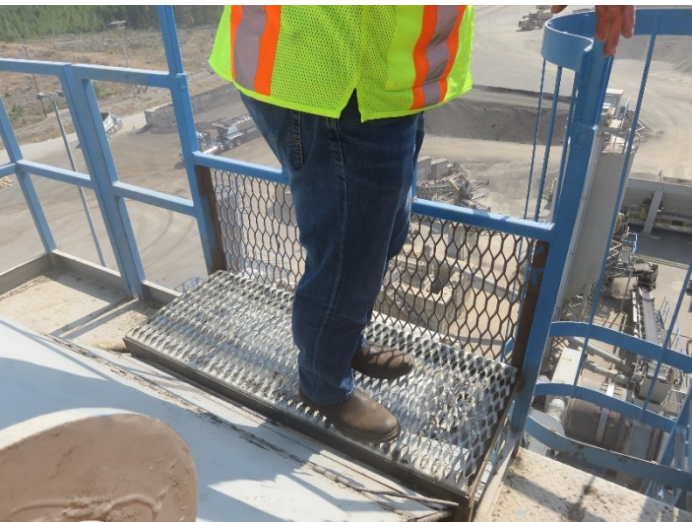
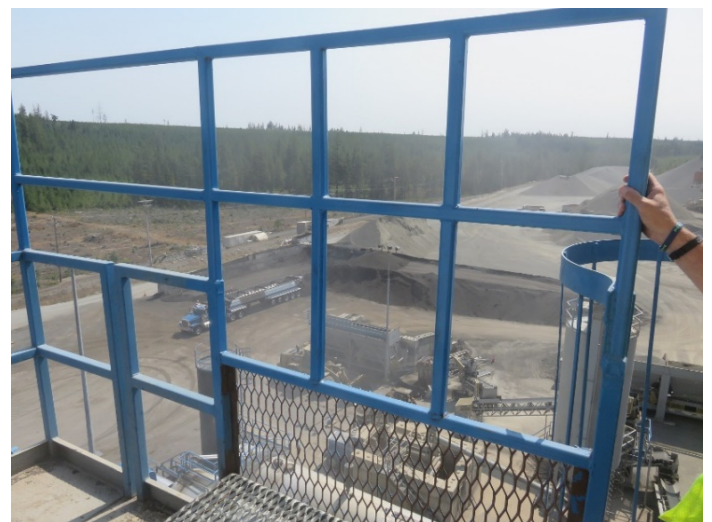
**Photos 13 through 16: Following the incident, the employer installed a work platform with guardrails to protect workers from a fall hazard or the necessity of using personal fall protection while performing maintenance on the conveyor's head sprockets.**

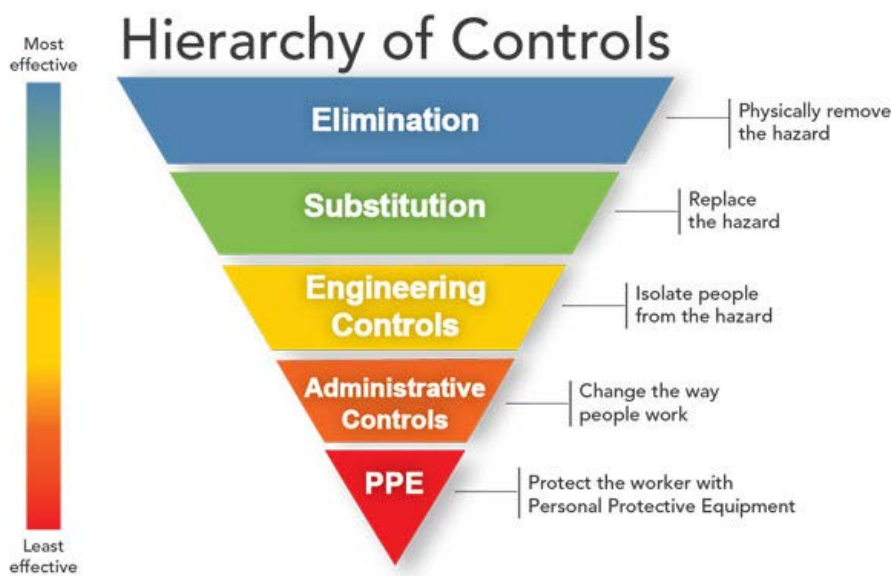
The concept behind the hierarchy of controls is a systematic approach to eliminating or reducing risks. The steps used to achieve this are ranked in sequential order from the most effective (elimination of the hazard) to the least effective (use of PPE, such as a personal fall arrest system).

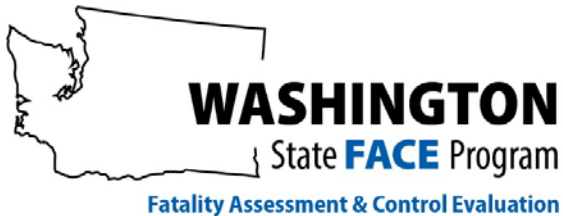
Based on the results of the JHA, employers should create a written guide to performing maintenance safely. The guide should be added to the APP and used to train employees on the procedures and as a reference to ensure procedures are followed. Post-incident the employer did create a guide.

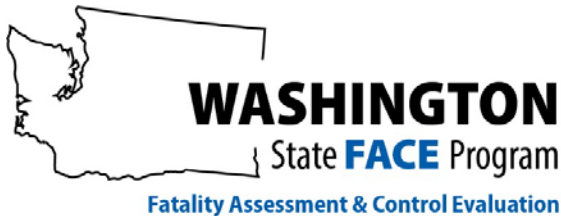
## ADDITIONAL RESOURCES
