Service Technicians Receive Electrical Burns When Electricity Arcs from Power Line to Boom Lift

INCIDENT FACTS

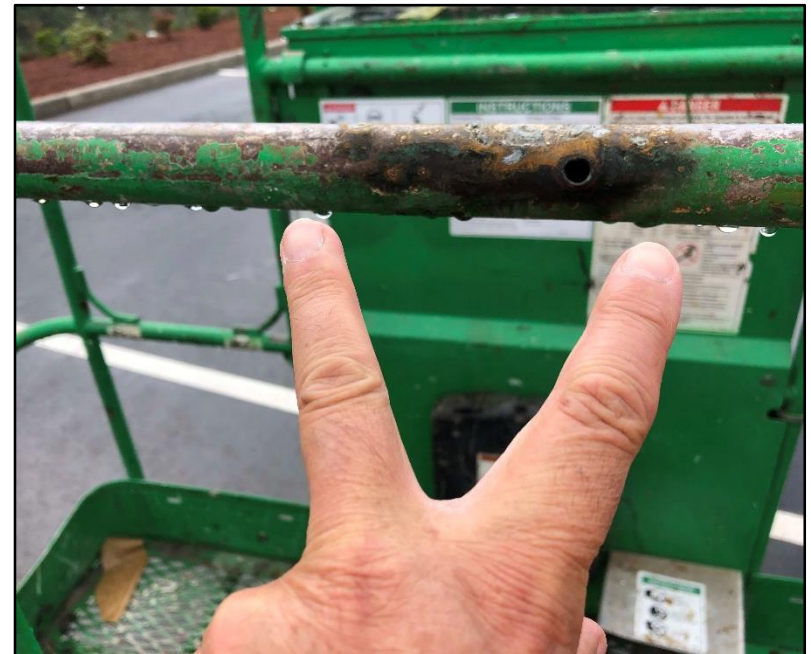
Two technicians servicing an articulating boom lift at a construction job site received electrical burns when electricity arced from a power line to the lift.

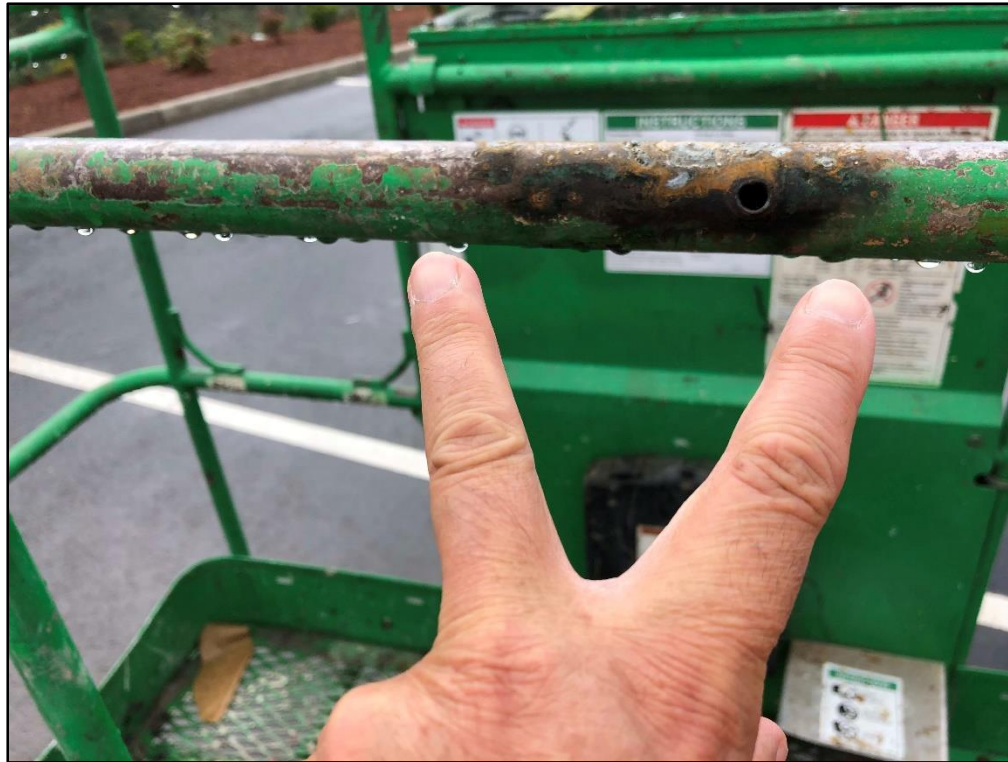
Photo 1. Entrance location where electric current made contact on railing of boom lift basket after arcing from a power line.

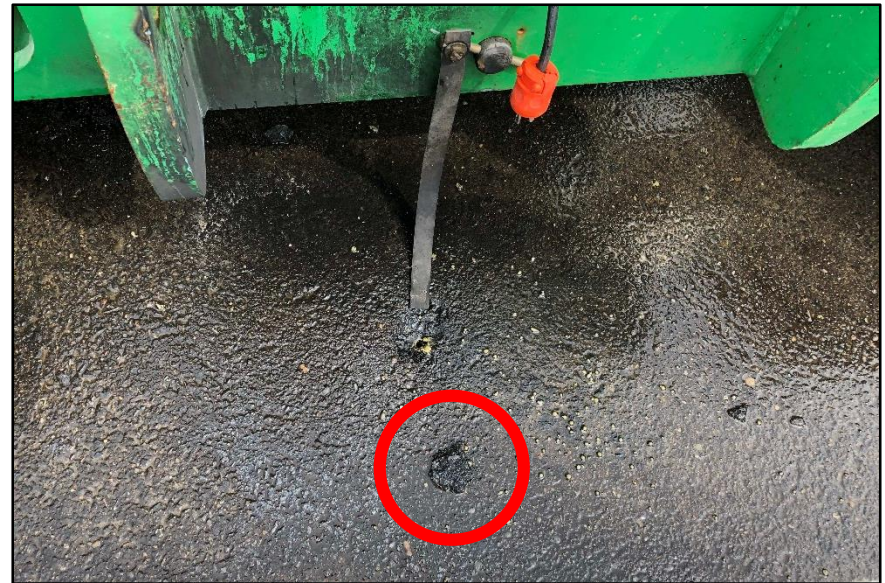
Photo 3. Hole burned into asphalt by electrical current (circled).

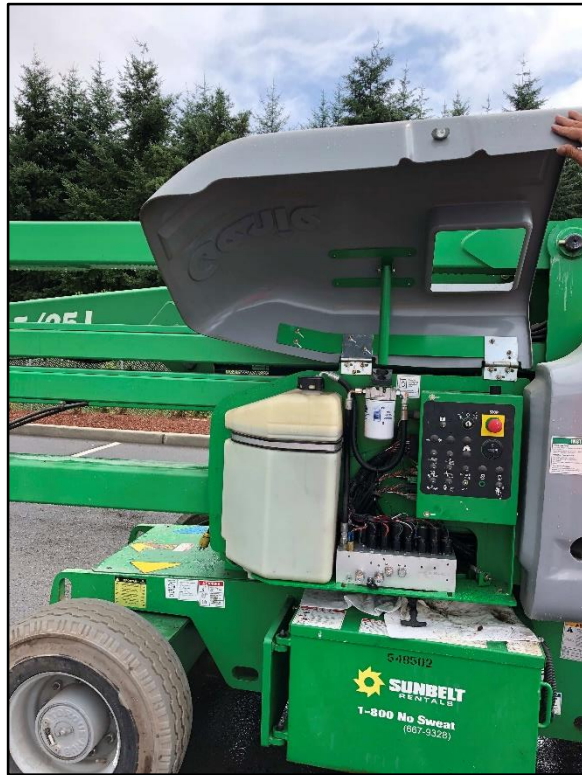
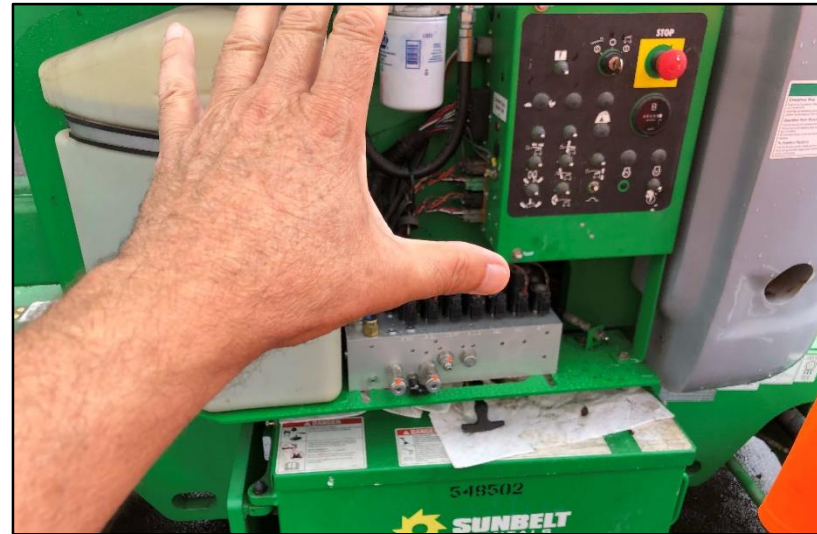
Photo 4 and 5. Location of the technician as he was operating the boom controls to perform tests. The other technician was standing in front of the lift.
