Ironworker Falls 42 Feet through Hole when Cover Fails

INCIDENT FACTS

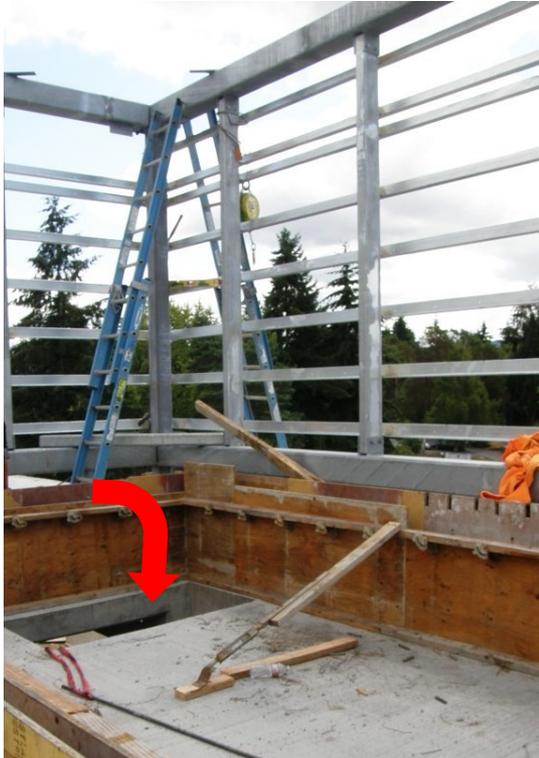
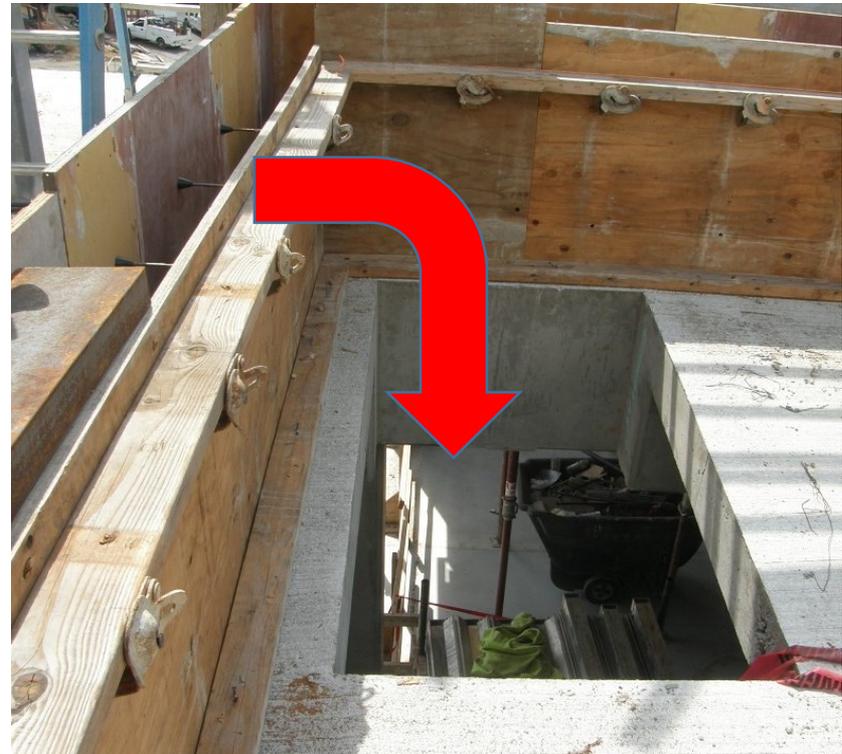
Photos 3 and 4. Incident scene on building roof deck. The ironworker had been working from an extension ladder installing sections of a windwall. In order to retrieve a clamp, he stepped from the ladder onto a wooden form and then jumped down onto a plywood hole cover (photo 3). The cover failed and he fell through the hole, landing 42 feet below on concrete (photo 4).

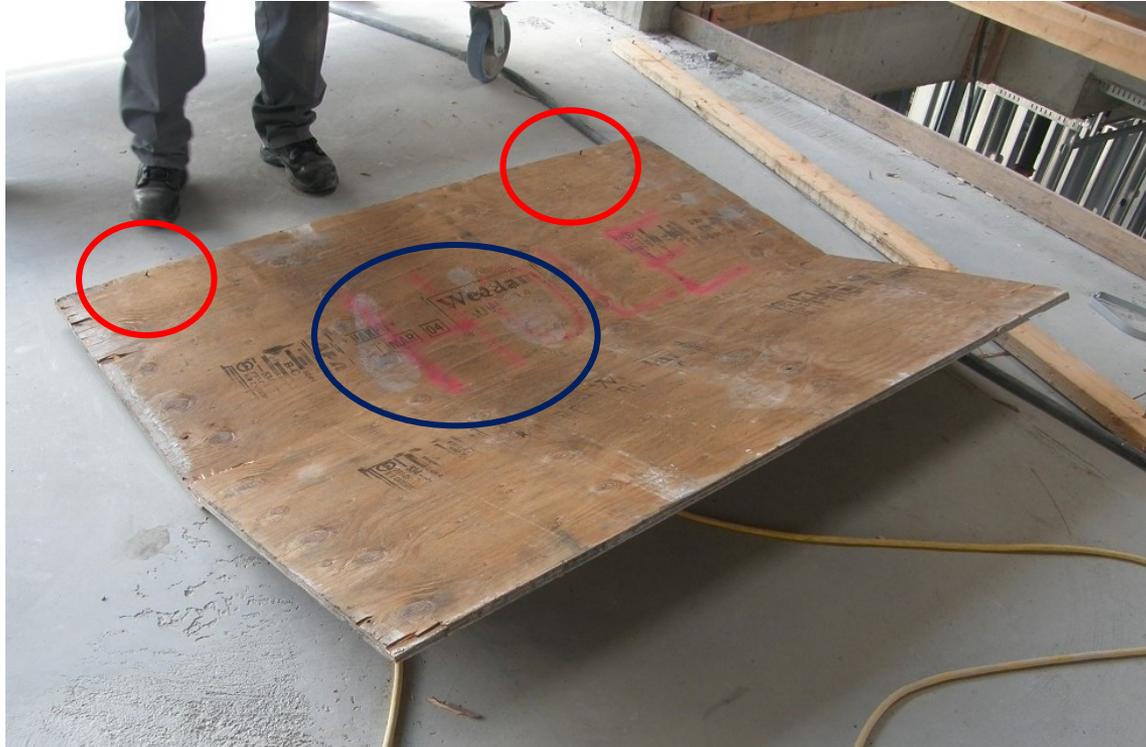
Photo 5. Plywood hole cover that failed with the word “HOLE” painted on it. Two nails that secured the cover to the stub wall sill are indicated by red circles. The ironworker’s boot prints are indicated by the blue circle.
