FATALITY INVESTIGATION REPORT

Media Company Grip Falls Down Empty Elevator Shaft

REPORT #: 52-50-2021 **REPORT DATE:** 11/08/2021

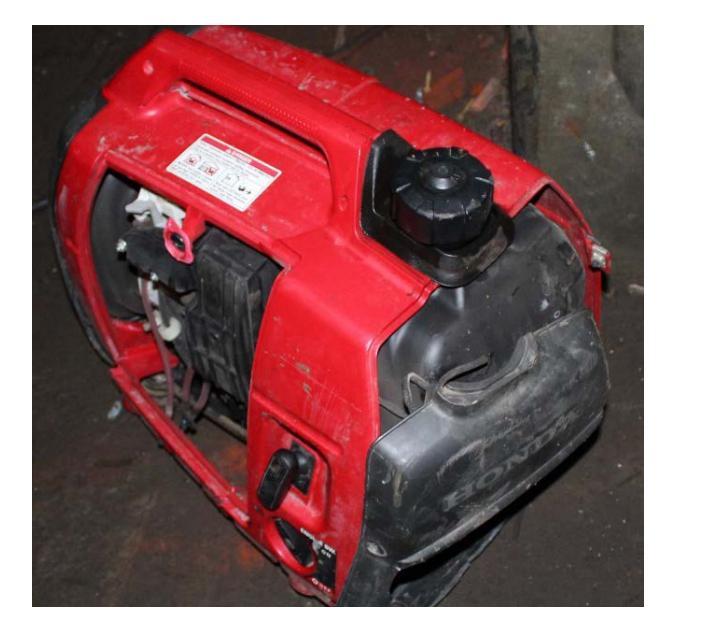
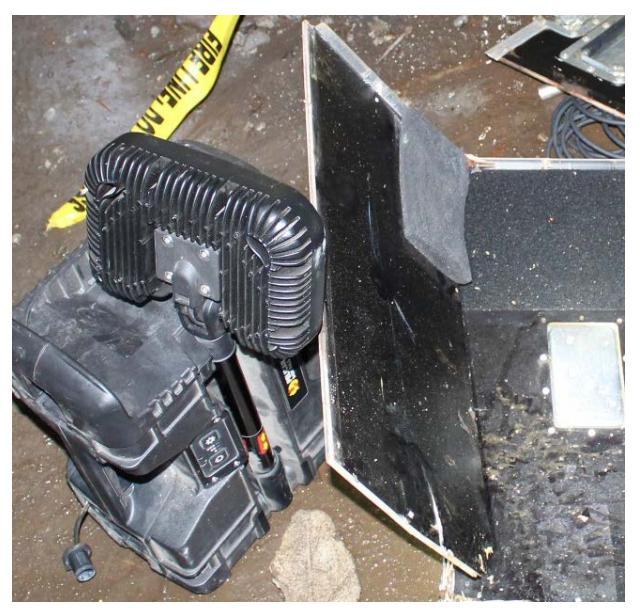
The grip was carrying a Honda EU 2000 generator and a fog machine during the filming work and when the incident occurred (see photos 1 and 2). The generator weighed 47 lbs. and the fog machine weighed approximately 13 lbs. for a combined weight of 60 lbs.

Photos 1 and 2: The left photo shows the generator and the photo on the right shows the fog machine the grip was carrying.

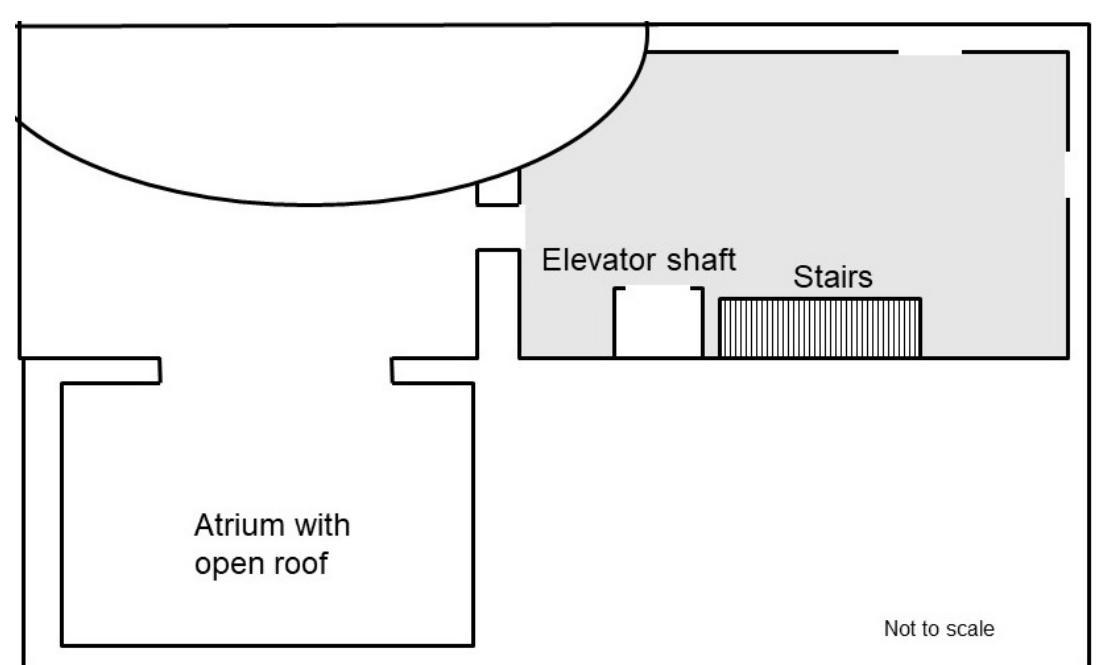
The grip was working with a crew on the fifth floor of the building on the evening of the incident (see diagram 1). The fifth floor had an atrium space with no roof that made it open to natural light. Adjacent to the atrium through a passageway was an interior area with a staircase and an elevator shaft. This interior area had a solid roof and no windows making it closed off from natural light other than the light coming through the passageway from the atrium (see photos 3 and 4). The incident time was estimated at 8:45 p.m., which was six minutes before sunset that evening. The amount of natural light would have been less than what is seen in the photos which were taken in the afternoon.

Diagram 1: Floorplan of fifth floor of building showing area where incident occurred.

Incident occurred in grey shaded interior room with no windows or light sources.

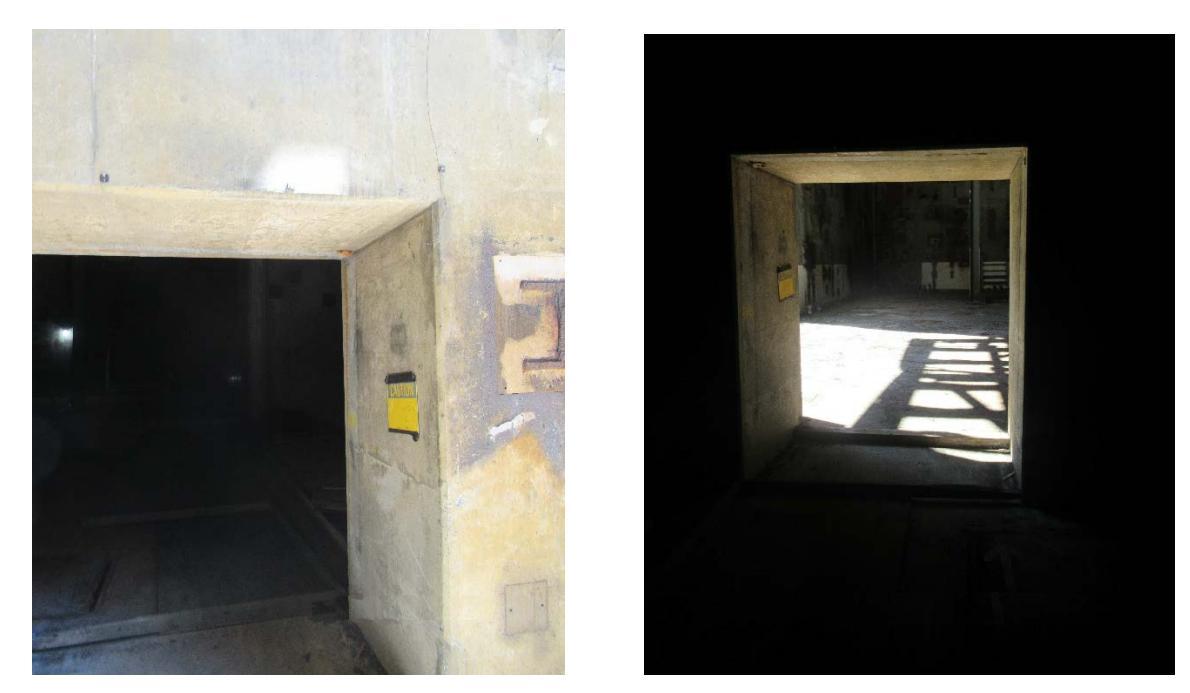
Photos 3 and 4: The left photo shows the fifth floor opening looking from the atrium with open roof into the interior room with the elevator shaft and stairwell. The elevator shaft was just inside to the right of the opening. The right photo is a view from the interior room out to the atrium. Note that photos were taken in the afternoon following the incident. The natural light would have been lower when the incident occurred at approximately 8:45 p.m. the previous evening.

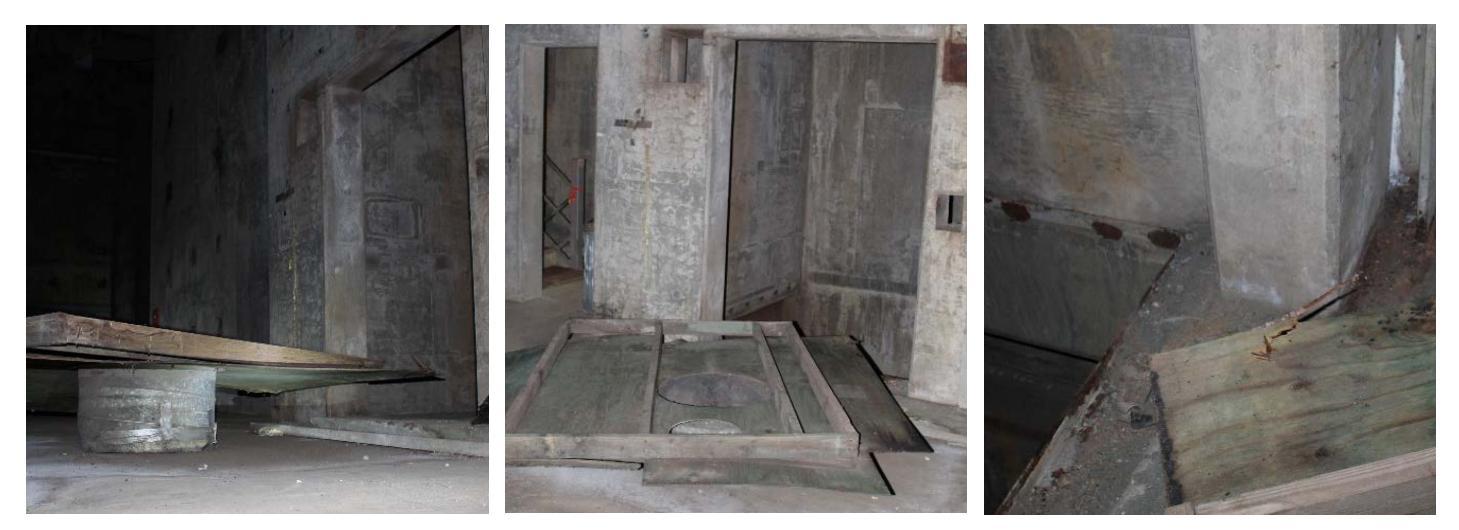
When they arrived at the fifth floor of the building they noticed a plywood guard was on the ground in front of an open elevator shaft (see photo 5). The guard was balanced approximately 12 inches off the floor on the frame of a round opening that was added to allow air pressure to equalize between the elevator shaft and the room (see photo 6). The bottom right corner of the guard had a splintered edge that appeared to have happened recently (see photo 7).

Photos 5, 6, and 7: The left photo shows elevator shaft with plywood guard down. The center photo shows the plywood guard resting on the round opening frame built into the guard. The right photo shows bottom right corner of guard with area that appears to have been recently splintered.

The grip's equipment was found at the bottom of the shaft. This indicates he was likely carrying it when he fell. The lower edge of the guard appears to have been recently splintered which also provides evidence that the grip may have stepped on or gotten snagged on the edge of the guard causing him to trip or lose his balance. On the other hand, the grip may not have recognized the opening beyond the guard was an elevator shaft and stepped into the shaft and fell.

A joint facility-employer-crew SSA would have identified the fallen guard and the need to secure it to eliminate that hazard. The need for an SSA is supported by the Washington Administrative Code (WAC), which states that employers must prohibit employees from entering, or being in, any workplace that is not safe.⁴

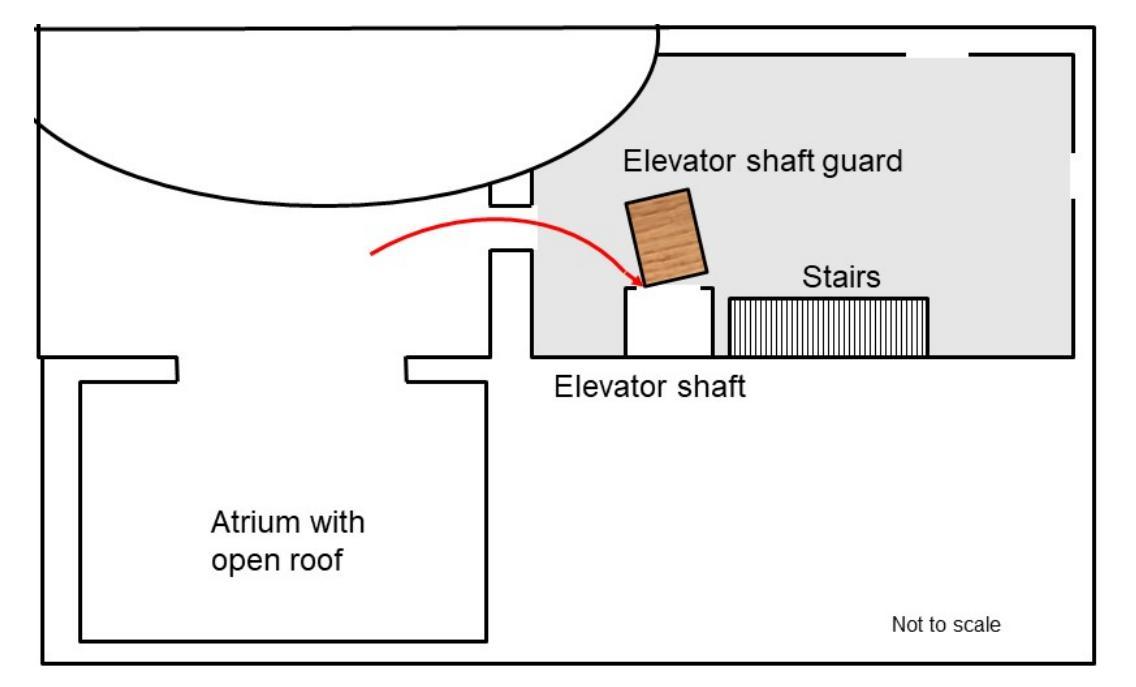
There were no witnesses to this incident. The grip was not wearing a headlamp and did not have a flashlight when he was found. Other crew members confirmed that the grip had not been using a headlamp prior to the incident. His headlamp was later found in his hotel room. He was seen carrying the generator and fog machine that had been used in a previous location as he entered into the enclosed room from the atrium area. Several of the crew commented that they did not think anyone would enter the room with the open elevator shaft due to the lack of light. Evidence at the scene provides insight into what might have occurred (see diagram 2).

Diagram 2: Shows the probable path the grip took into the dark interior room.

There are a multiple scenarios about how the grip fell. Either the guard was already down or he removed it. Then he either tripped on the guard and fell or did not realize it was an elevator shaft and stepped in and fell.

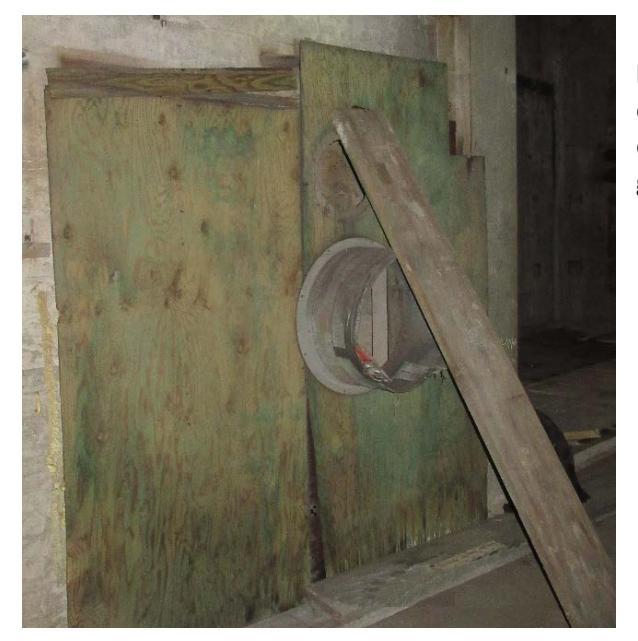
Either the guard was already down or the grip removed it from the shaft opening. None of the crew reported seeing or entering the area with the elevator shaft prior to the incident so the position of the guard prior to the incident was unknown. It is likely that the guard was already down because the light was so low it would have been difficult for the grip to see well enough without a headlamp or flashlight to remove it. The guard may have been knocked down by the pressure differential between the elevator shaft and interior room or may have been taken down by other facility users. The guard did have a round opening intended to allow air to flow and pressure to equalize between the shaft and the room. The guard was not permanently affixed to the wall surrounding the shaft but had a plank leaning against it to keep it in place (see photo 8).

Photo 8: Elevator shaft guard as originally installed with round opening to allow air to flow and pressure to balance between elevator shaft and the room and wood plank for support. The guard was not fastened to the wall around the shaft opening.
