## INCIDENT HIGHLIGHTS

July 29, 2019

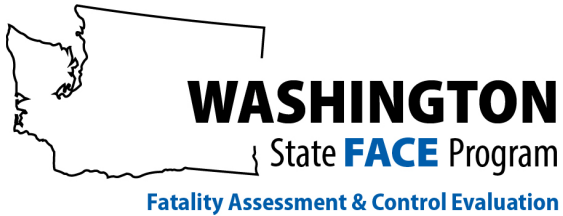
Washington FACE • PO Box 44330 • Olympia, WA 98504-4330  
1-888-66-SHARP (toll-free) or 360-902-5667

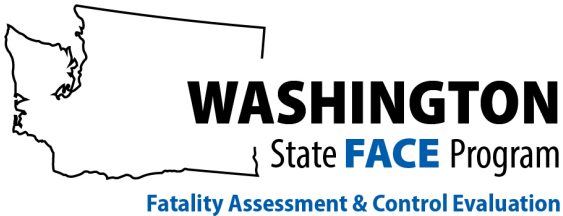
Washington FACE • PO Box 44330 • Olympia, WA 98504-4330  
1-888-66-SHARP (toll-free) or 360-902-5667

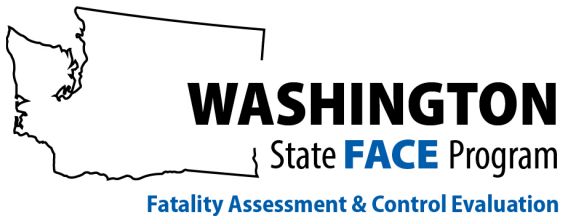
Washington FACE • PO Box 44330 • Olympia, WA 98504-4330  
1-888-66-SHARP (toll-free) or 360-902-5667

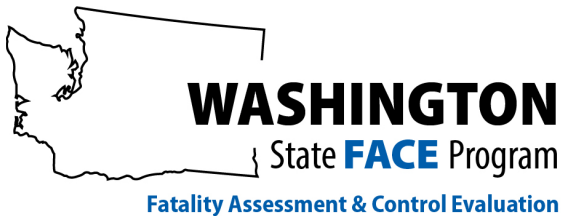
Washington FACE • PO Box 44330 • Olympia, WA 98504-4330  
1-888-66-SHARP (toll-free) or 360-902-5667

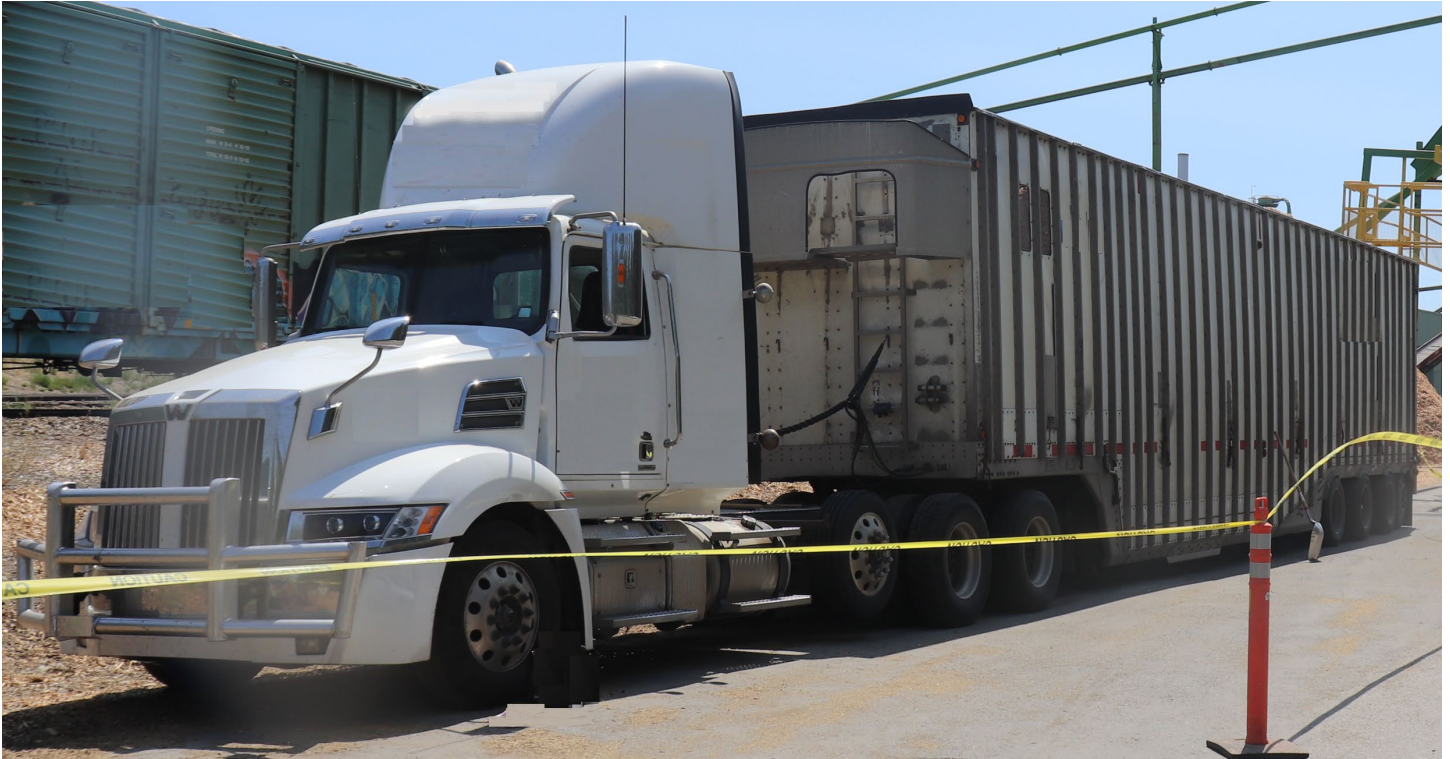
**Photo 1: The fatally injured driver operated this 2016 Western Star semi-tractor with a 2004 TYCROP high-cube, quad-axle, possum belly Super B-train chip trailer.**

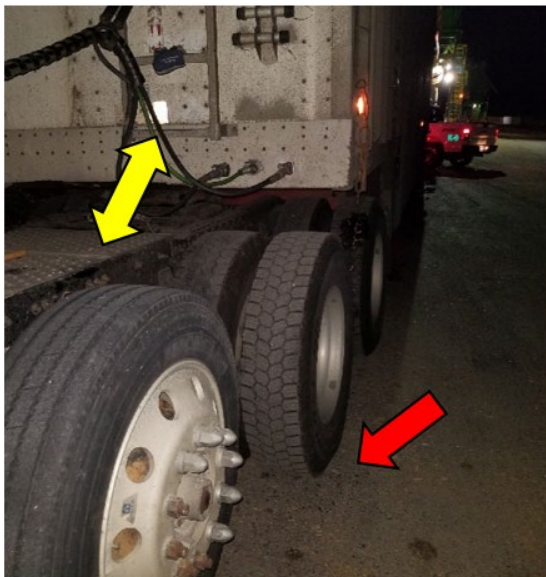
**Photo 13:** Red arrow in top left photo shows approximately where the driver's body was found crushed under the chip truck's left front drive wheels. Yellow arrows show base of front trailer ladder and walkway between cab and trailer that the driver attempted to access as his truck rolled.

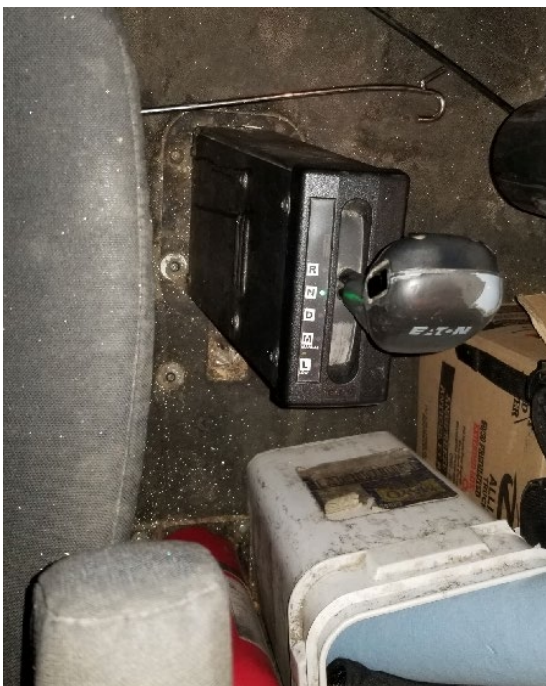
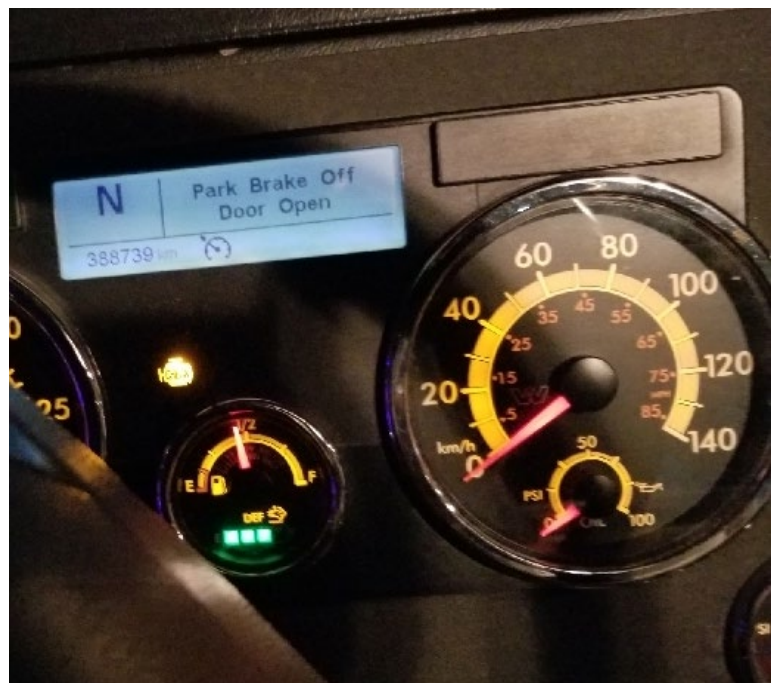
**Photos 14 and 15:** Bottom left photo shows chip truck's transmission shifter set to "N" neutral after the crushed driver was found. The transmission did not have a "P" park position. Bottom right photo shows dashboard instrument panel indicator showing that the truck's transmission shifter was in "N" neutral and parking brake disengaged when the incident occurred.

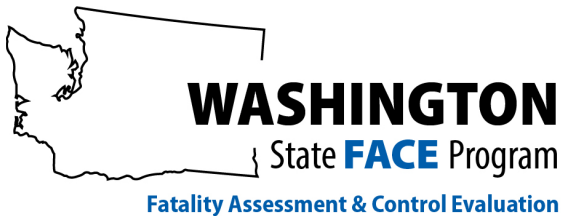
Washington FACE • PO Box 44330 • Olympia, WA 98504-4330  
1-888-66-SHARP (toll-free) or 360-902-5667

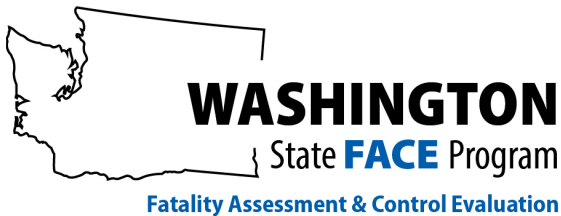
Washington FACE • PO Box 44330 • Olympia, WA 98504-4330  
1-888-66-SHARP (toll-free) or 360-902-5667

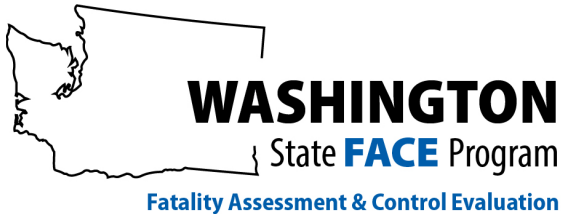
Washington FACE • PO Box 44330 • Olympia, WA 98504-4330  
1-888-66-SHARP (toll-free) or 360-902-5667

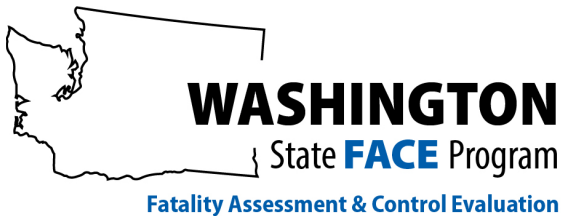
Washington FACE • PO Box 44330 • Olympia, WA 98504-4330  
1-888-66-SHARP (toll-free) or 360-902-5667
