INCIDENT HIGHLIGHTS

July 28, 2020

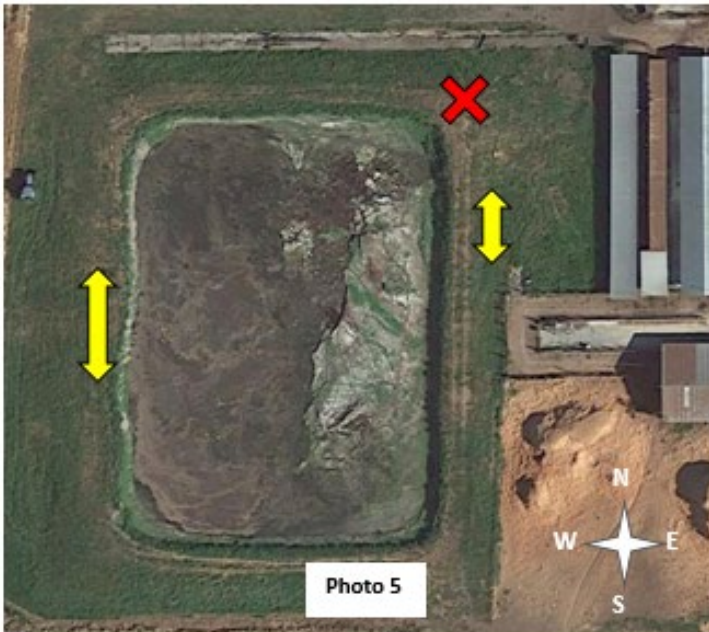
Photo 5: Aerial view of the rectangular manure pond where incident occurred. Red X shows tractor rollover location. Yellow arrows indicate the uneven, rutted, dirt track road on the elevated crest of the pond’s earthen embankment. The pond area was dark, and the embankment road had no lighting system, hazard signs, or reflective markers. Photo courtesy of ESRI.
