# Operator Crushed When Tractor and Sprayer Roll Over

**REPORT #:** 71-184-2019s

**EVENT TYPE:** Tractor rollover

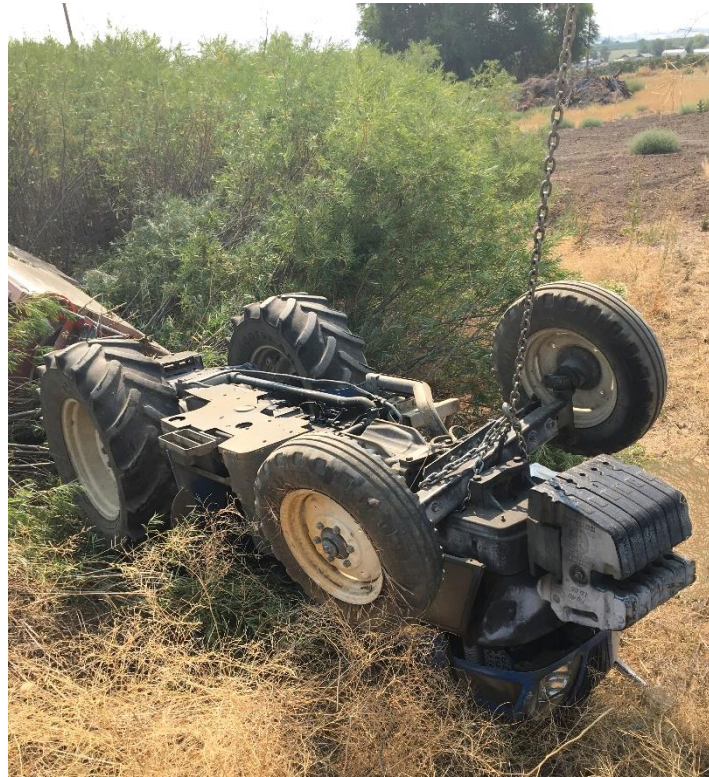
At about 9:30 a.m. he began another trip back to the mixing station. He drove out of an orchard block and onto a gravel county road. As he was driving along a slight downhill section in the road, the tractor and sprayer went off the left side of the road, down an embankment, and rolled over.

He was thrown from his seat and the tractor landed on top of him, fatally crushing him.

**Photo 1.** Overturned tractor with sprayer at the incident scene.

- Employers should train tractor operators to use ROPS and a seatbelt to provide a protective zone for tractor operators in case of a rollover. The use of ROPS and a seat belt is estimated to be 99% effective in preventing death or serious injury if a tractor should rollover.
- When traveling downhill, operators should ensure that they operate the tractor at a safe speed and in an appropriate gear for the slope and terrain, this is especially important when towing equipment such as a sprayer.

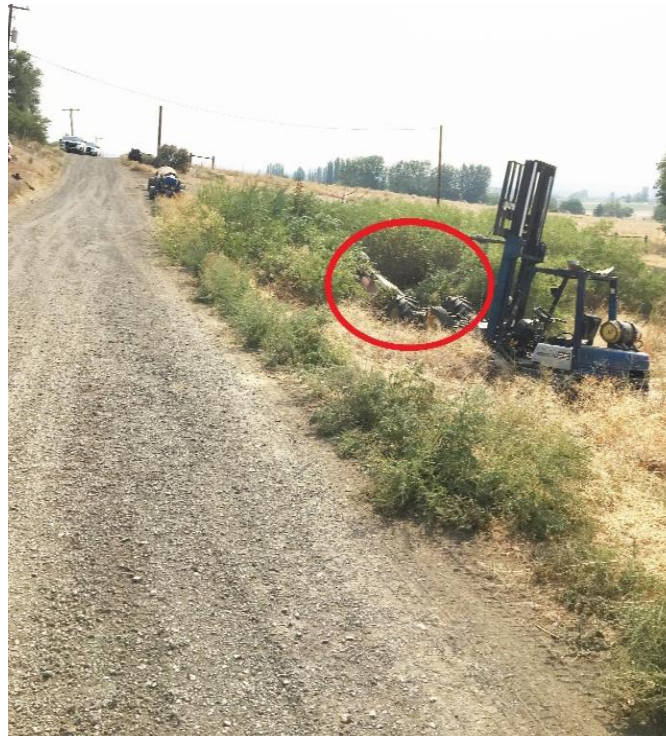
**Photo 2.** The operator was driving down a slight hill on a county road when the tractor went off the left side of the road, down an embankment and rolled over.

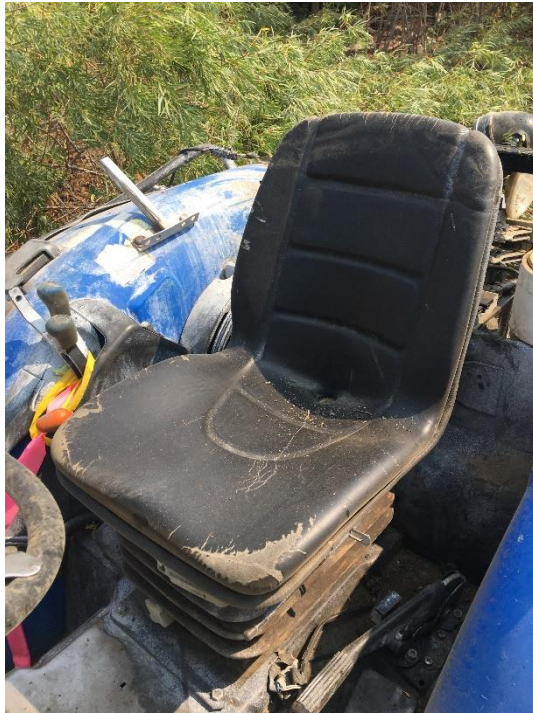
Investigators found that the tractor had a foldable rollover protective structure (ROPS), or roll bar, but the operator did not have it in the “up” position as required.

While driving on the road, the tractor did not meet the Washington State ROPS exemption allowed in orchards where height clearances would interfere with normal operations.

Additionally, the tractor did not have a seatbelt.

**Photo 3.** The tractor with its ROPS in the “down” position and no seatbelt installed.

- Employers must provide a rollover protective structure (ROPS) for each employee-operated tractor that is covered by [WAC 296-307-080](#). See [WAC 296-307-08009](#).
- Where ROPS are required by WAC 296-307-080 employers must:
  - a) Provide each tractor operator with a seat belt;
  - b) Require each employee use the seat belt while the tractor is moving;
  - c) Require that each employee tighten the seat belt sufficiently to confine the employee to the ROPS protected area. See [WAC 296-307-08012](#).

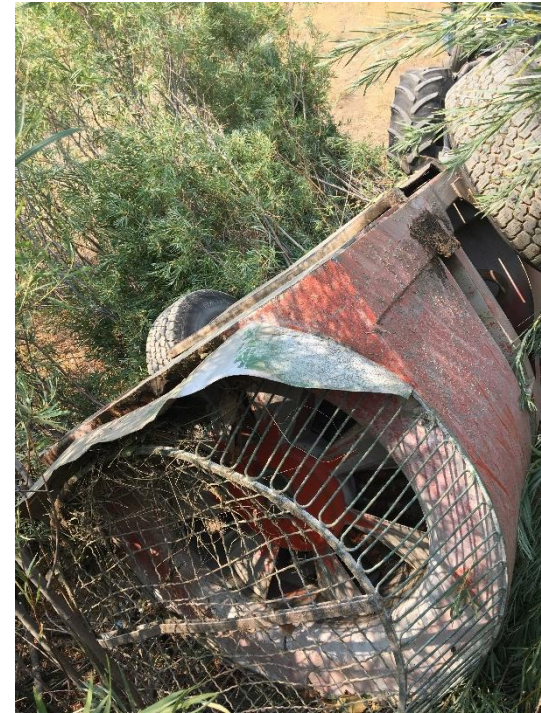
**Photo 4.** The sprayer.
