Spotter Pinned between Excavator Bucket and Trench Box

REPORT #: 71-183-2019s

SCENE: Construction job site of sewer installation project.

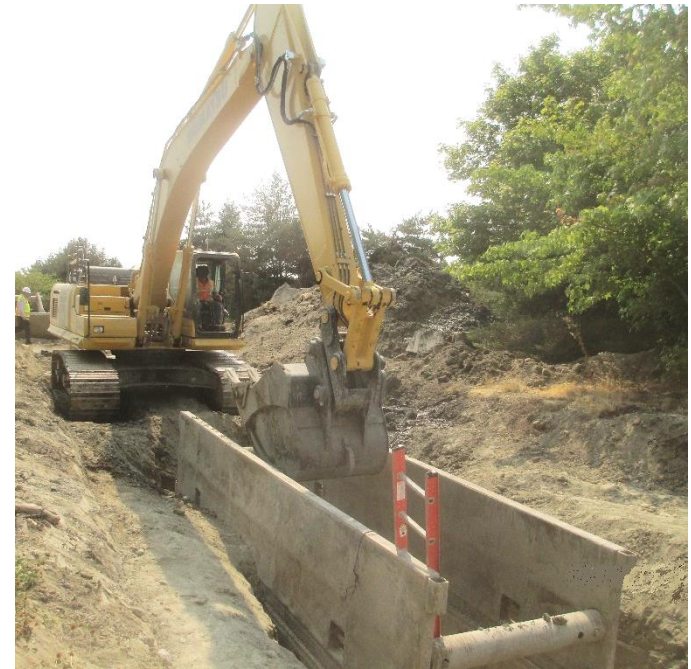
A 23-year-old construction worker was severely injured when he was pinned between the bucket of an excavator and a trench box. He was spotting the lowering of a sewer pipe.

As he was doing this, the bucket pinned the middle of his body against the top of the box.

State investigators found that the victim was standing in the area of the excavator bucket's swing and that he was in the operator's blind spot behind the bucket.

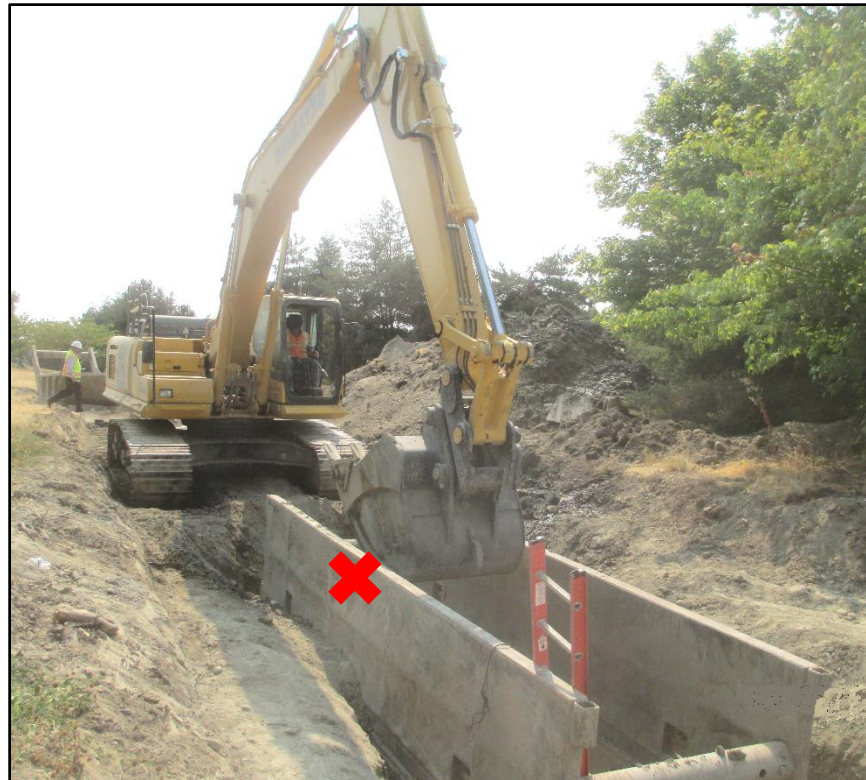
Photo 1. Excavator with bucket in its approximate position when it pinned the spotter against the top of the trench box.

- Pre-plan a job task to ensure safety of the crew. For example, in this case the task could have been accomplished by having only one spotter/signal person and no one in the trench.
- Ensure all ground workers are aware of the excavator's swing areas and blind spots when hoisting materials and stay outside of these areas.
- Before hoisting materials, review and confirm communication signals between the equipment operator and workers on foot.

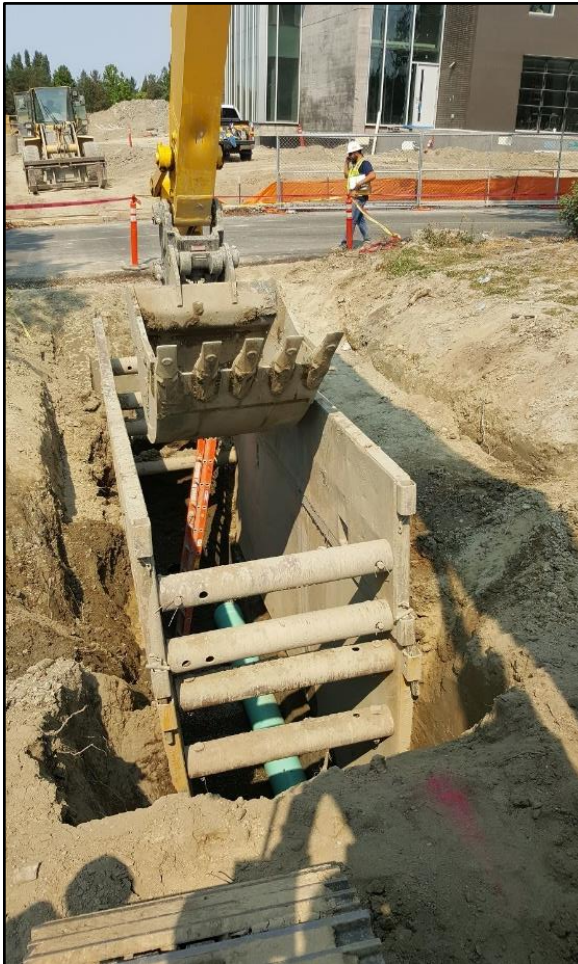
Photo 2. View from excavator's cab of the approximate position of the bucket when it pinned the middle section of the spotter's body against the top of the trench box.

The spotter was in the operator's blind spot to the right of the bucket.

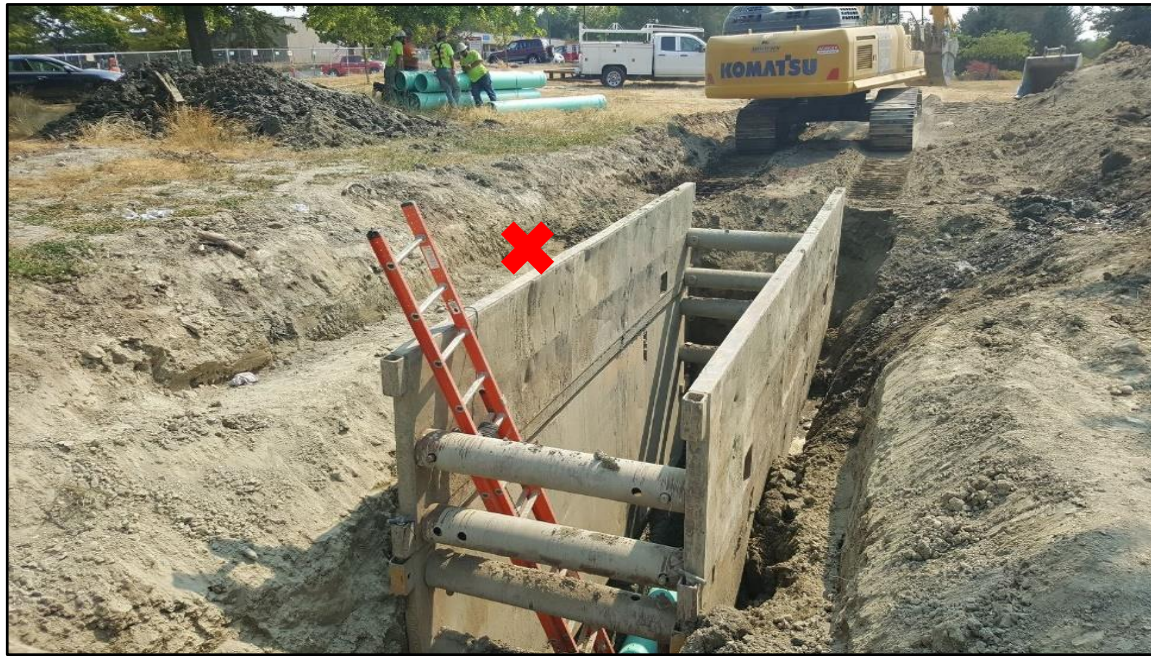
Photo 3. The “x” indicates the approximate position of the spotter.
