## Truck Driver Crushed by Cardboard Bale

**REPORT #:** 71-207-2021s

**SCENE:** Loading dock area of delivery site

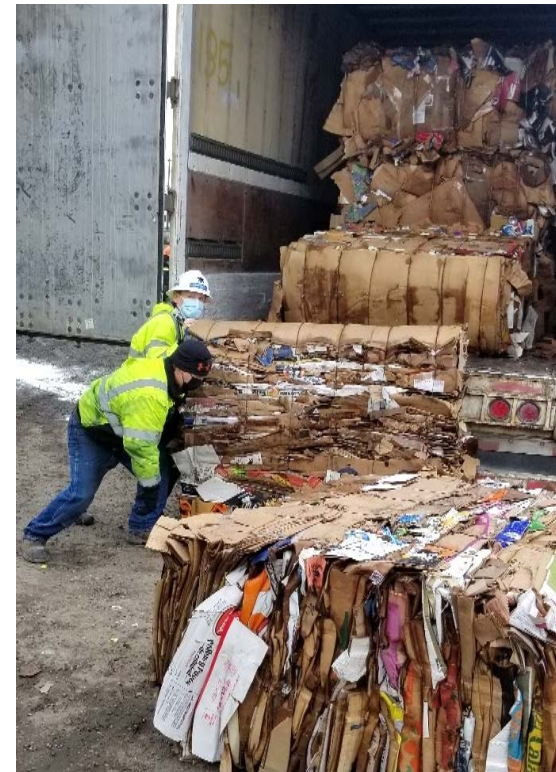
A 47-year-old truck driver was struck by a 1,500-pound bale of recycled cardboard when it fell on him after he opened the doors of a loaded semi-trailer.

He then opened the trailer door on the driver's side. As he opened the trailer door on the driver's side, a stack of bales became unstable and two of the bales fell out of the trailer.

He was struck by a 1,500-pound bale that came to rest on him.

- Ensure that drivers are protected from the hazard of falling bales.
- Ensure that when bales are loaded into trailers that they are properly secured and will not fall over during transport or when drivers open the trailer doors.

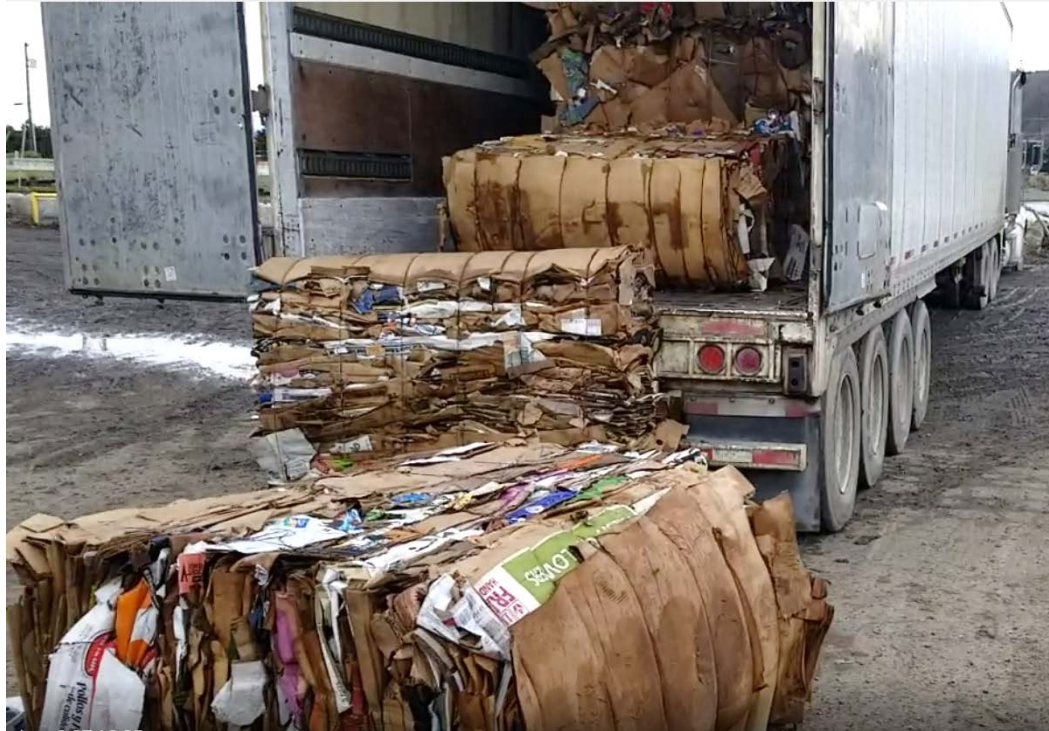
**Photo 1.** Incident scene showing the two cardboard bales that fell from the trailer. The bale closest to the trailer struck the driver as he was opening the trailer door.

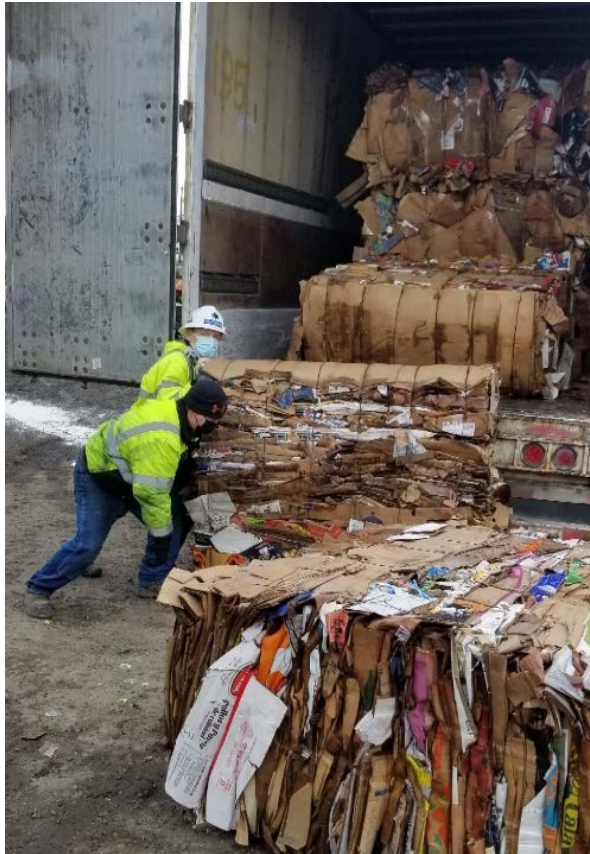
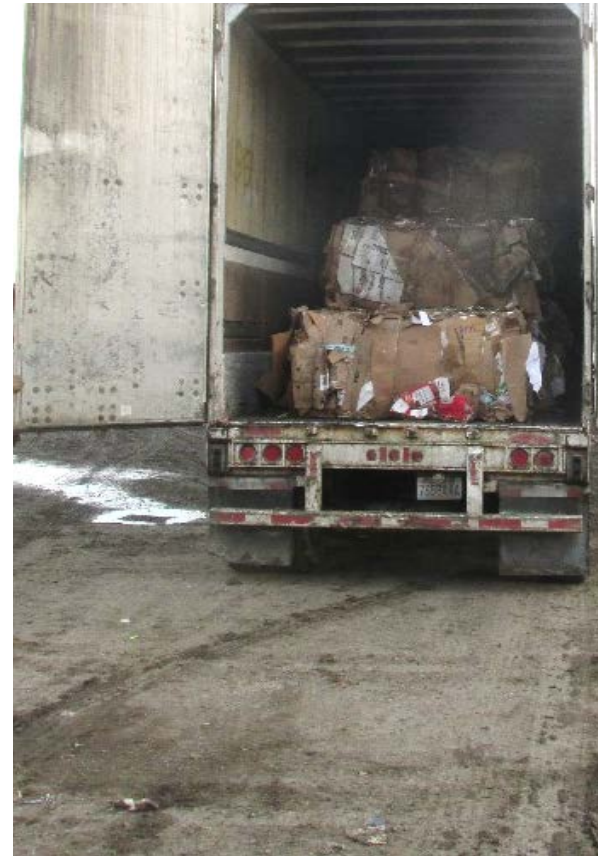
**Photos 2 and 3.** Incident scene showing the two 1,500-pound bales of cardboard that fell from the trailer, one of which struck and crushed the driver, and the remaining bales in the trailer. Workers are shown moving the bale that struck the driver into an upright position.

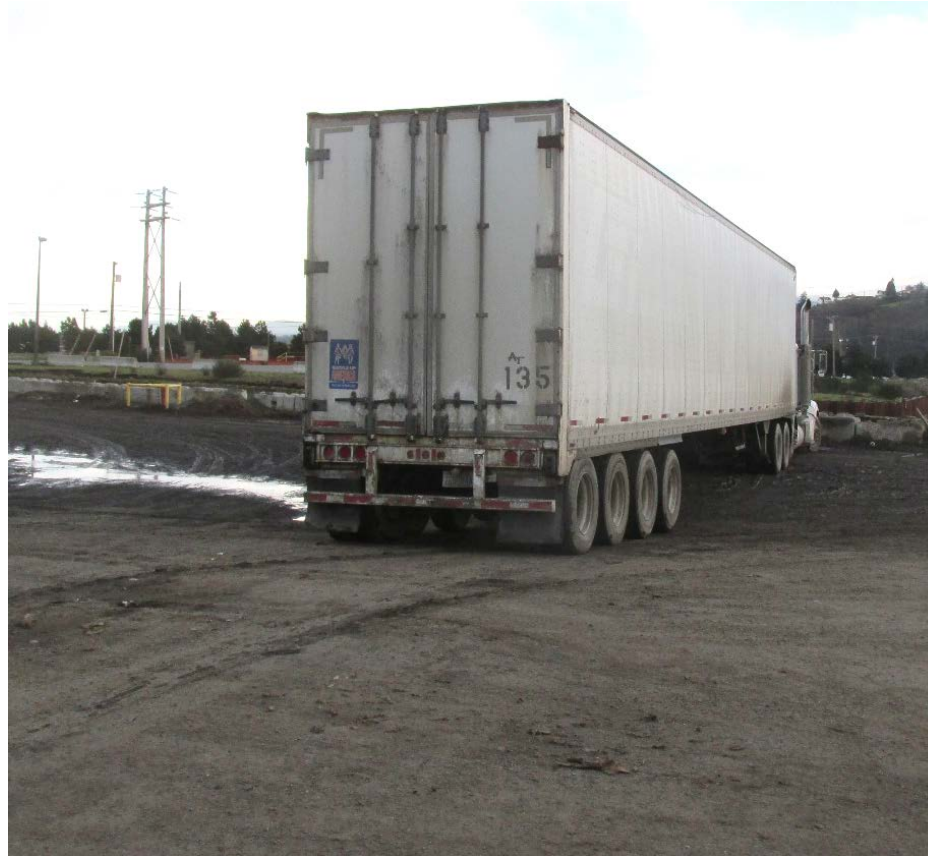
Additionally, the semi-trailer was parked on uneven ground, which may have destabilized the stack of bales.

**Photo 4.** The semi parked in incident location showing slope and ground conditions.

- Provide and require drivers to use cargo securement devices such as straps.
- Ensure that drivers park truck and trailer are on level ground before opening trailer doors.
- Ensure that drivers unlock and open one trailer door at a time and shield themselves from falling bales by standing behind the door.

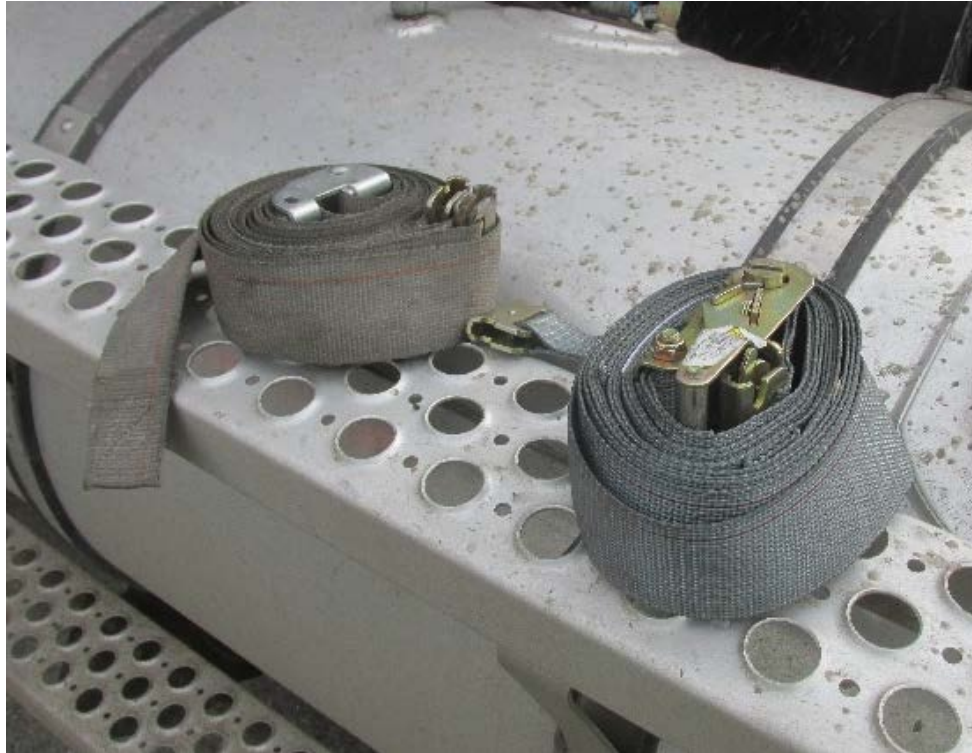
Investigators found that the employer provided straps to prevent bales from tipping over and falling out when drivers opened the trailer doors, but the drivers did not use them.

**Photo 5.** The employer provided straps so that drivers could secure loads in the trailers and prevent them from falling out when drivers opened the trailer doors. Drivers did not commonly use them.
