Truck Driver Crushed while Loading Backhoe onto Trailer

REPORT #: 71-219-2022s

REPORT DATE: April 18, 2022

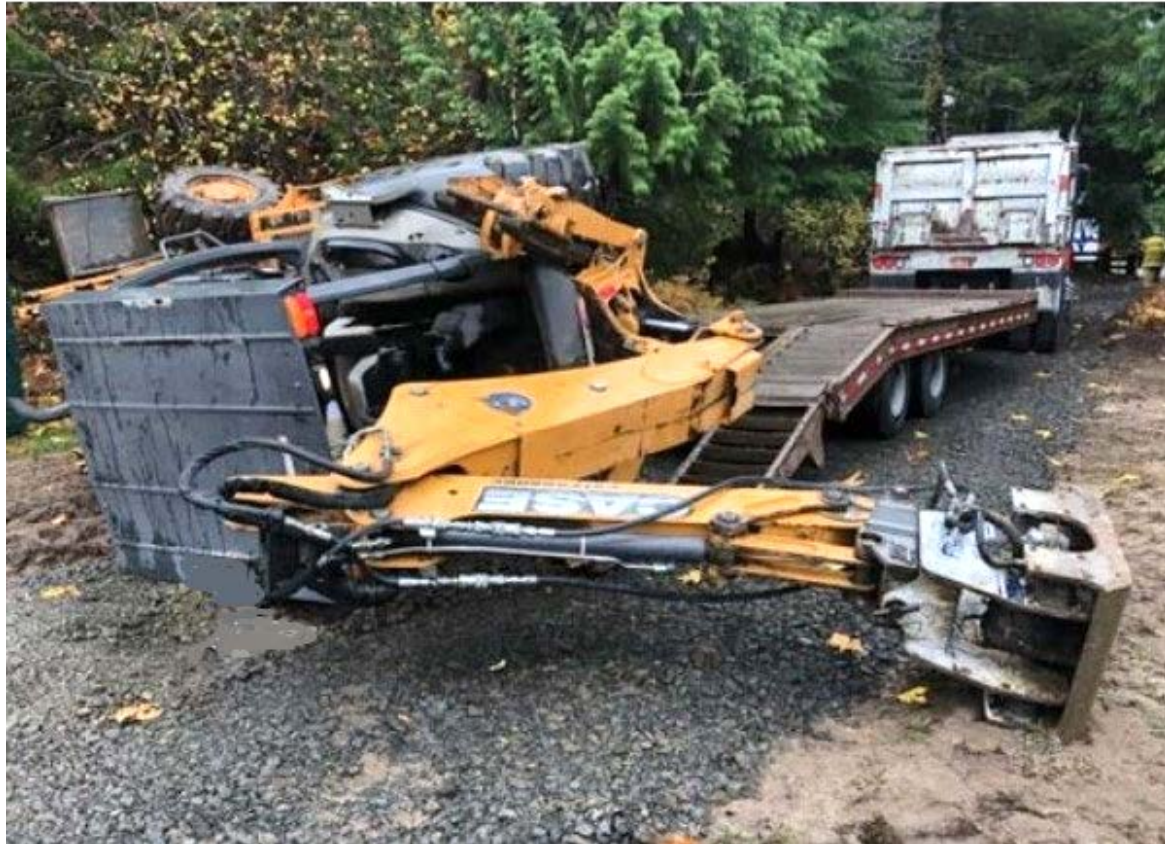
It is possible that the driver had started moving the backhoe up the trailer's two metal ramps, and then backed up to better position its wheels. As he was doing this, the wet, muddy tires may have slipped on the ramps resulting in a rear wheel going off the ramp, causing it to rollover on its side.

Either the driver, who was not wearing the backhoe's seatbelt, attempted to jump from the operator's seat or he was thrown from it as the backhoe rolled over.

He was crushed under the backhoe's rollover protective structure (ROPS).

Photo 1. Backhoe rolled over on its side as the operator was attempting to load it onto a lowboy flatbed trailer.

Train equipment operators and ensure they always use a seatbelt when operating equipment, including when loading and unloading onto or off a transport trailer.

Use a spotter to provide directions to the equipment operator during loading and unloading to ensure that the operator positions equipment correctly for safe movement.

Create a job hazard analysis (JHA) for safely loading and unloading construction equipment on and off trailers.

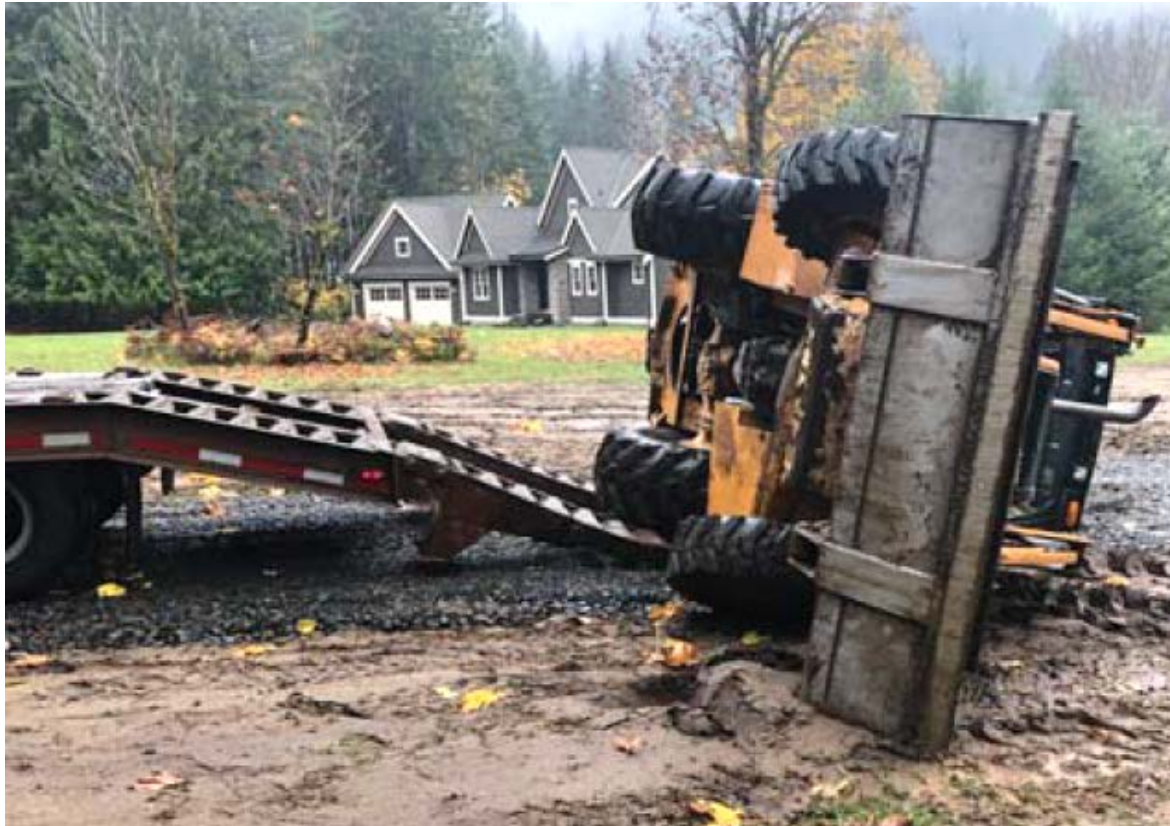
Photo 2. Backhoe rolled over on its side and trailer ramps.

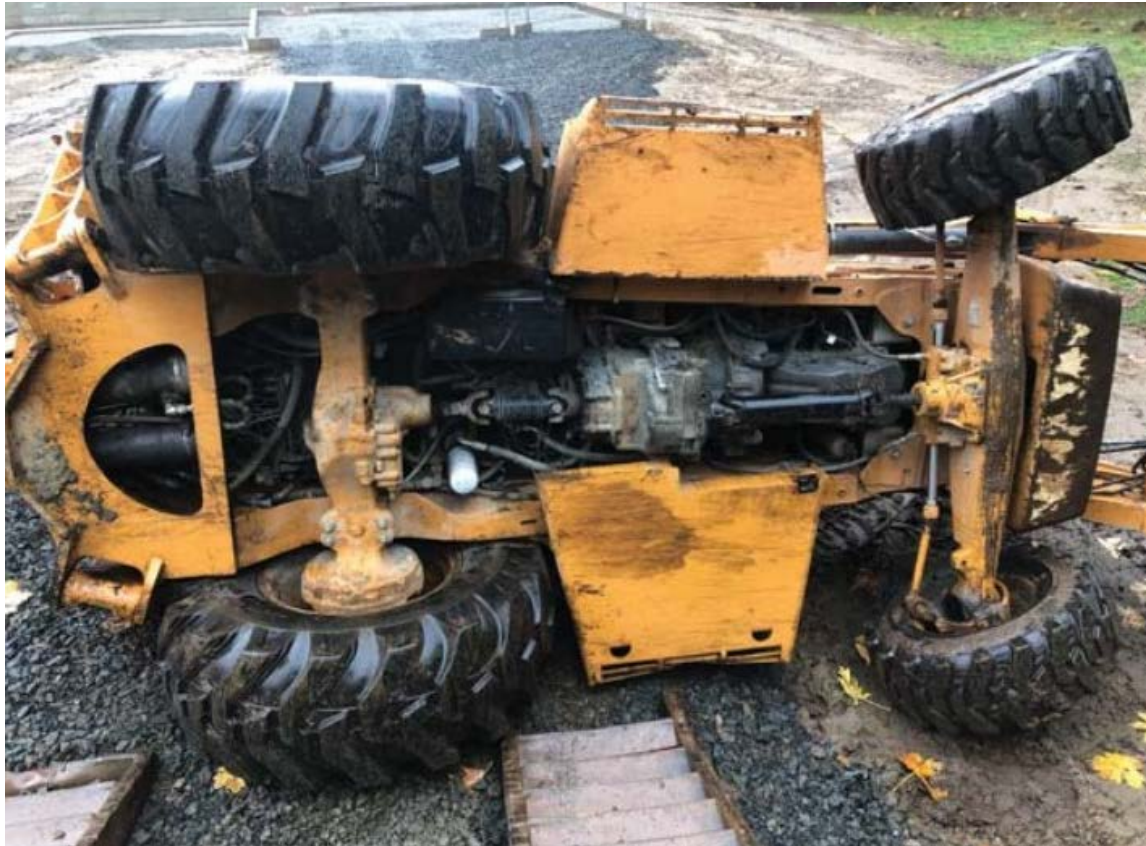
Photo 3. Backhoe rolled over on its side and trailer ramps.

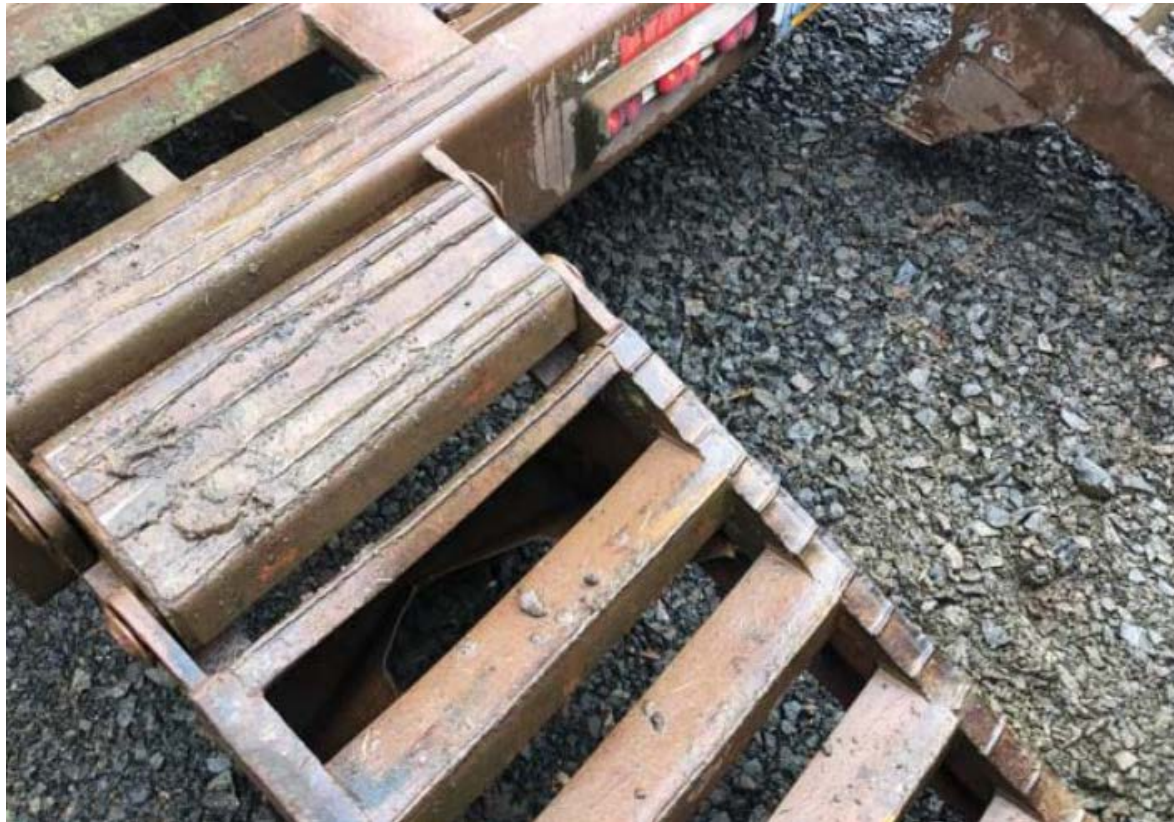
Photo 4. Wet, muddy trailer ramp.
