## INCIDENT FACTS

71-220-2022

## Truck Driver Has Fatal Fall While Tarping Flatbed Trailer

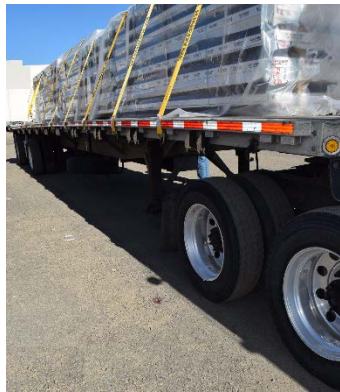
Passenger side of flatbed trailer where driver fell to the ground.

As the incident had no witnesses, investigators presumed from physical evidence that the driver had climbed on top of the trailer, placed tarps at the front and rear ends, and at some point afterward fell around 51 inches to the ground on the passenger's side. Evidence at the scene suggested that the driver got up after falling, walked around the front of the tractor, climbed into the cab, and, while exiting the cab, fell again to the ground where he was found. The employer's Accident Prevention Plan (APP) or safety program lacked a requirement policy for drivers to use specific procedures to safely access, exit, and tarp flatbed trailers. Other possible contributing factors were that the driver was wearing loosely tied sneakers and in poor health with coronary and kidney diseases. The employer did not follow state requirements to report workplace fatalities within eight hours and to leave equipment unmoved at the incident scene.

- Require drivers to use fall protection, a tarping station, or elevating work platform, if possible.
- Create a Job Hazard Analysis (JHA) that describes specific hazards and safety procedures for each type of trailer tarping operation. Routinely update each JHA. Include workers in JHA development.
- Regularly evaluate drivers to make sure they are following flatbed tarping safety procedures.

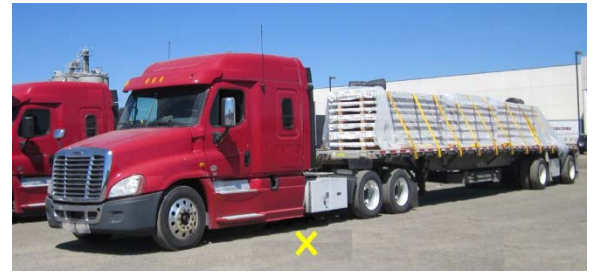
Semi-truck with loaded flatbed trailer at incident scene. Yellow X shows where fatally injured driver was found.
