INCIDENT FACTS

71-222-2022

Orchard Worker Driving UTV Struck By Car

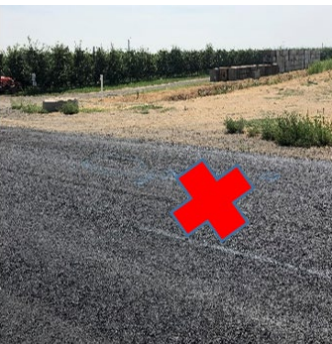
Red X shows where passenger car struck worker's UTV on paved county road.

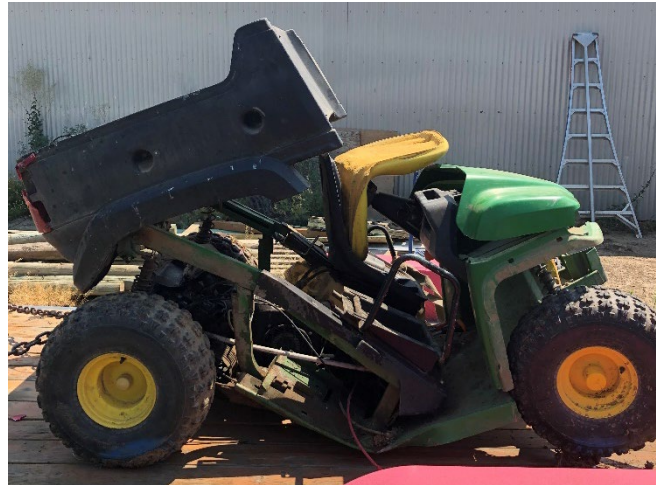
The speed limit was 55 mph, but there were no traffic signs or street lights in the area. It is unknown if the vehicles had their lights on. As the car caught up to the UTV, it struck it from the rear and pushed it 310 feet, nearly the length of a football field, before coming to a stop in an orchard adjacent to the road. First responders pronounced the worker dead at the scene.

Utility Task Vehicle (UTV) with collision damage caused by passenger car.

- Use a utility trailer or road safe/legal vehicle to transport UTV, ATV, and other off-road vehicles to worksites to have them avoid using public roads when such use is deemed unsafe by vehicle manufacturers and/or restricted by local ordinances.
- As part of their APP, do a job hazard analysis (JHA) of tasks involving farm vehicles and equipment that may pose risks. Workers should be involved in creating the JHA.
- Make sure APP policies and safety training instruct UTV, ATV, and other off-road vehicle operators to follow manufacturer's safety guidelines and local vehicle and traffic rules.
- Develop APP policies that require UTV, ATV, and other off-road vehicle operators to turn on lights and wear DOT-compliant helmets and reflective, high visibility clothing in poor visibility conditions.
