Siding Installer Falls 23 Feet from Pump Jack Scaffold

REPORT #: 71-227-2022s

SCENE: Apartment building under construction

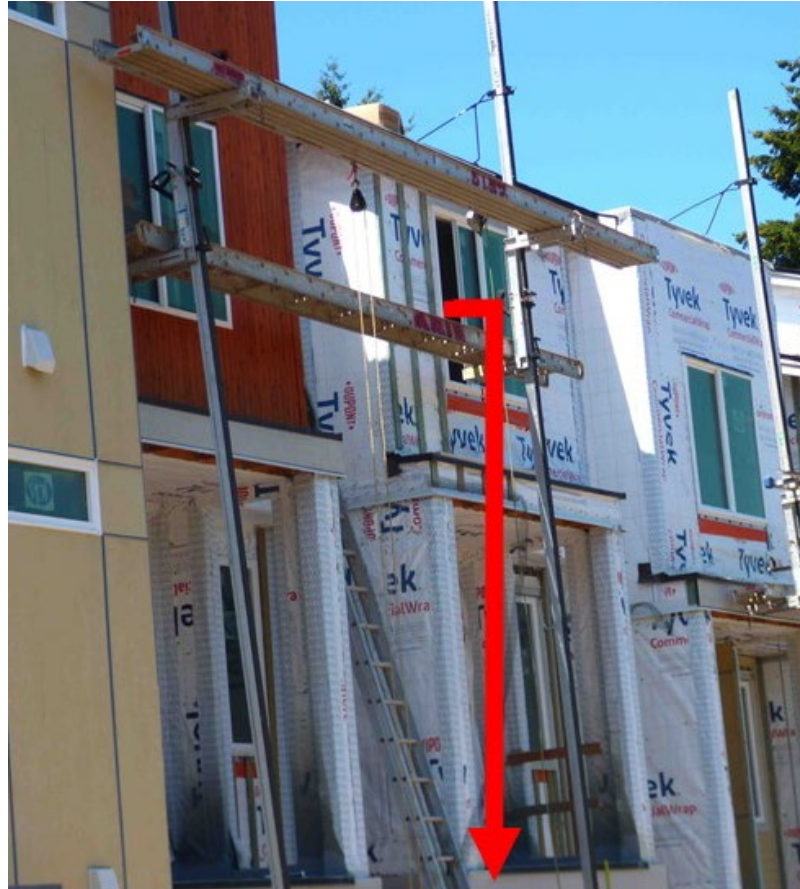
On the day of the incident, the installer accessed the scaffold platform at the building's third floor level by climbing an extension ladder. The scaffold was not equipped with a guardrail system; it only had a workbench, which alone does not meet the requirement of a guardrail system.

Photo 1. Unguarded pump jack scaffold from which the installer fell 23 feet.

- Make sure guardrails are installed along all open sides and ends of platforms. See [WAC 296-874-20064](#)

- Use guardrails on scaffolds whenever practical instead of or in addition to personal fall protection.
- Emphasize the requirement that workers maintain 100% tie off. This should be written in the work contract.
- Inspect scaffold operations at the start of each day before work begins and periodically throughout the day to ensure workers use fall protection.

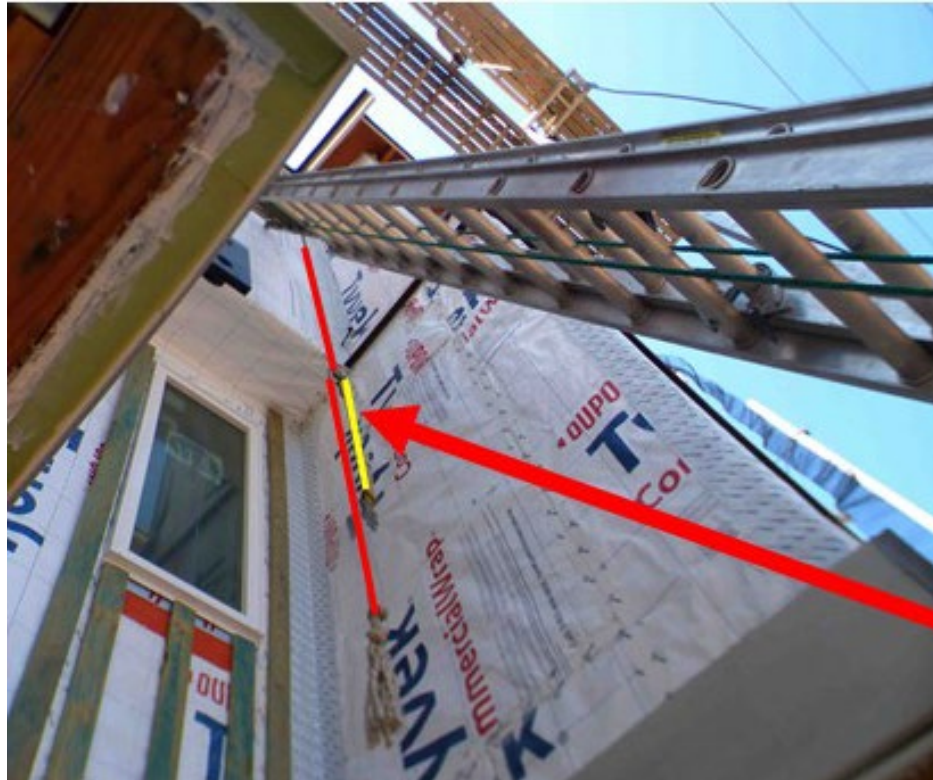
The installer provided his own full body harness, but he was not wearing it. The subcontractor provided the pump jack scaffolds and the rest of the personal fall arrest system consisting of a vertical rope lifeline with a rope grab and connector. The subcontractor required that site workers use the personal fall arrest system.

Photo 2. Rope grab lifeline (in red) with connector (in yellow) that worker did not use, as he was not wearing his full body harness. The scaffold walkway and workbench are visible in the top center of the photo.

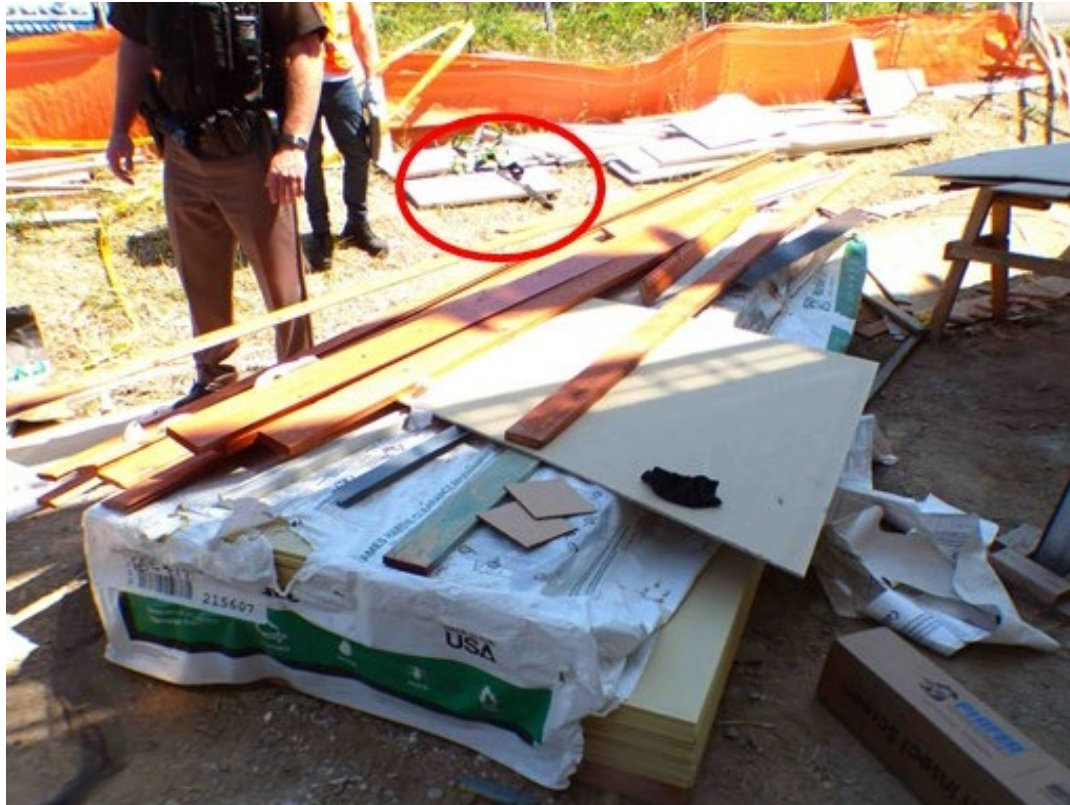
As the installer was working from the scaffold platform, he fell 23 feet, landing on a pile of construction materials on the ground. He died of multiple blunt force injuries due to the fall.

Photo 3. Location where the installer landed after falling 23 feet. His full body harness was in the background (circled).

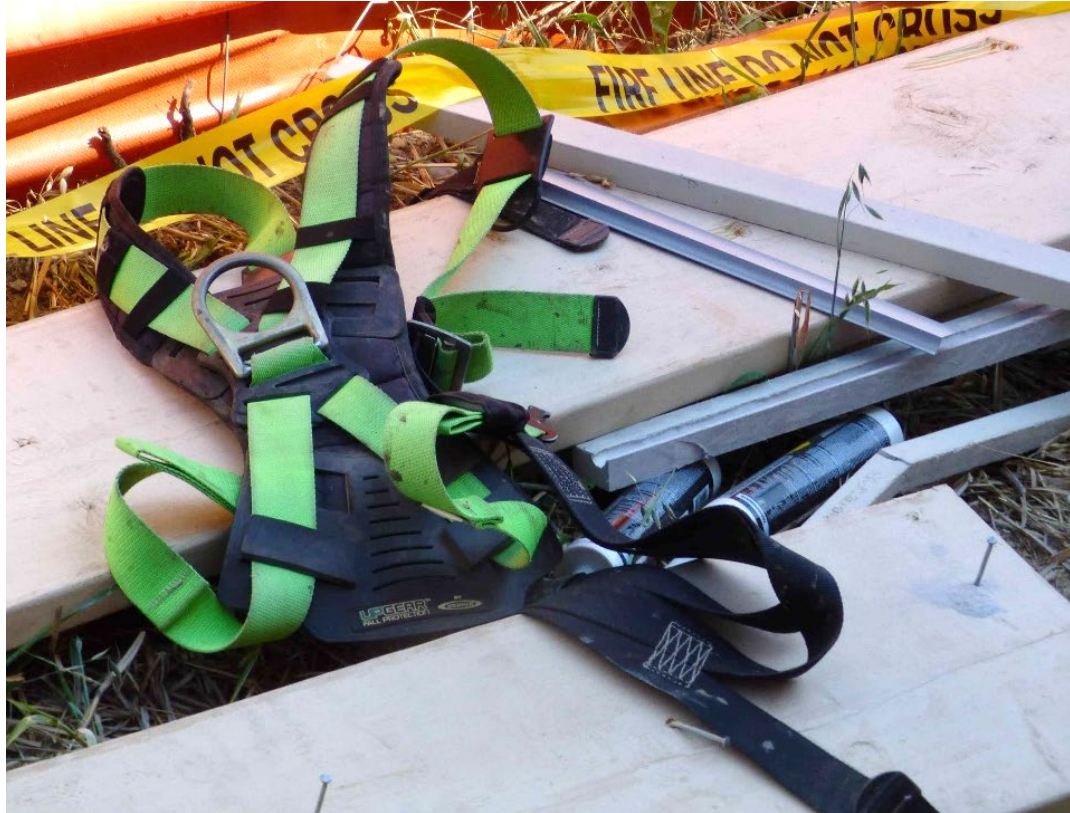
Photo 4. Installer's full body harness.

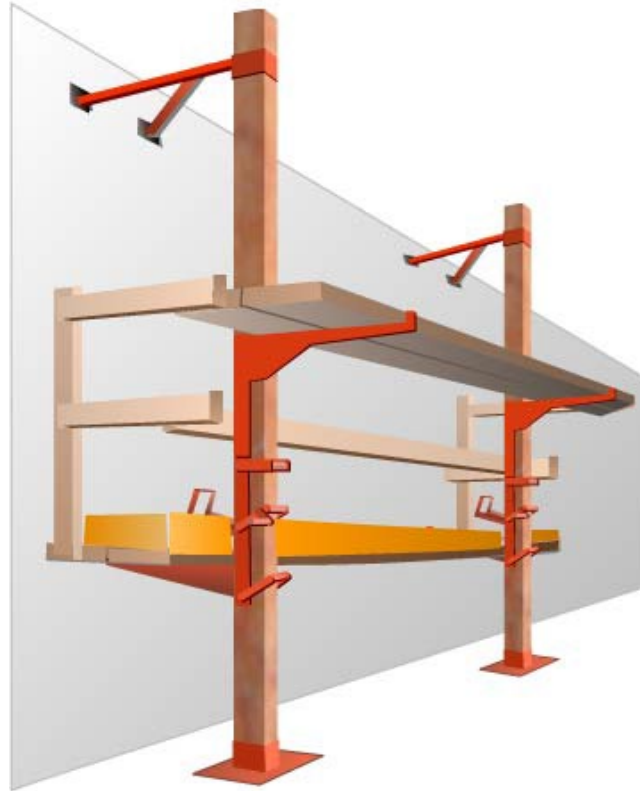
Illustration 1. Pump jack scaffold with workbench and guardrail. Courtesy of The Occupational Safety and Health Administration (OSHA).

- Protect each employee on a scaffold from falling ten feet or more to a lower level, by providing either:
 - (a) A personal fall arrest system; or
 - (b) Guardrails.
