INCIDENT FACTS

71-237-2023

New warehouse construction site

Rofer Falls Constructing Leading Edge of Metal Roof

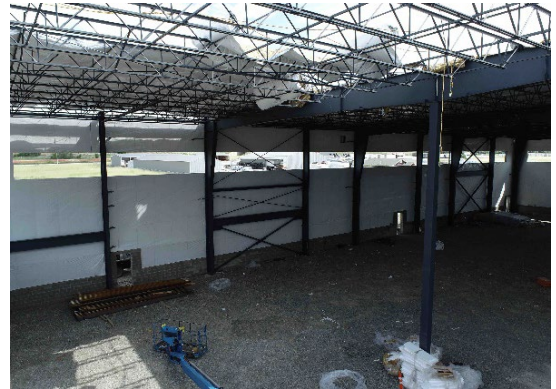
Inside of warehouse where the roofer fell 33 feet from the roof onto the gravel floor.
