Operator Crushed between Backhoe Boom and Stabilizer

REPORT #: 71-238-2023s

REPORT DATE: May 15, 2023

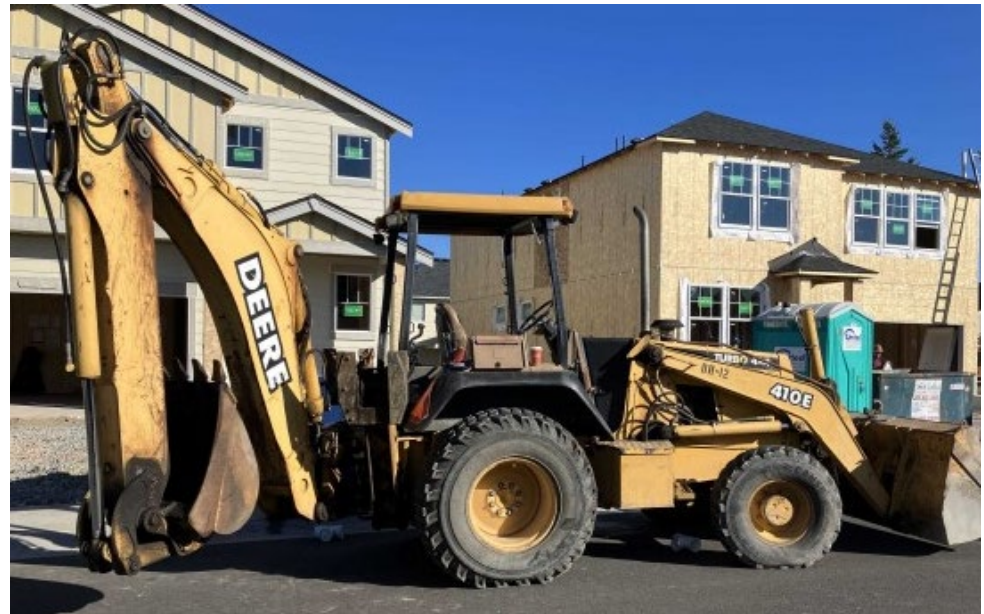
A 54-year-old operator died when the raised boom of a backhoe loader swung and crushed him against one of the machine's retracted stabilizers.

This caused the boom to swing sideways toward him, pinning and crushing him between the boom and one of the machine's two retracted stabilizers.

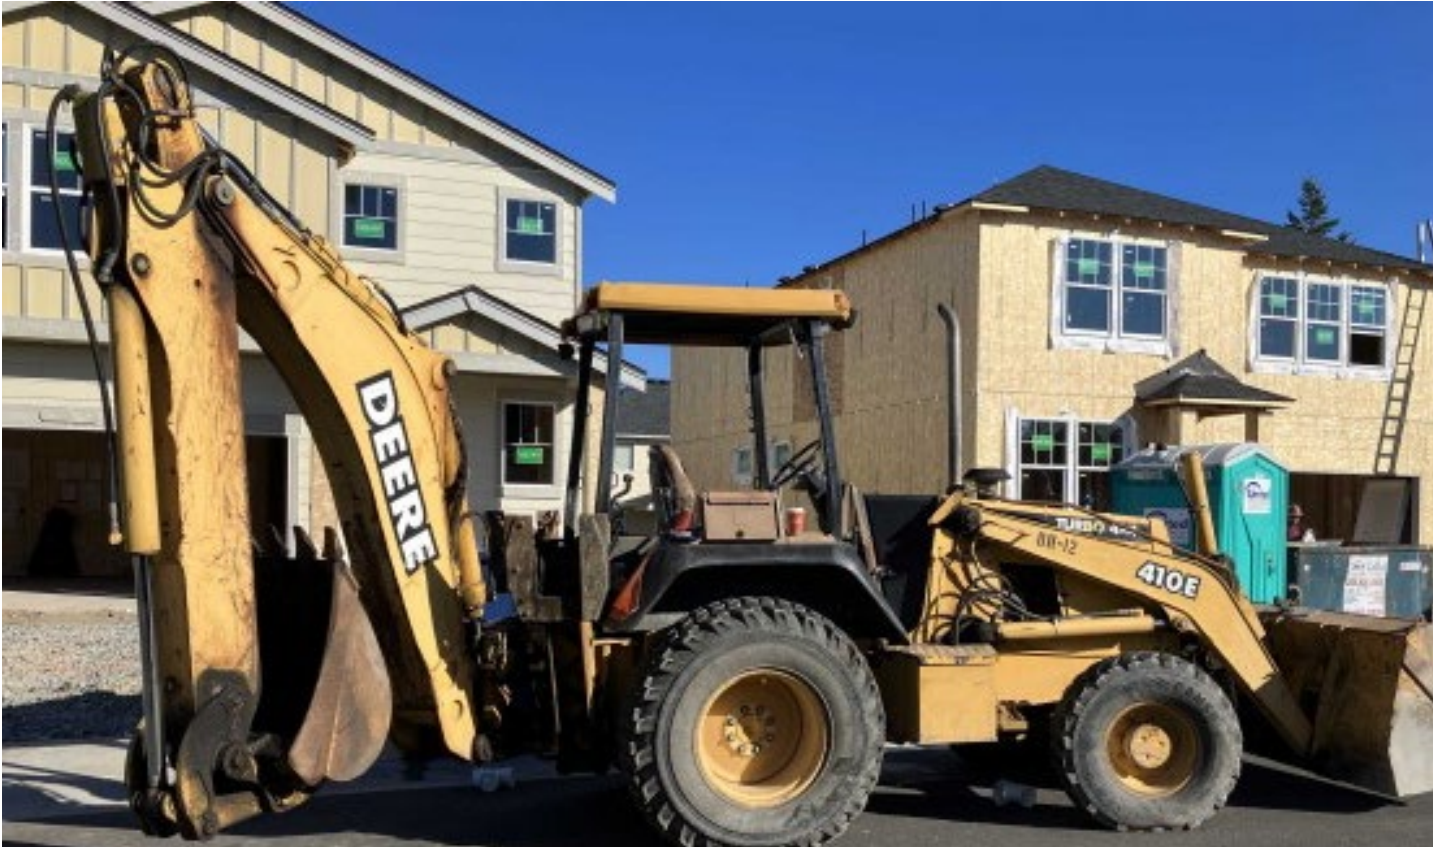
Photo 1. Backhoe loader at the incident scene

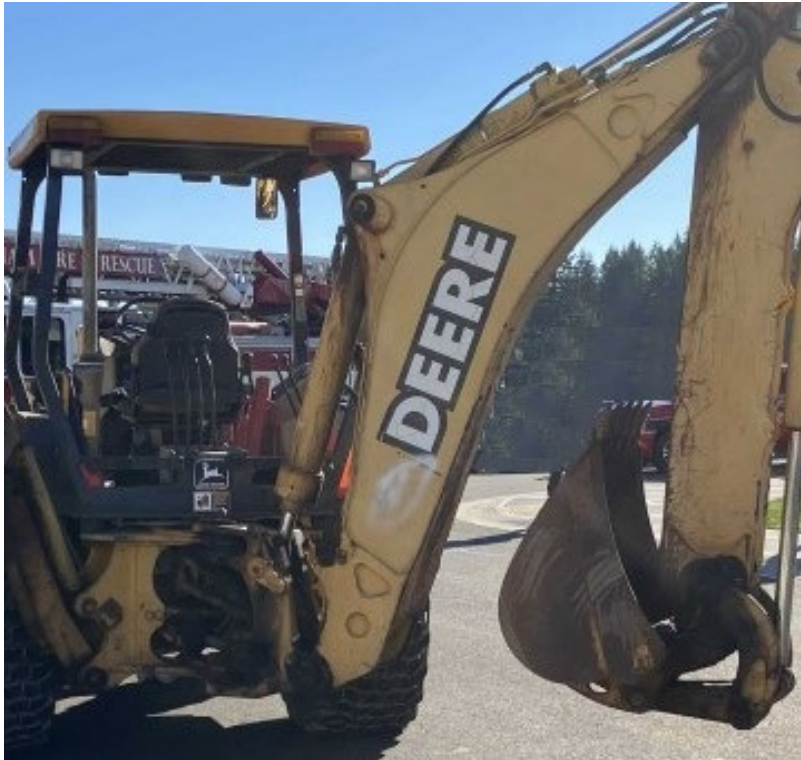
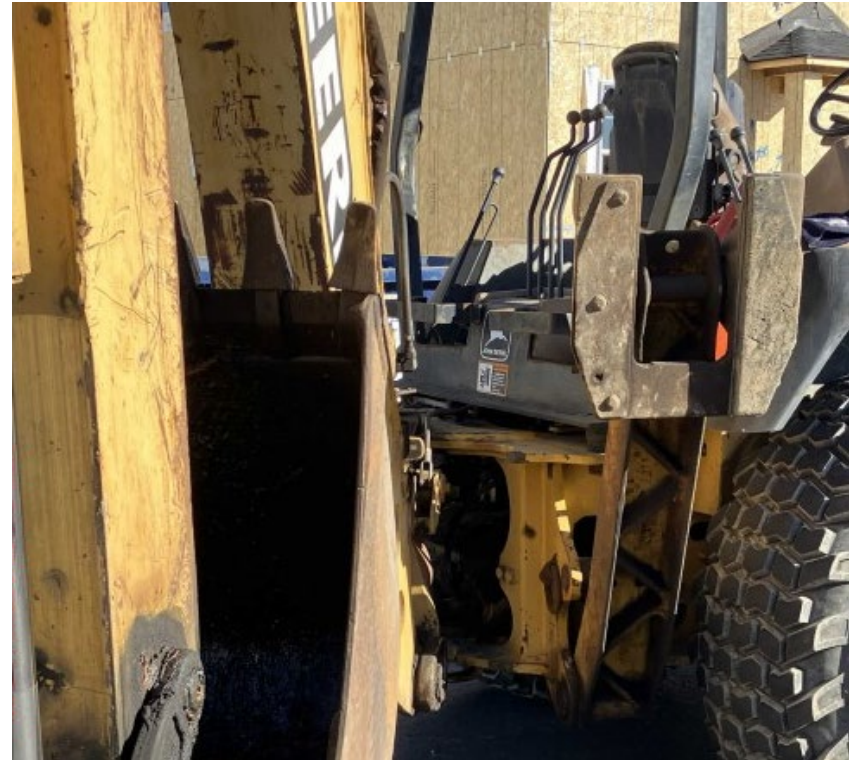
Photos 2 and 3. The pinch points located on each side of the rear of the backhoe. The operator was standing on the ground in the pinch point when he was crushed.

- Lower the boom to a safe position with the bucket on the ground and turn off the machine before stepping off for any reason.
- Never place tools, parts, or other objects in the cab that have the potential to activate the foot pedals or other controls.
- Never stand in the pinch point of the boom of a running or operating backhoe.

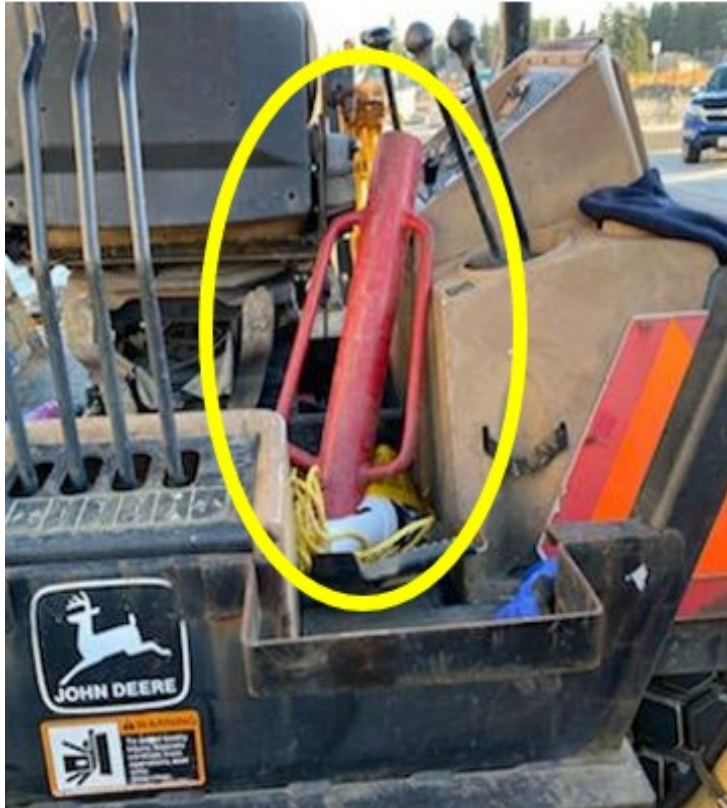
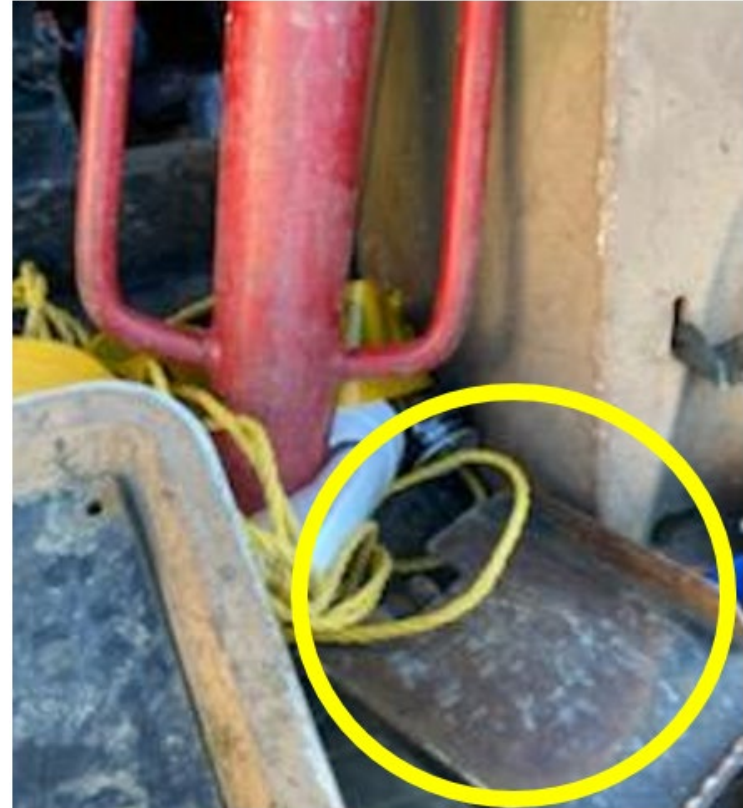
As he was doing this, he apparently dropped the post pounder on one of the two foot pedals that controlled the backhoe boom swing.

Photos 4 and 5. The post pounder on the left and the boom swing foot pedal on the right (circled) that the post pounder landed on, causing the boom to swing.

- You must not leave tools on the cab floor. You must not store spare cans of oil or fuel, and spare parts, in cabs, except in approved racks provided for that purpose.

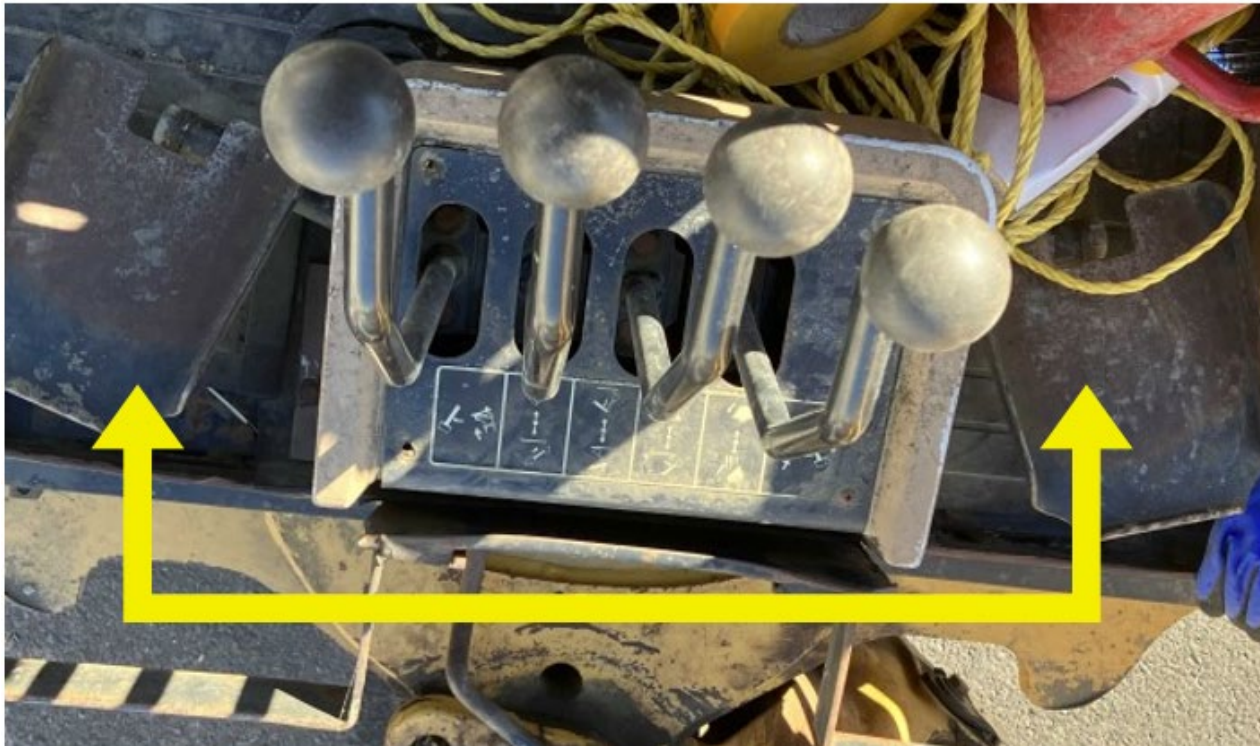
Photo 6. Foot pedals that control the backhoe boom swing.
