## Spotter Loses Fingertips in Excavator Quick Coupler

**REPORT #:** 71-242-2023s

**REPORT DATE:** July 17, 2023

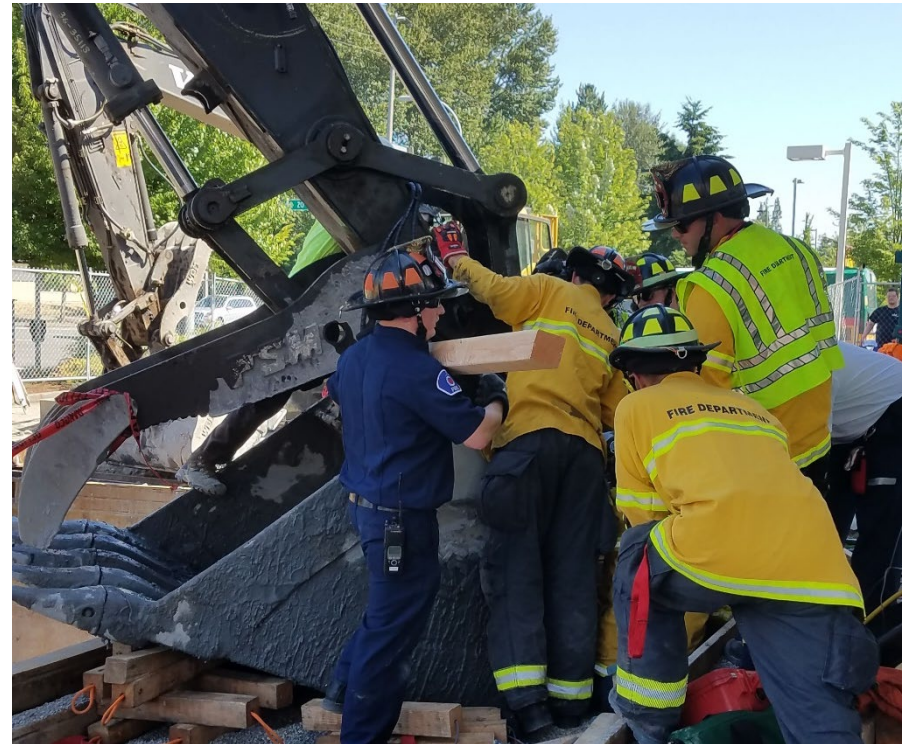
A 20-year-old worker lost three fingertips from his right hand when a quick coupler connecting a bucket to an excavator failed. He had been with the employer for 5 months, working as a ground person.

Just then, the spotter noticed the safety knuckle of the quick coupler on the ground. It had detached from the coupler where it connected the bucket to the excavator.

He picked up the knuckle and moved in front of the bucket where he used his hands to feel around inside the coupler and tried to reattach the knuckle.

Suddenly, the wedge of the coupler locked into place crushing his fingers between the wedge and the bucket.

- Train equipment operators and workers on the ground to:
  - Never place hands inside the quick coupler or anywhere near the linkage mechanism while the hydraulic system is pressurized or the machine is on.
  - Never attempt to repair failed equipment and to notify site supervisors when issues with equipment are suspected or noticed.
  - Always communicate intentions and wait for confirmation before proceeding.
- Use an excavator-mounted pile driver instead of a bucket to drive piles.

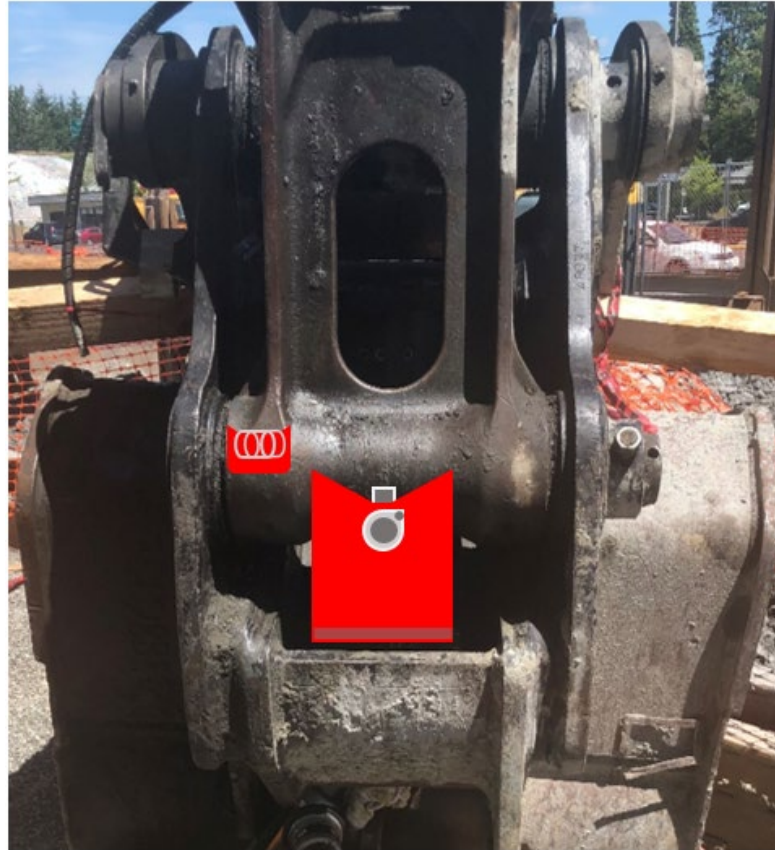
**Photo 1.** Quick coupler connecting bucket to excavator boom with illustrations of approximate locations of wedge (center) and safety knuckle (on left). Not to scale.

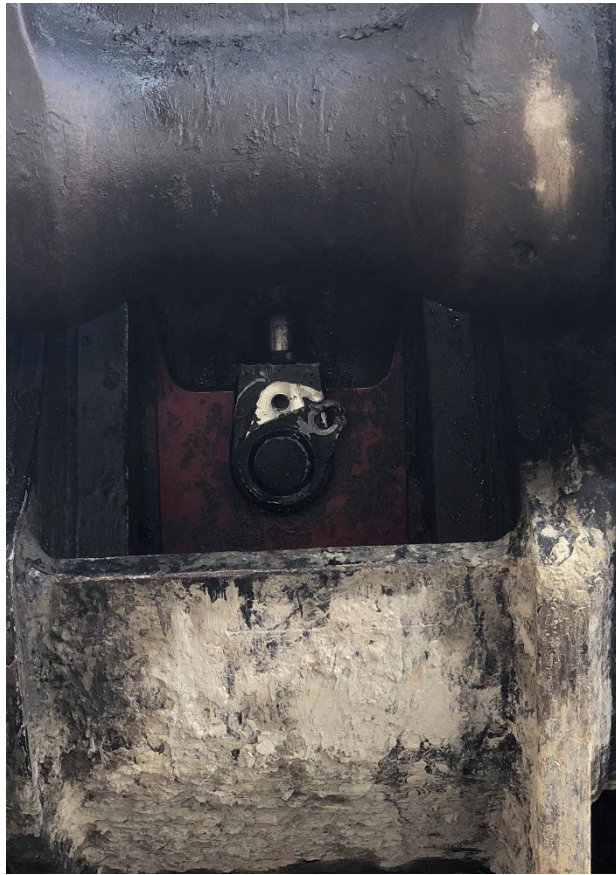
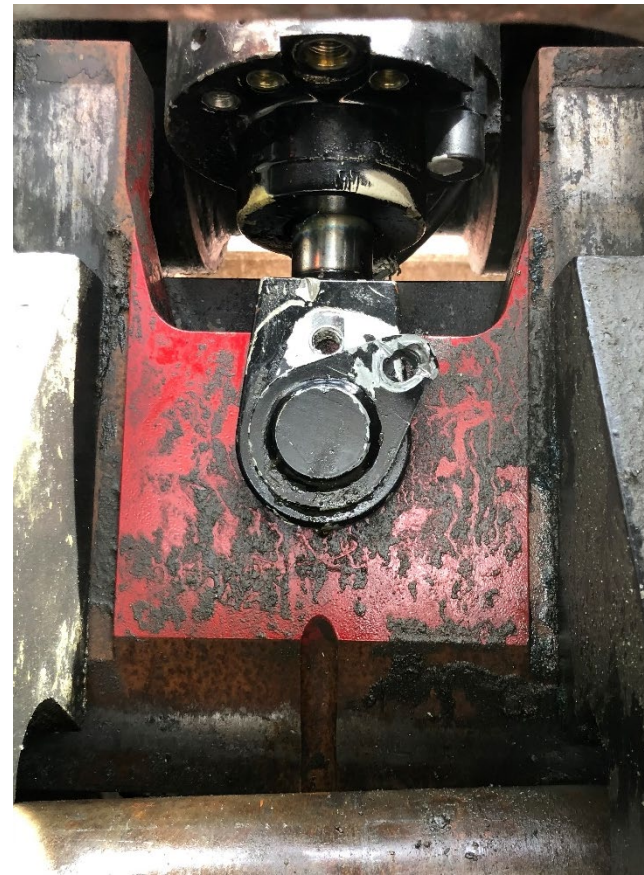
**Photos 2 and 3.** View of the wedge lock within the coupler on the left and close-up of the wedge in the unlocked position on the right.

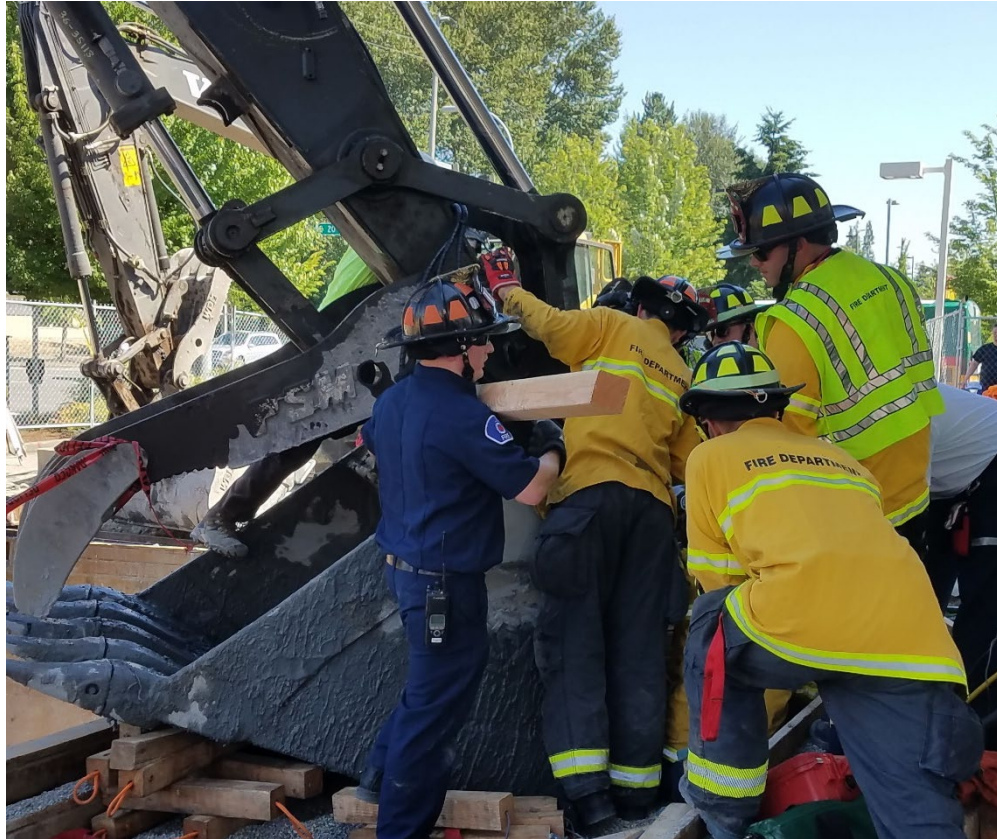
The incident evolved into a 3-hour, multiple agency technical rescue. The spotter lost the tips from the first three fingers of his right hand.

**Photo 6.** Rescue workers using bracing to prevent the bucket from shifting and other tools while trying to free the spotter's fingers from the coupler.

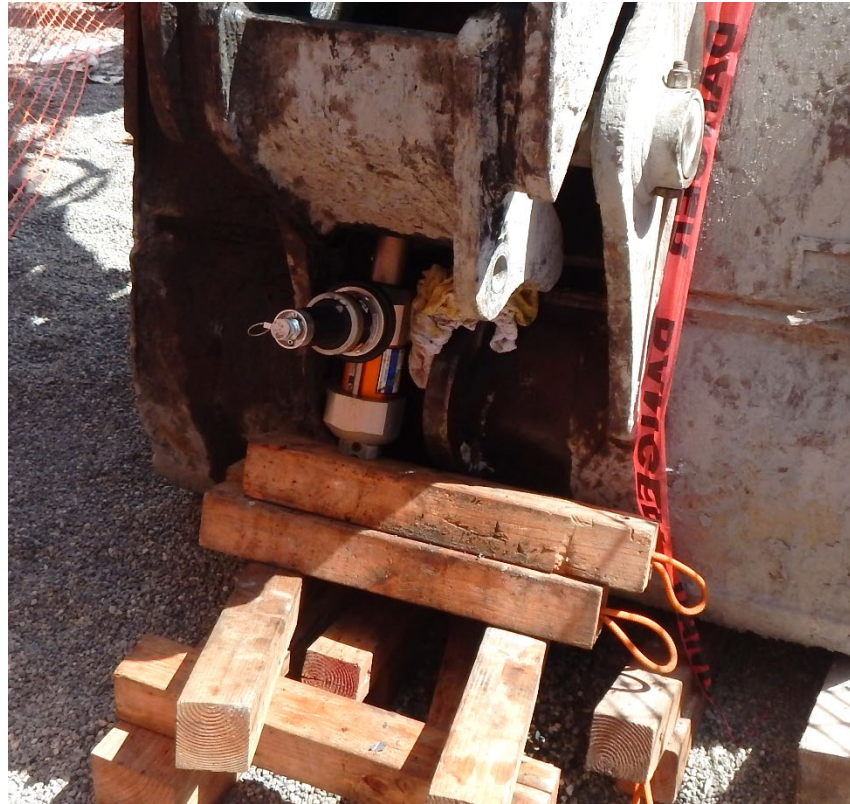
**Photo 7.** Bracing and tool that rescue workers used to stabilize the bucket and retract the wedge while trying to release the spotter's fingers.
