INCIDENT FACTS

71-247-2023

Company Co-owner Backed Over by Work Truck

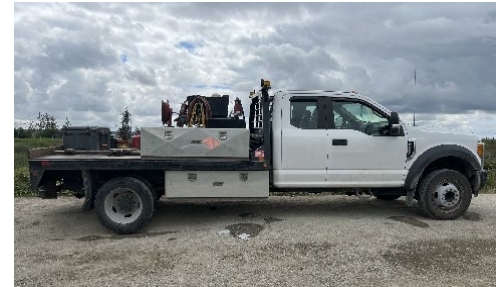
Visibility through truck's rear view mirror partially obstructed by steel tube headache rack and fuel transfer tank hose reel.

Heavy-duty work truck that backed over company co-owner.

- Create and enforce vehicle backing safety policies in their accident prevention program (APP) that:
 - Drivers maintain clear visibility of workers on foot. When visibility is lost, drivers should stop and not resume movement until visibility is re-established.
 - Workers stay out of backing zones unless trained and acting as an observer signaling the driver.
 - Prohibit workers on foot from using radios or phones when crossing roads when there is vehicle traffic.
- Increase availability of vehicle turnaround areas on construction site roads to minimize backing distances.
