Truck Driver Crushed by Freight Pushed Off Flatbed Trailer

INCIDENT FACTS

REPORT #: 71-249-2024s

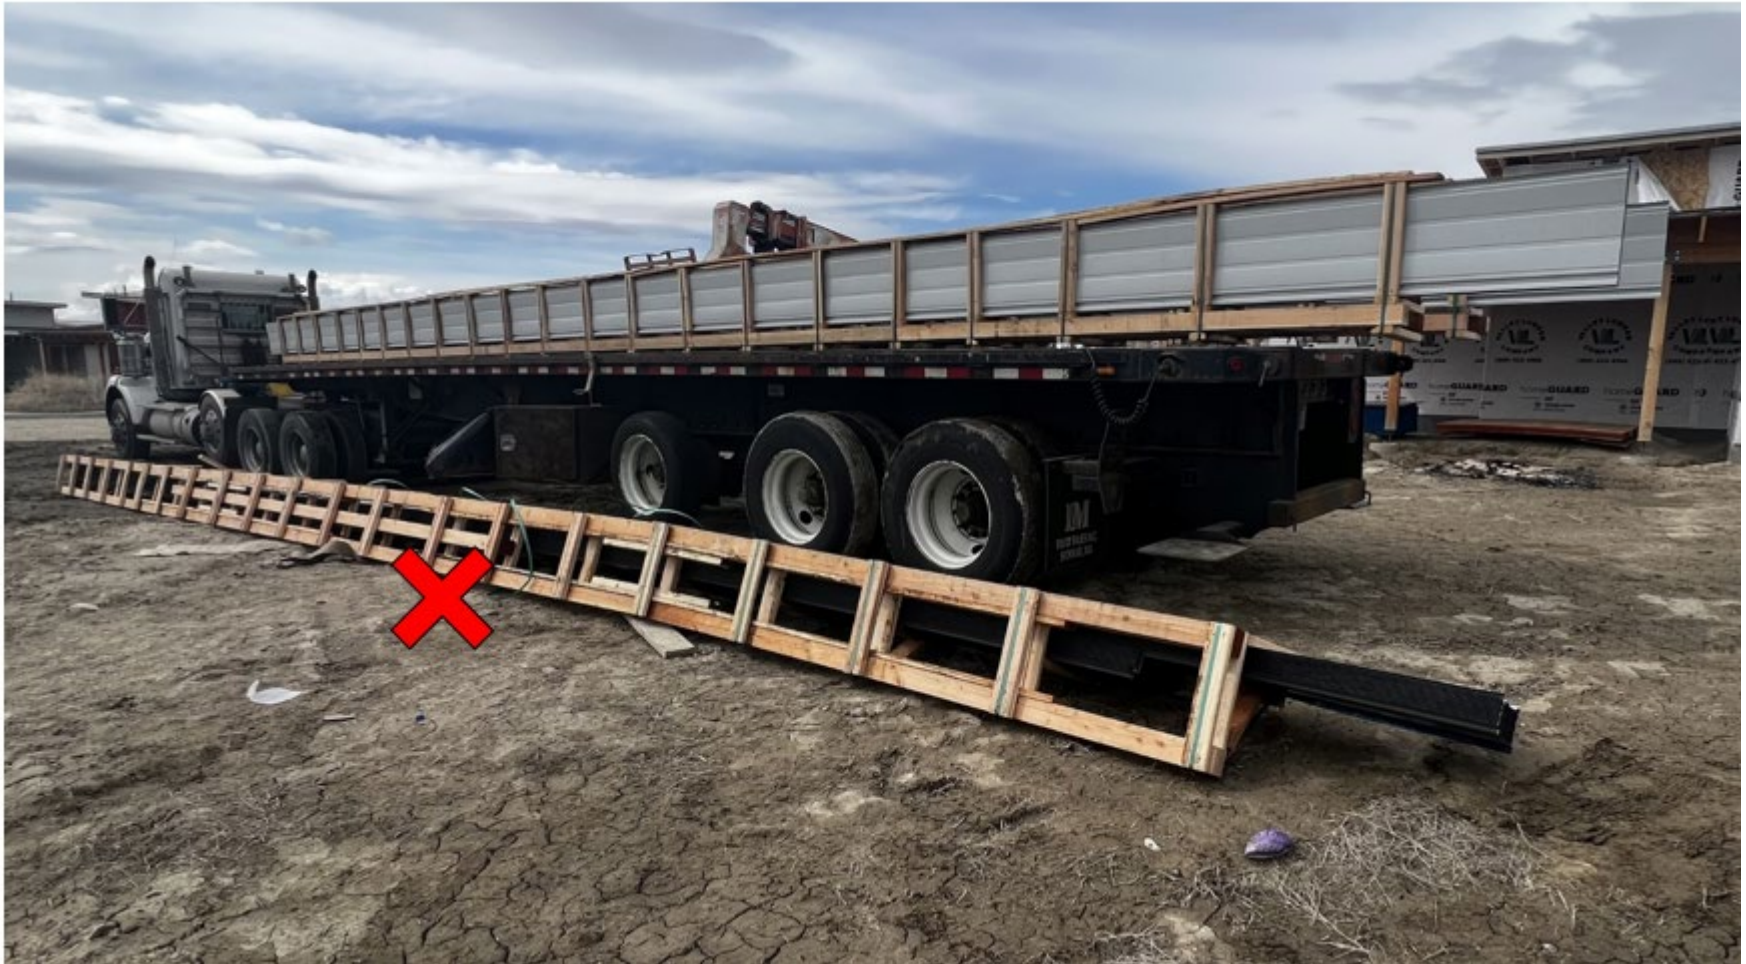
As the operator began to lift the crates, the third crate was inadvertently pushed off the driver's side of the trailer. When the construction workers heard the crash, they went around the trailer and found the driver crushed under the fallen crate, which weighed around 2,500 pounds. They used a skid steer to lift the crate off him, started CPR, and called 911. Medics arrived shortly after, but he had already died at the scene.

Photo 1. Location (x) where truck driver was crushed by crate that was pushed off the trailer by a forklift on the other side.

- Place high visibility warning signs at each end of the blind zone on the opposite side of the flatbed trailer from where the forklift or crane operator is unloading. Mark the blind zone even when a spotter is present, and make sure no one enters it. Verify signage and other safeguards before starting work.
- Wait in cab or designated safe zone when other workers operate forklifts or cranes.

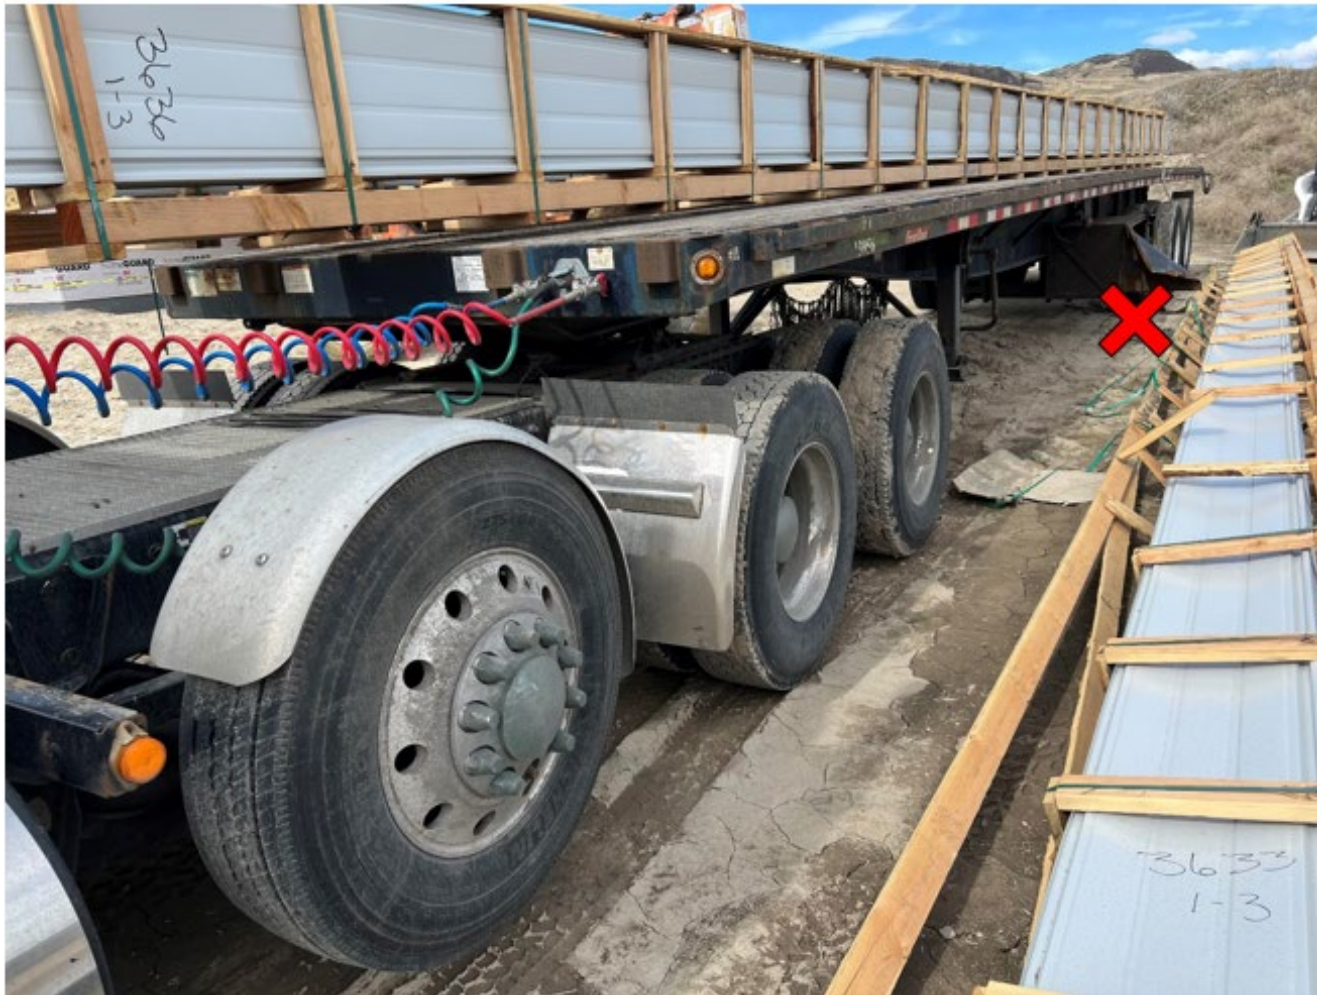
Photo 2. View of incident area from back of truck cab.

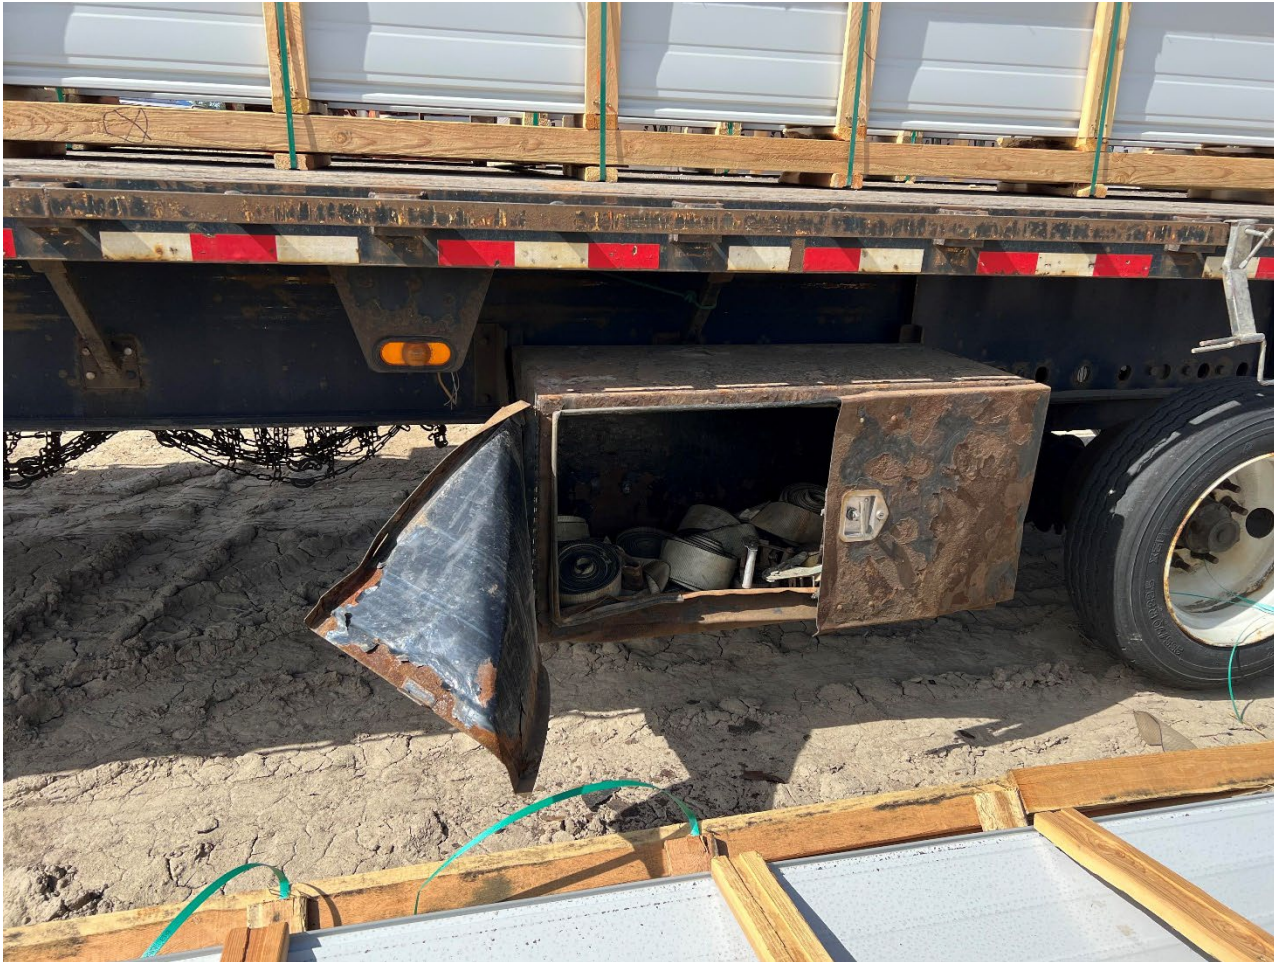
Photo 3. Damage to trailer's underbody toolbox caused by crate that crushed driver.

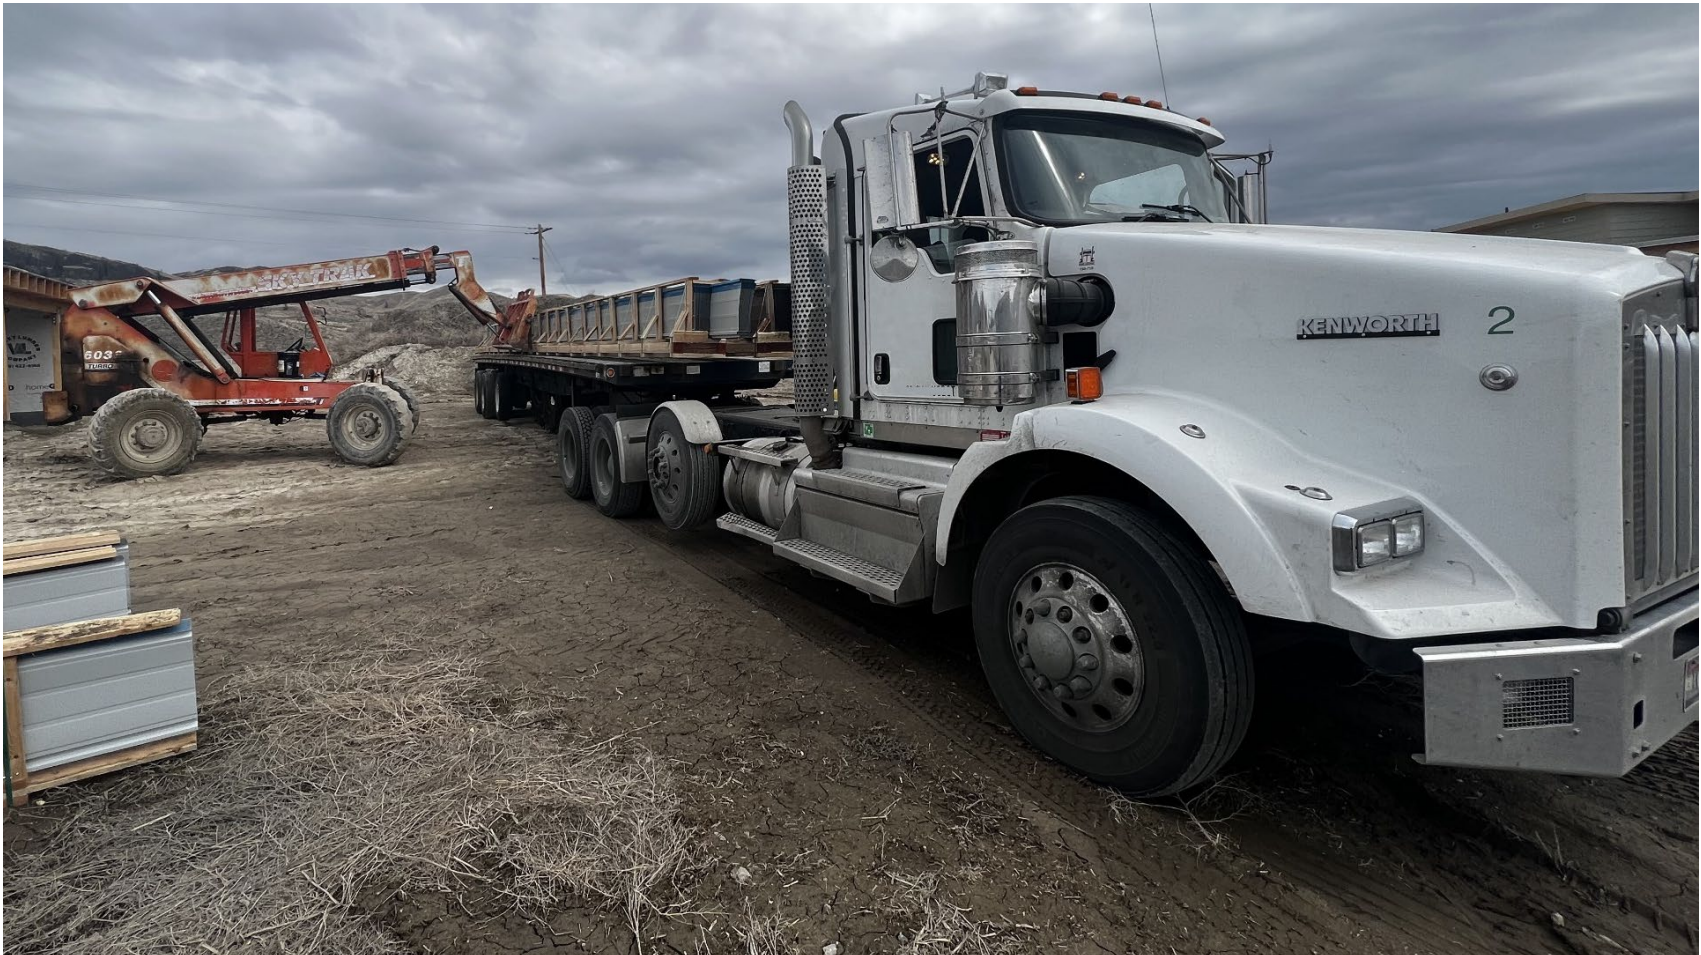
- The crate base lacked enough clearance for the telehandler's forks to slide under it unobstructed.
- The telehandler operator and spotters had obstructed views of the load and workers on the ground. They also thought the driver was in his truck cab when they were unloading the trailer.
- The driver was not wearing a hi-visibility vest or hardhat.

Photo 4. Telehandler forklift on passenger side of flatbed trailer. The truck driver was in the blind zone on the opposite side of the trailer when the crate was pushed off.
