## Painter/Rigger Falls 200 Feet from Bridge into River

# ***FATALITY NARRATIVE***

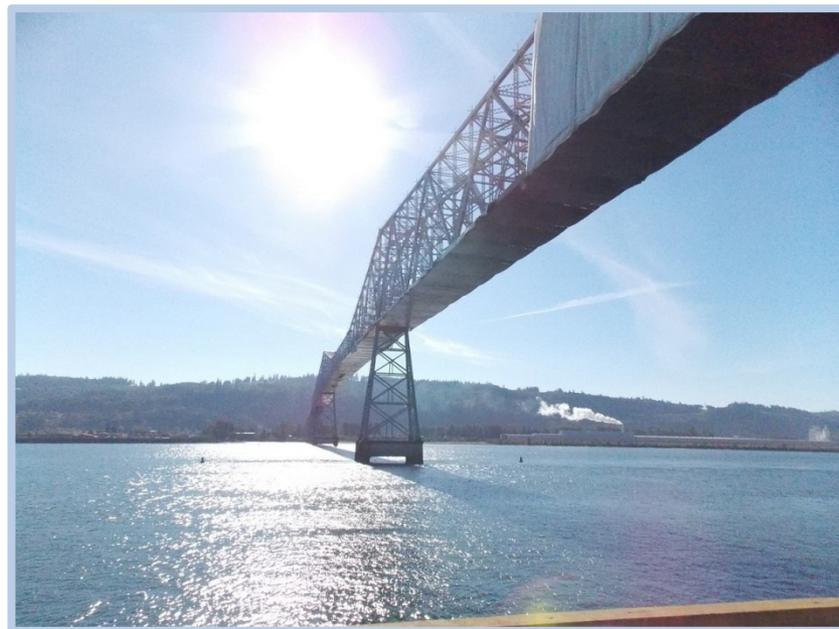
On October 7, 2012, a 40-year-old journeyman painter/rigger died when he fell from a bridge. The incident happened at a bridge over a large river where the steel superstructure was being cleaned and painted.

On the day of the incident the victim was part of a crew rigging cables and tarps to create debris containment areas. Crews would later work in those areas using high-pressure air hoses to blast away rust and old paint from the bridge's steel superstructure. The victim was working from a temporary deck located alongside the bridge and about six feet below the main bridge deck. He was rigging a safety cable along the outside of the deck to serve as a horizontal lifeline to which workers could tie off. There was a safety cable at about head height; the victim was rigging another cable beneath it at mid-body level. Another rigger was feeding out cable to the victim as he strung it out by walking along the deck. When the victim got to the end of the cable he climbed up on a partially collapsed containment area tarp positioned over the deck to reach an anchor in order to secure the cable. As he did so, he lost his balance and fell off the side of the deck. He landed in the river 200 feet below.

His body was found four weeks later. An examination of the victim's body by investigators revealed that he was wearing a personal fall arrest system consisting of a full body harness with two lanyards and the appropriate connectors. His system was found to be in working condition, which indicates that he was not tied off when he fell.

Ensure that workers maintain 100% tie off when exposed to fall hazards.

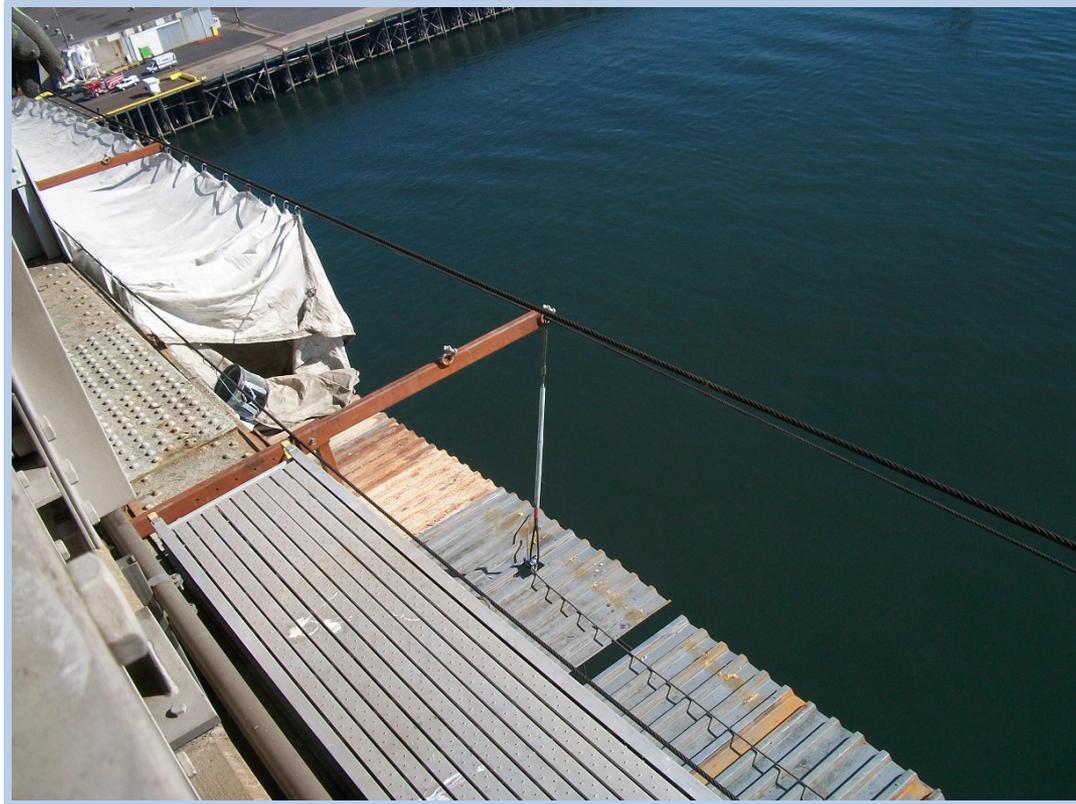
Photo taken from bridge deck looking down to the temporary deck where the victim was rigging a safety cable. He climbed onto the tarp to reach an anchor in order to secure the cable. He fell from the tarp and over the side of the deck, landing in the river 200 feet below. He was not tied off. The cable he was attempting to rig can be seen running along the deck surface and over the edge.

- **Fall Protection Systems.** Ensure that the appropriate fall protection system is provided, installed, and implemented according to the requirements in Part C-1, Fall Protection Requirements for Construction when employees are exposed to fall hazards of four feet or more to the ground or lower level when on a walking/working surface. See WAC 296-155-24609(1).
- **Fall Protection Work Plan.** Develop and implement a written fall protection work plan for each area of the work place where the employees are assigned and where fall hazards of ten feet or more exist. See WAC 296-155-24611(2).
- **Training.** Train and instruct employees in the requirements of the fall protection work plan. See WAC 296-155-24611(2)(b).

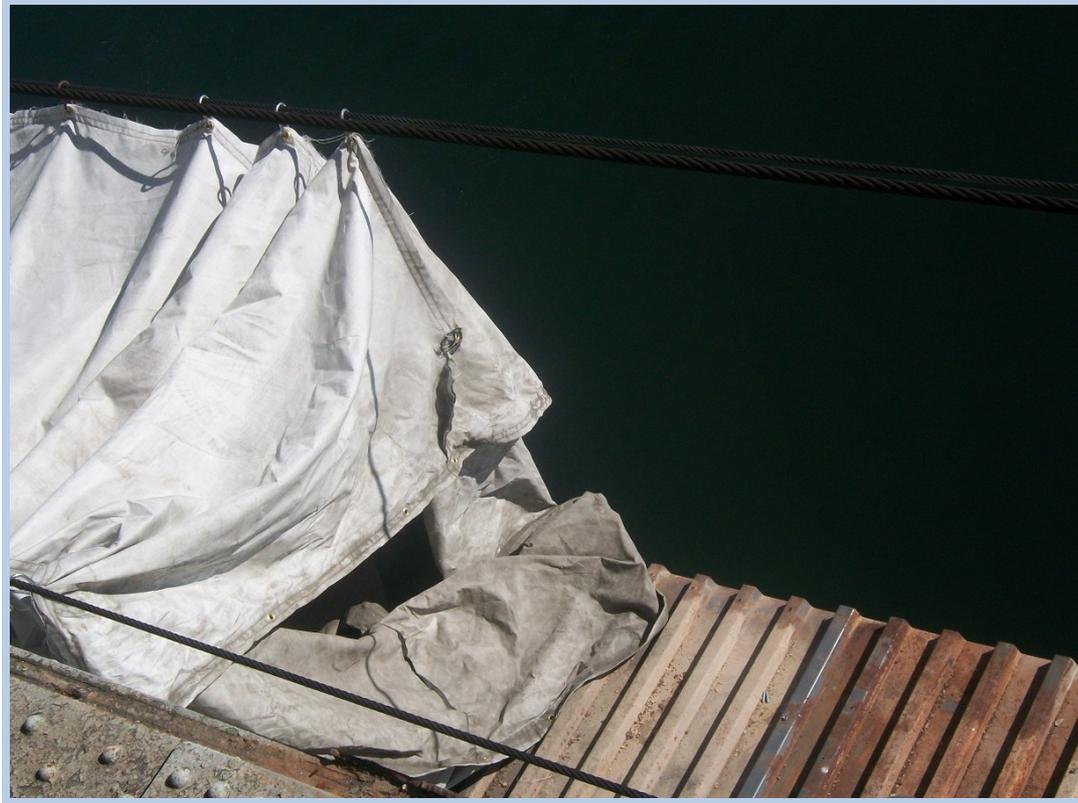
Location where the victim fell from a tarp covering a temporary deck.

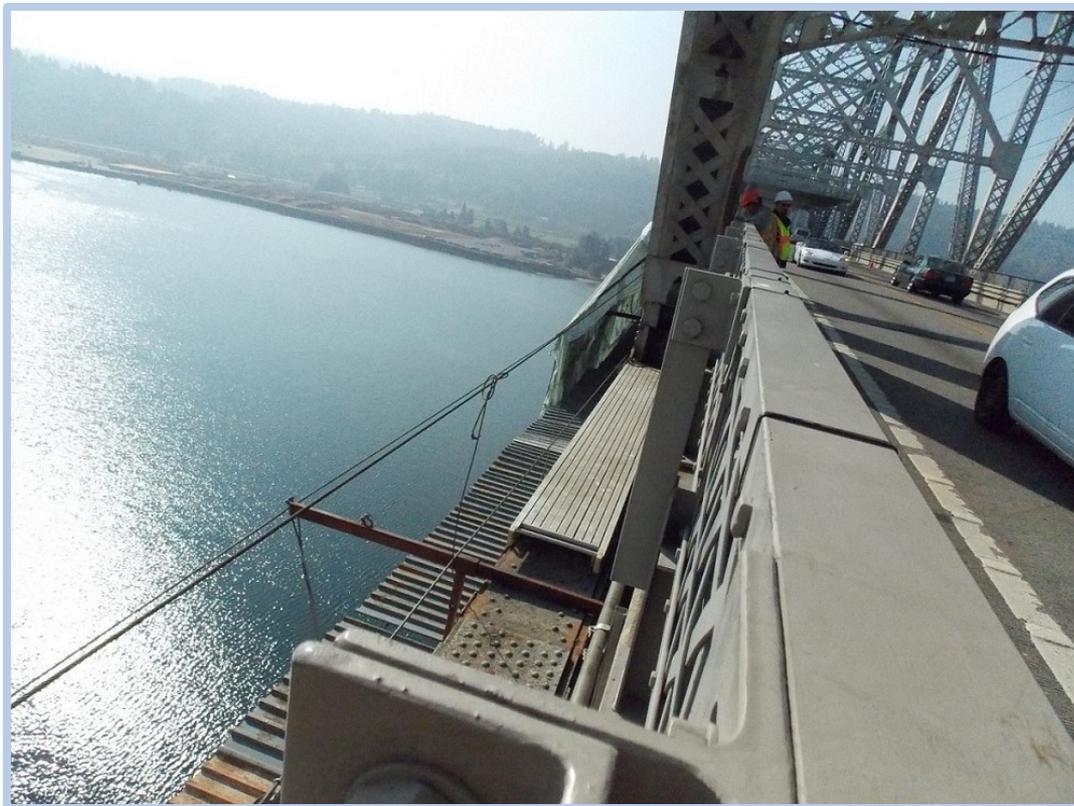
Temporary deck below main bridge deck. The victim had been stringing a safety cable along the temporary deck. The location from which he fell is just beyond the lower left of the photo.
