Coffee Stand Owner Dies When Leak from Propane Cylinder Causes a Fire

Investigation: # 16WA00101

SHARP Report: # 52-37-2016

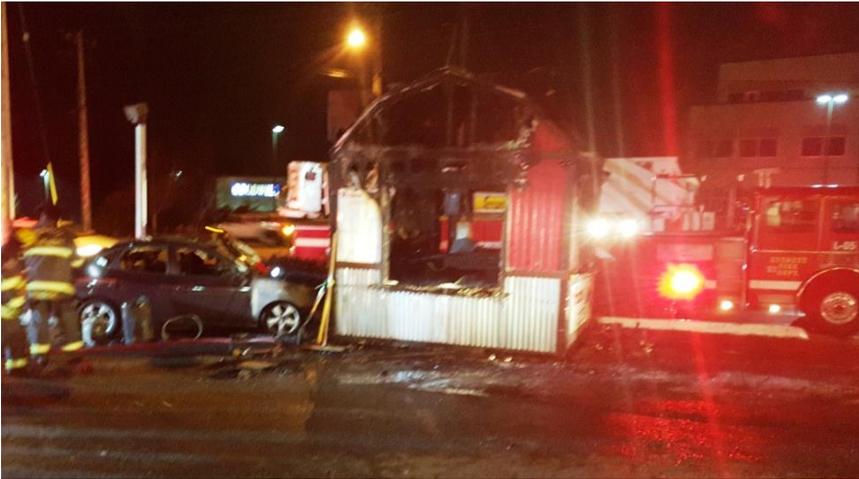
Photo 1: The coffee stand after fire department personnel had extinguished the fire.

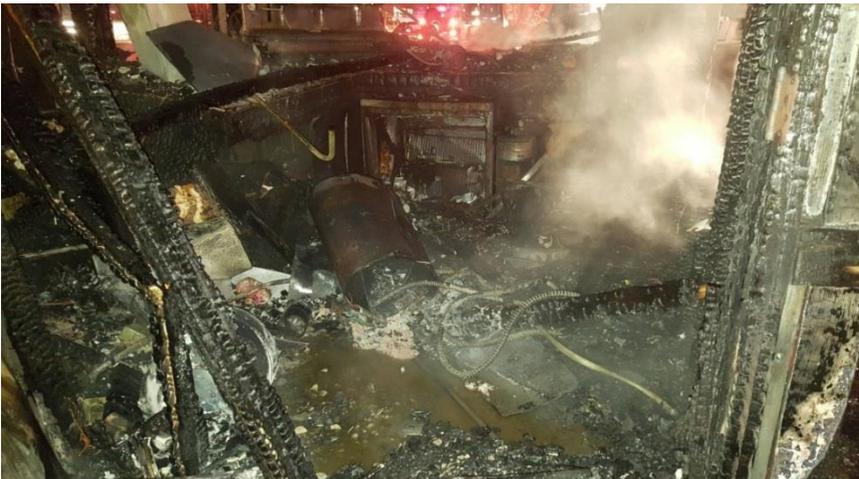
Photo 2: The coffee stand interior after the fire.

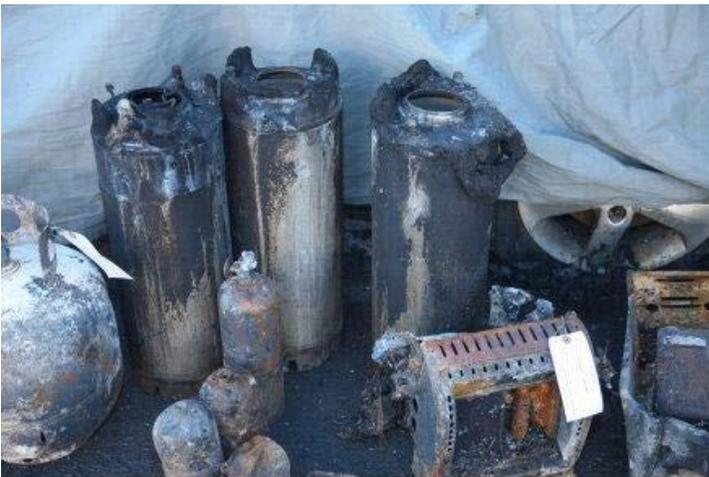
An investigation by the city fire department found that the ignition source of the fire was the open flame of the space heater pilot light that ignited an uncontrolled release of propane vapor from the 20-pound propane cylinder that was located inside the stand.

Photo 3: Incident propane cylinders and space heater.

Recommendation #1: Employers and business owners should recognize and train employees on the potential fire, explosion, and burn hazards associated with propane gas vapor in the vicinity of an open flame, such as the pilot light of a propane-powered space heater.

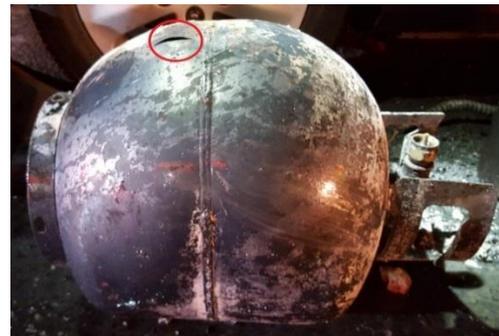
Photo 4: Incident 20-lb. propane cylinder as found inside the stand. A cylinder breach crack was caused by the fire (circled).

Discussion: The explosion and fire occurred while the victim was using a propane adapter to transfer propane from a 20-pound cylinder to 1-pound cylinders. Fire investigators determined that a leak from the 20-pound cylinder was the source of propane vapor that was ignited by the space heater's pilot flame, thereby causing a flash fire. It is unknown why the leak occurred. It is possible that the adapter was improperly secured to the 20-pound cylinder's valve, thereby causing propane leakage. Or there may have been damage to the 20-pound cylinder's valve, or some other factor that caused the leak. The condition of the 20-pound cylinder prior to the incident is unknown. What is known is that the cylinder was manufactured before September 30, 1998. This is the date by which the National Fire Protection Association (NFPA) guidelines, as specified in NFPA 58 Liquefied Petroleum Gas Code, required propane cylinders with a 4 to 40-pound capacity to be manufactured with an Overfilling Prevention Device (OPD). Washington State adopted this requirement in 2002. There is no federal requirement to have an OPD. The 20-pound cylinder in this incident did not have an OPD. This indicates that the cylinder may not have been properly maintained if the OPD was not installed when it was refilled.

The U.S. Department of Transportation's Pipeline and Hazardous Materials Safety Administration (PHMSA) recommends that cylinders that are in poor condition or have not been requalified by certified propane personnel should not be used, as they may put users at risk of severe injuries or death. Both propane (Class 2.1, Flammable Gas) and the cylinder to which it is stored are regulated by the Hazardous Material Regulations (HMR). Cylinders containing flammable gases are required to fully conform to the packaging, qualification, maintenance, and use requirements of the HMR. Propane cylinders must be requalified or replaced every 5-12 years depending on the cylinder type, condition, and previous requalification method. Users

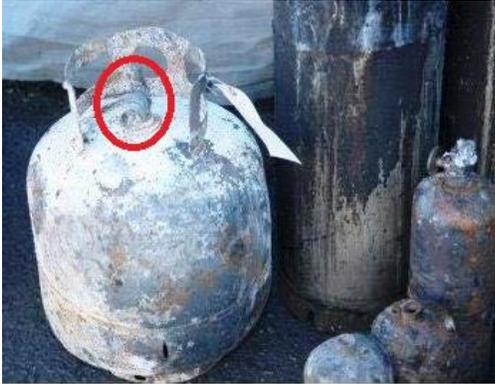
Photo 5: Incident 20 lb. propane cylinder with threaded adapter attachment in valve orifice.

Recommendation #2: Employers and business owners should not use adapters to transfer propane from larger cylinders to refill one-time use only 1-pound propane cylinders, as this practice creates a risk of fire, explosion, serious injury, or death.

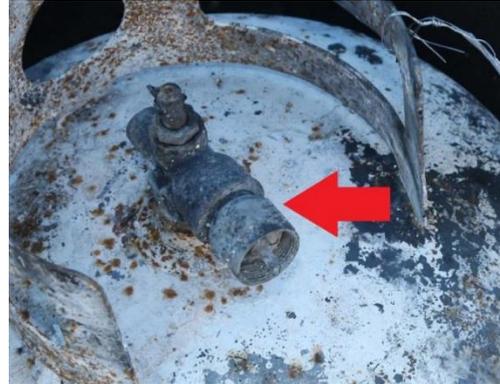
Photo 6: Close-up of the adapter.

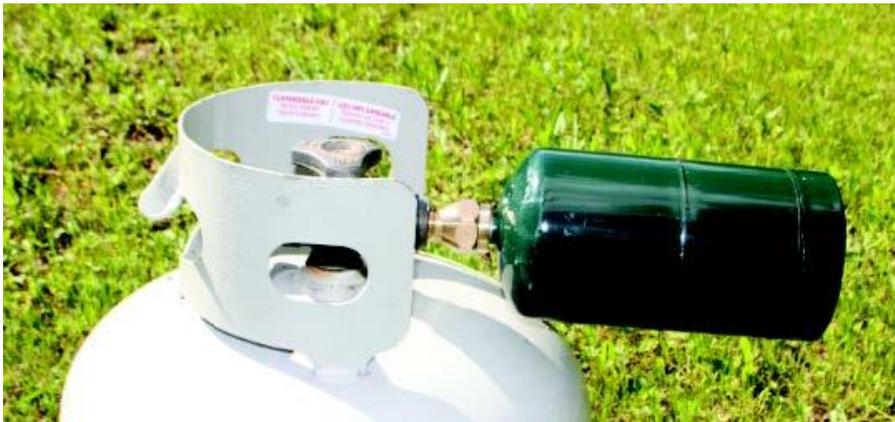
Photo 7: Non-reusable DOT 39 propane cylinder on the right attached by an adapter to a larger propane cylinder. This configuration is similar to that of the incident cylinders and adapter.

Though not a factor in this incident, because the 1-pound cylinders are manufactured for one-time only use and are not subject to the more rigorous manufacturing standards of refillable cylinders, they may present a safety hazard if refilled and reused. Over time, with the stresses of multiple refills and emptying, these cylinders may become less durable and potentially subject to failure, presenting a risk of fire, explosion, serious injury, and death.

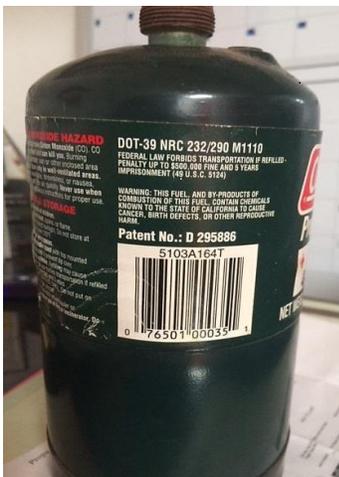
Photo 9: Standard warning label on 1-pound DOT 39 propane cylinder with message: "FEDERAL LAW FORBIDS TRANSPORTATION IF REFILLED – PENALTY UP TO \$500,00 FINE AND FIVE YEARS' IMPRISONMENT (49 U.S.C. 5124)"

Additionally, Federal law forbids the transportation of these 1-pound cylinders, also known as DOT 39 cylinders, if they are refilled. Washington State law does not allow the refilling or reuse of containers manufactured in accordance with the specifications of 49 CFR Part 178 and authorized by 49 CFR Chapter 1 as a “single trip” or “nonrefillable container” in LP (Liquefied Petroleum) gas service.

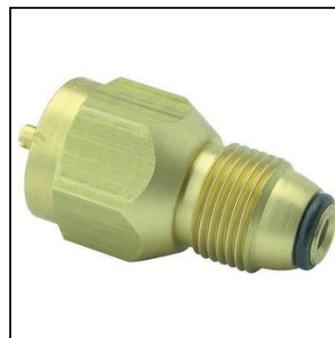
Photo 8: Adapter example.
