Crane Operator Dies after Falling From Crane Turntable Deck in Washington State

Investigation: # 10WA046
Release Date: October 11, 2011
SHARP Report: # 52-22-2011

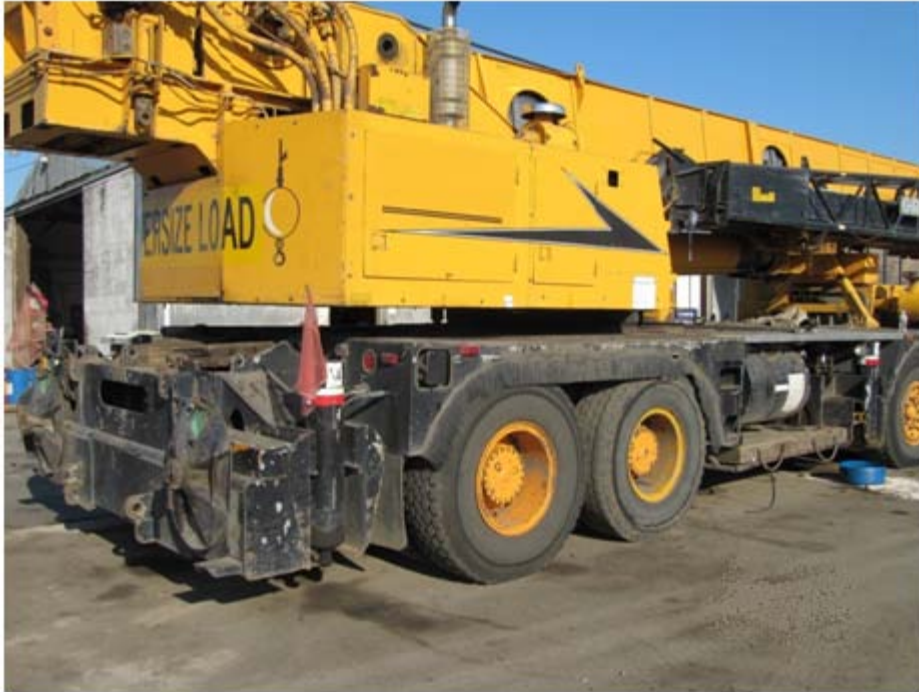
Photo 1. Incident crane viewed from the right rear. At the time of the incident the cab was rotated approximately 30 degrees right.

The crane involved in this incident was a 120-ton truck- or carrier- mounted hydraulic mobile crane with a telescoping boom (see photo 1). The crane's wheel-mounted truck carrier, designed for transporting the crane's superstructure which is mounted on it, is 40 feet 9 inches long by 10 feet 11 ½ inches wide. The top of the crane's turntable deck is 5 feet 1 ¼ inches high off the ground. The crane is designed to travel to and about a job site under its own power. It was manufactured in 1991 and was purchased used the employer. In addition to the original manufacturer's placement of ladders, steps, handrails, and handholds used to access parts of the crane and as aids to mounting and dismounting, the previous owner had added extra handholds and steps at various locations (see photos 3-5, 8, 9). The crane's walking surfaces were coated with an anti-slip coating. No modifications to the crane were made by the current owner. In Washington State all cranes used in construction must be certified that they meet certain requirements for safe operation, as specified by state law. The crane was a certified crane, as specified by state requirements. Comprehensive crane safety inspections are done yearly. Pre-job walk around safety inspections are performed by the crane operator before the crane leaves the company yard.

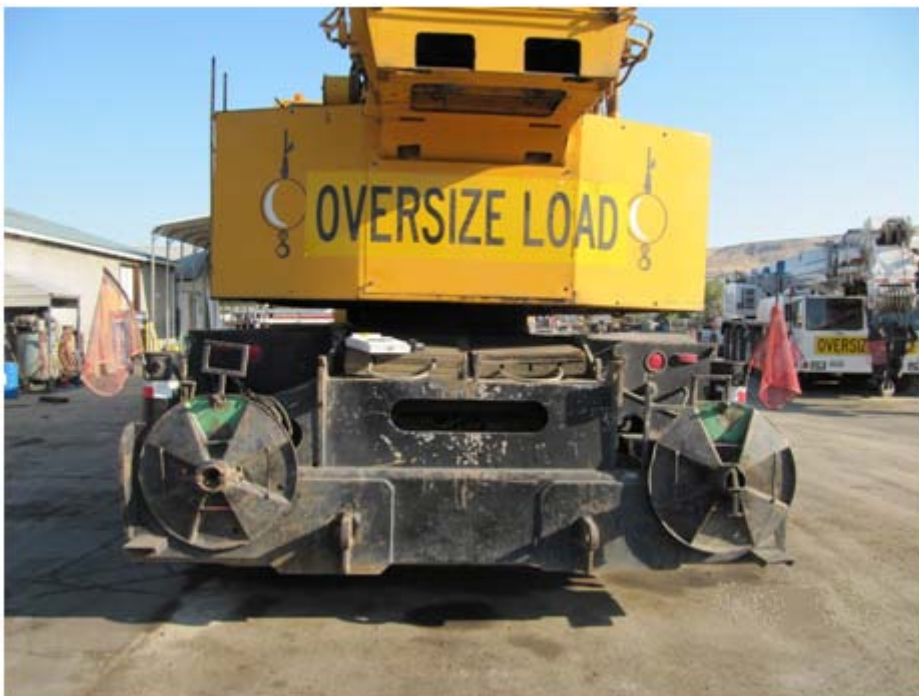
Photo 2. Incident crane rear view. Victim fell from the right rear crane turntable deck.

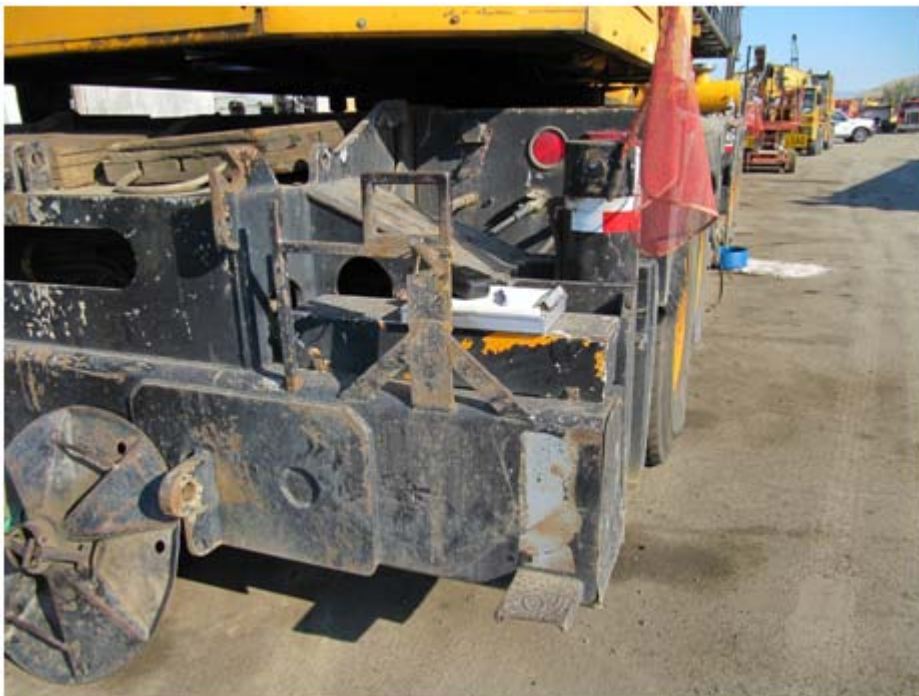
Photo 8. Incident crane rear access system where victim fell.

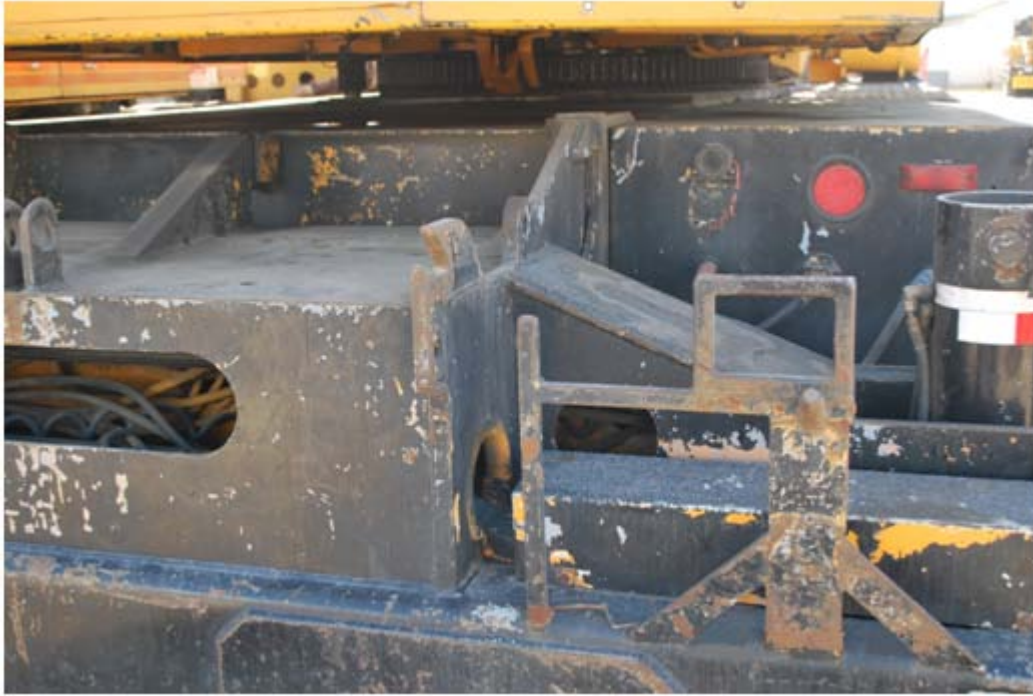
Photo 9. Incident crane close-up of features of rear access system.

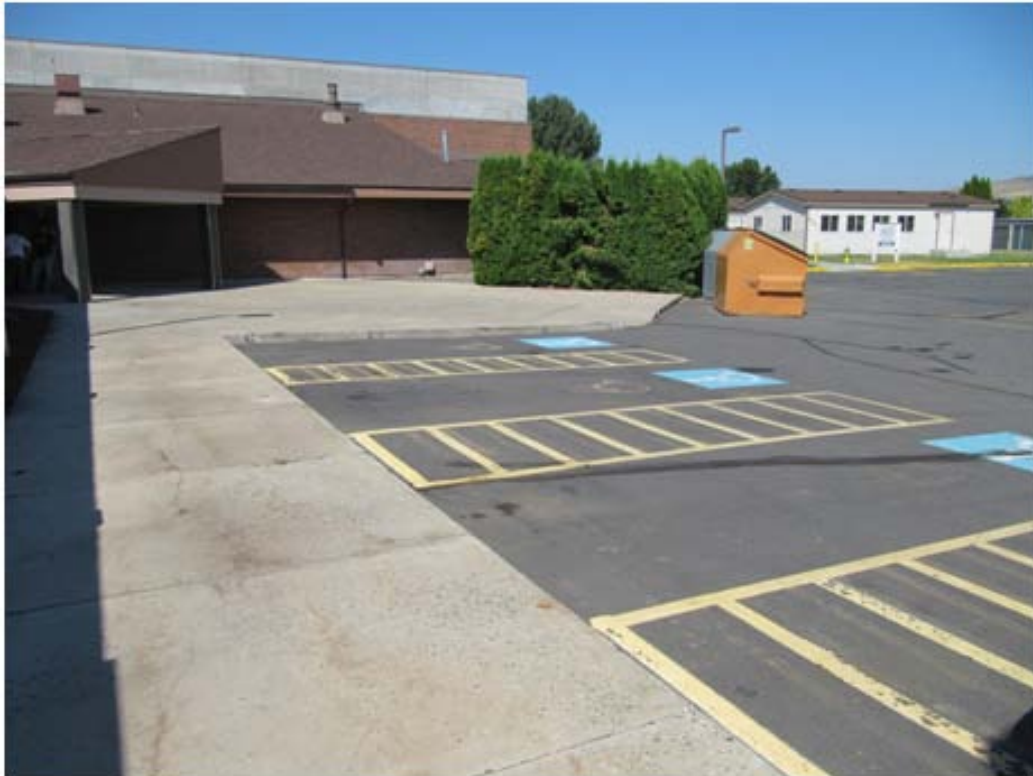
Photo 10. Incident location in parking lot of elementary school. Crane was backed into the parking stall in the upper middle of the photo.
