Flagger Killed When Struck by Dump Truck, During Road Construction in Washington State

FATALITY INVESTIGATION REPORT

Investigation: # 99WA07001
SHARP Report: # 52-8-2002

Fatality Assessment and Control Evaluation (FACE) Program

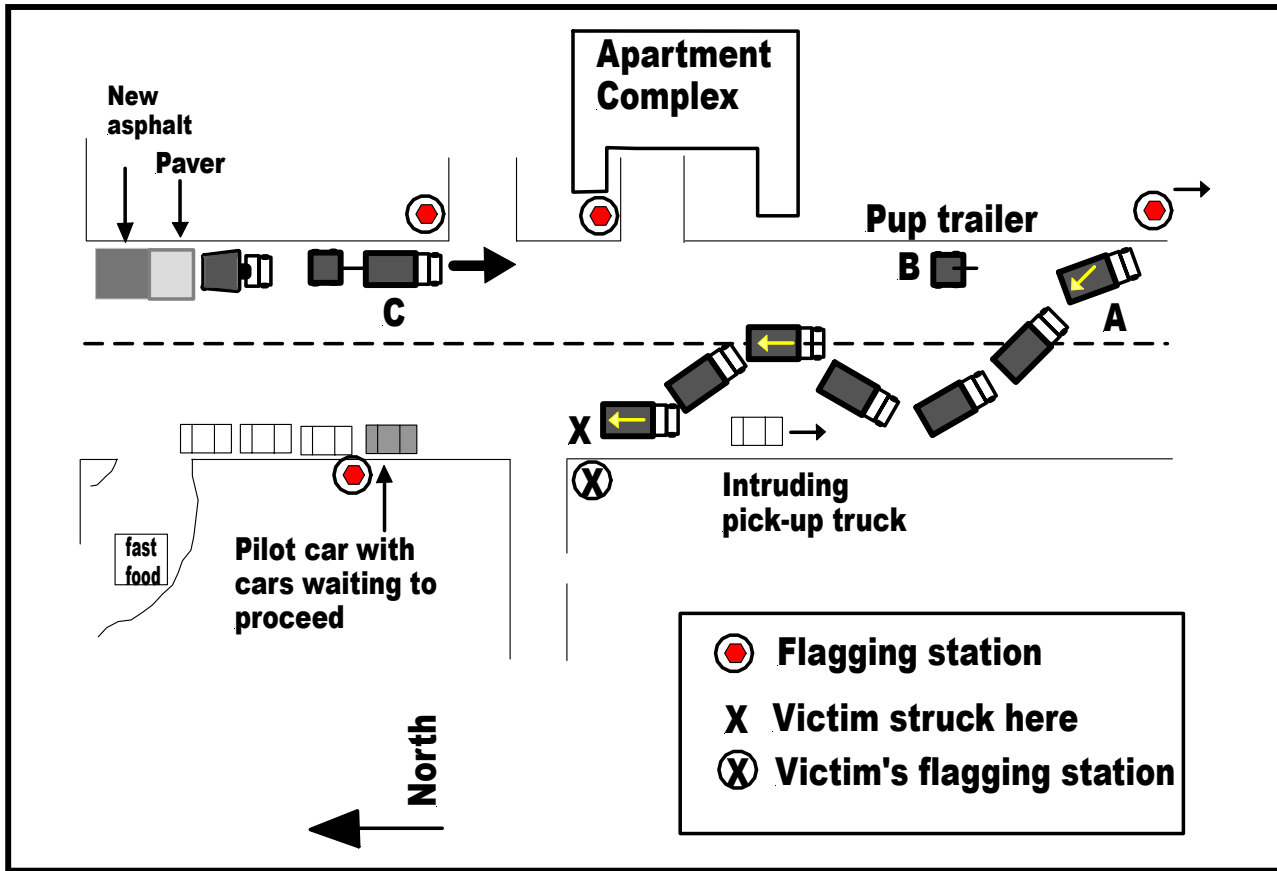
Figure 1. Schematic of work zone and the incident.

The flaggers were positioned at various points along the work zone for traffic control and worked in conjunction with a pilot car to manage traffic along the section of road being paved. One of the traffic control supervisors drove the pilot car. The flaggers who were stationed at the two work zone project entrance locations were equipped with two-way radios. The flaggers stationed along the work zone controlling street intersections and apartment complex driveways did not carry two-way radios (See figure 1).

At approximately 8:15 AM, a contract dump truck had been given the signal from the paving foreman to bring his load to the paver. He was driving a 19.8 ton Kenworth dump truck (A in figure 1) and had previously dumped a load from his pup trailer (B) and disconnected the trailer. He began backing up his truck to dump his load of asphalt. At about the same time that the dump truck was backing up, the pilot car was traveling toward the backing truck. The pilot car driver saw a white pick-up truck intruding into the work zone and called to warn the dump truck driver. The dump truck pulled into the east lane of the road to allow the pick-up truck to pass and then moved back to the lane of travel (the west lane) and continued to back up. Backing up in the west lane allowed an empty dump truck (C) to exit from the paver using the east lane (See figure 1).

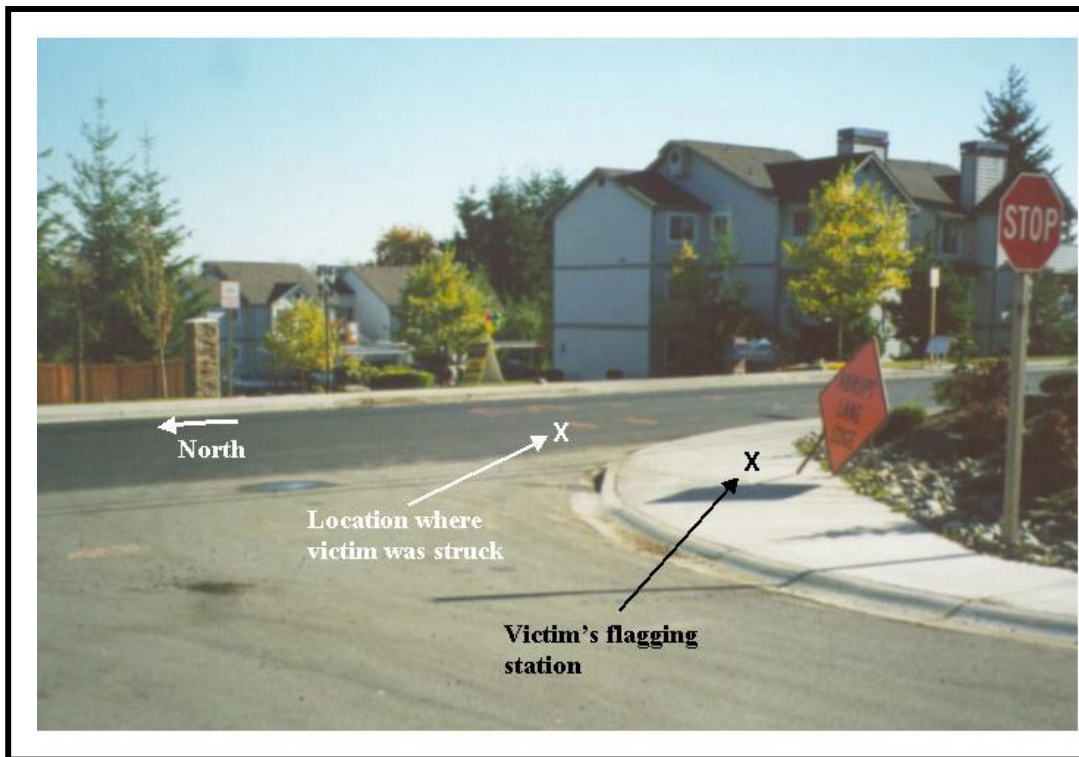
Figure 2 Victim's flagging post.

The victim had been assigned to control traffic from one of the intersections which lead to a cul-de-sac along the work zone, and to watch for traffic turning into and out of an apartment complex across the street (figure 2). The victim did not have a two-way radio.

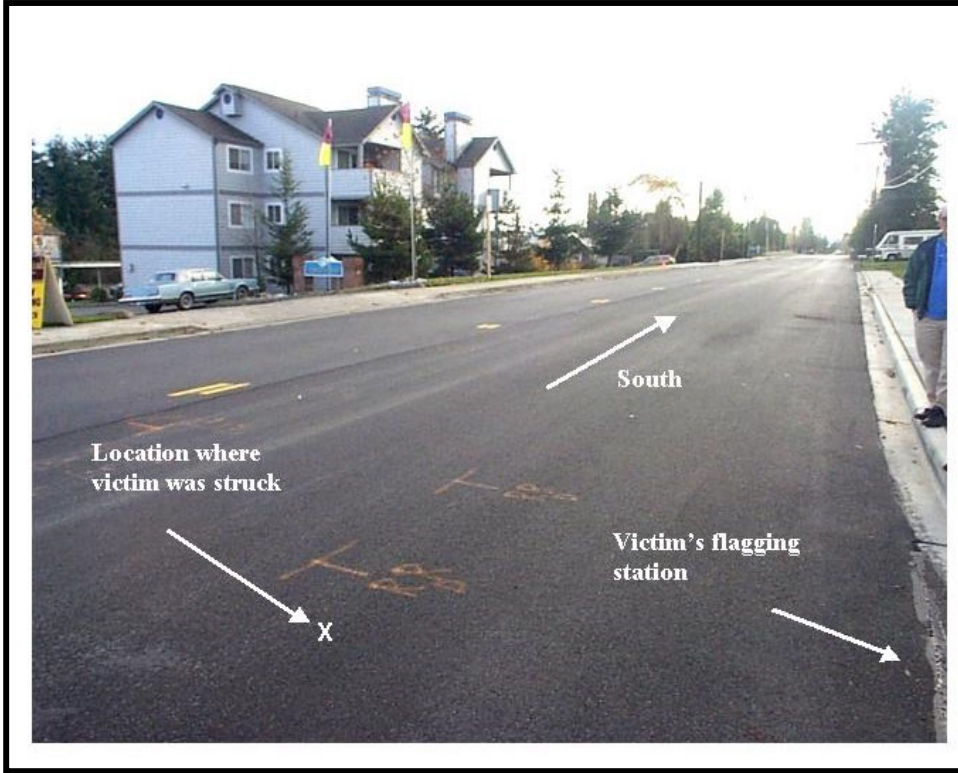
Figure 3. View flagger had towards the on-coming dump truck.

The section of street where the victim was standing was relatively level and visibility towards both ends of the work zone was good (figure 3). The weather was clear and dry. Witnesses stated that there was little or no wind and the truck's back up alarms were very noticeable.
